Aquatic Biodiversity Assessment

**Proposed Tourism Development on Portion 11 of Melkhoutfontein
Farm 449, Hessequa District, Western Cape.**

September 2024

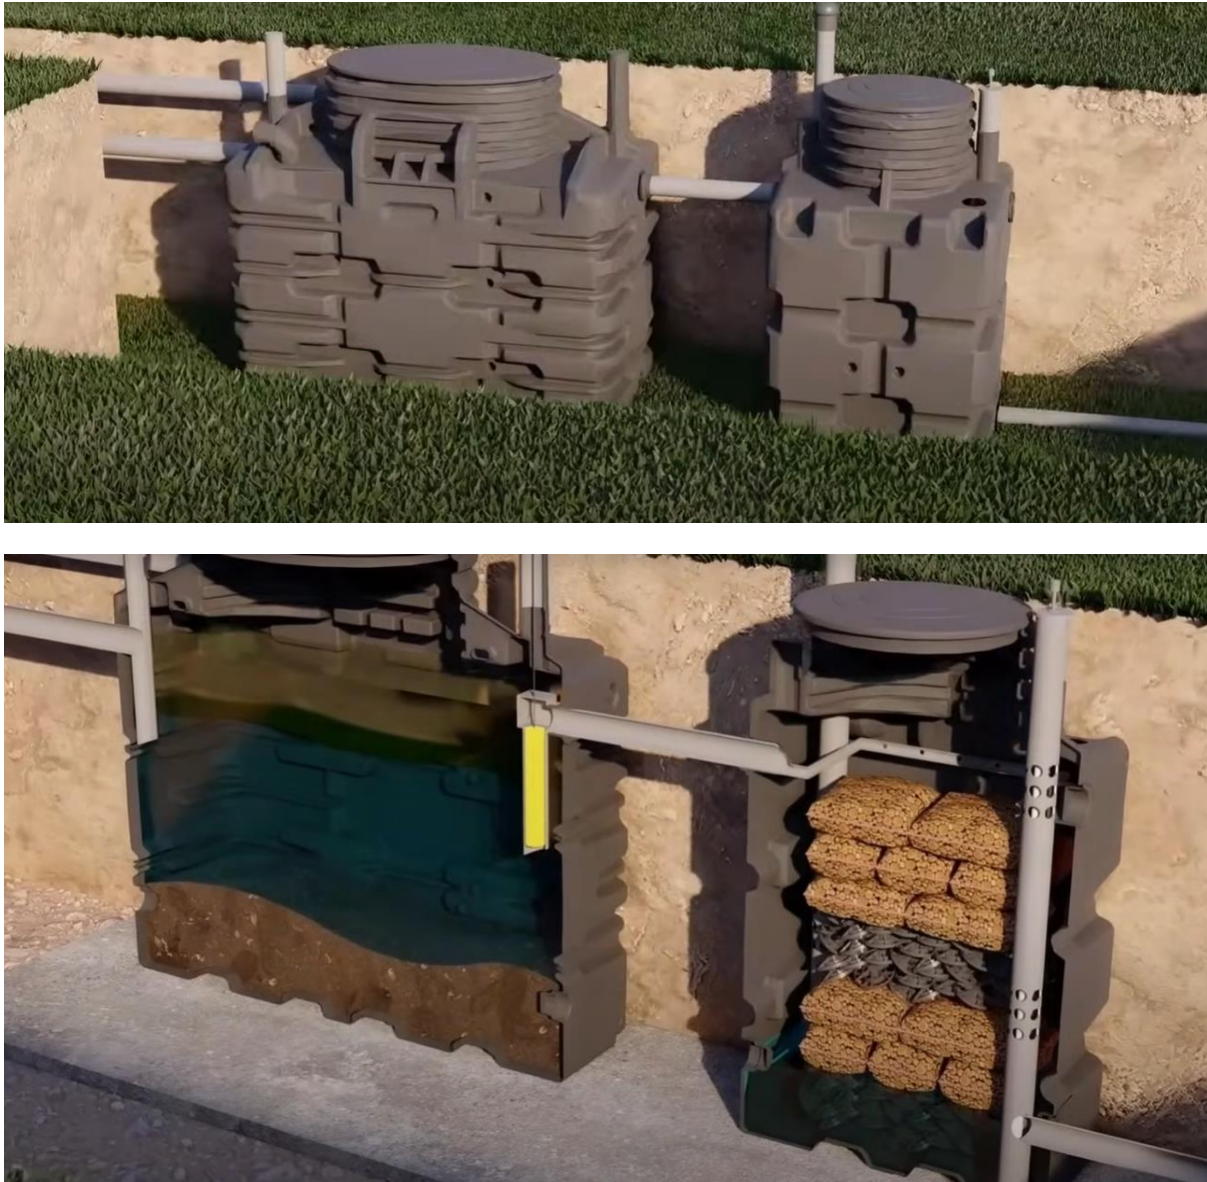
Figure 8. Stock images from BioRock website showing the arrangement of primary and bioreactor tanks.

Sewage for each node will be treated using a BioRock system installed at each node (See <https://biorock.com/how-biorock-works>). The basic process described for this system is a three-step process:

The Primary Tank clarifies the raw sewage by dividing fats, oils, greases and organic solids. The sewage then passes through an effluent filter, before discharging into the BIOROCK reactor.

The Bioreactor purifies further the pretreated wastewater with a biological process. To naturally treat the wastewater, our systems use our unique BIOROCK Media, an exclusive and very efficient carrier material for bacteria.

Depending on the ground type, effluent will be discharged by gravity, or by a pump.

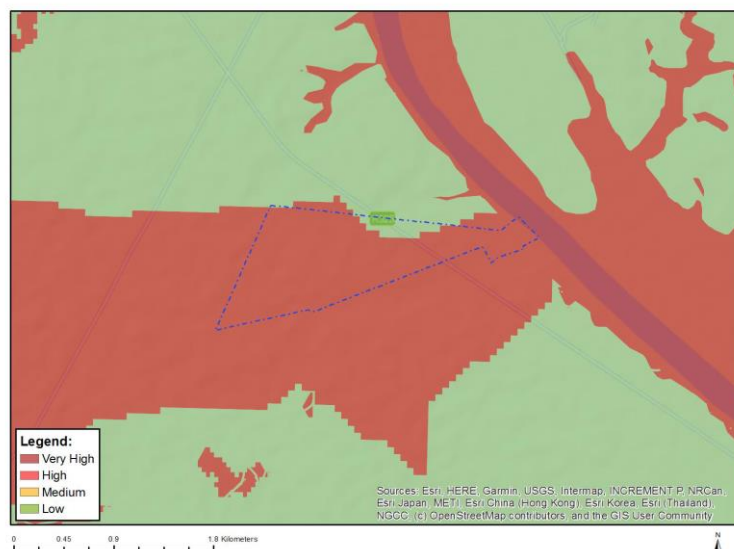
Figure 9. Results of the DFFE Screening Tool which indicate Very High Sensitivity of the Aquatic Biodiversity theme for Portion 11/449 Melkhoutfontein.

According to the Department of Environment, Forestry and Fisheries (DFFE) screening tool, aquatic biodiversity at the site has a **Very High** sensitivity (Figure 9). The sensitivity features identified are as follows:

- Critical Biodiversity Area 1 (CBA): Aquatic
- CBA 2: Aquatic (degraded)
- Estuary Gouritz
- FEPA Sub-catchment
- Rivers_AB
- Wetlands_(Estuary)
- Wetlands Albany Thicket (Valley-bottom)

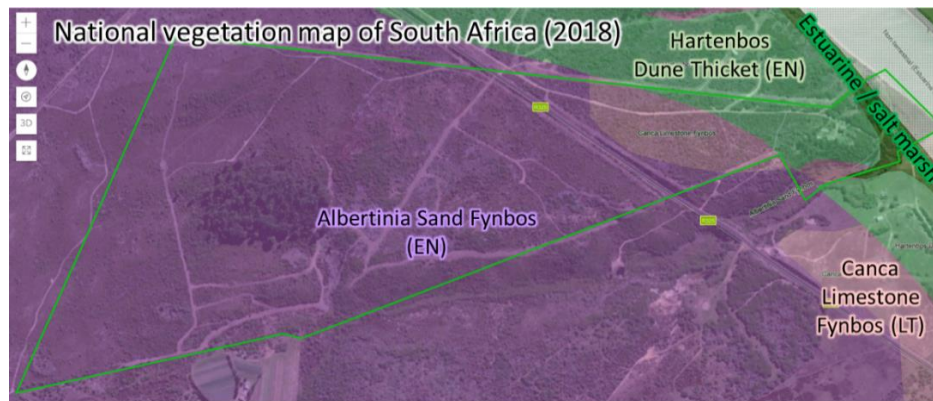
Figure 12. Mapped vegetation types according to VegMap (2018) from Botanical Specialist Report by Bianke Fouche (Jul 2024).

The mapped vegetation type at the site is **Albertinia Sand Fynbos** (FFd9; **Endangered**; National Vegetation Map of South Africa (NVM), 2018), **Hartenbos Dune Thicket** (AT40; **Endangered**; NVM, 2018) and **Estuarine Salt Marsh** is mapped in a narrow strip along the Gouritz River (NVM, 2018), and has been categorised to have Very High sensitivity in the screening tool report. A detailed botanical specialist assessment is available for the site (Confluent Environmental, Botanical Specialist Assessment 2023). Development Node 1 is located in the mapped Hartenbos Dune Thicket and Development Node 2 is in Albertinia Sand Fynbos. A detailed assessment of the vegetation on site has been compiled by Bianke Fouche of Confluent Environmental (July 2024).

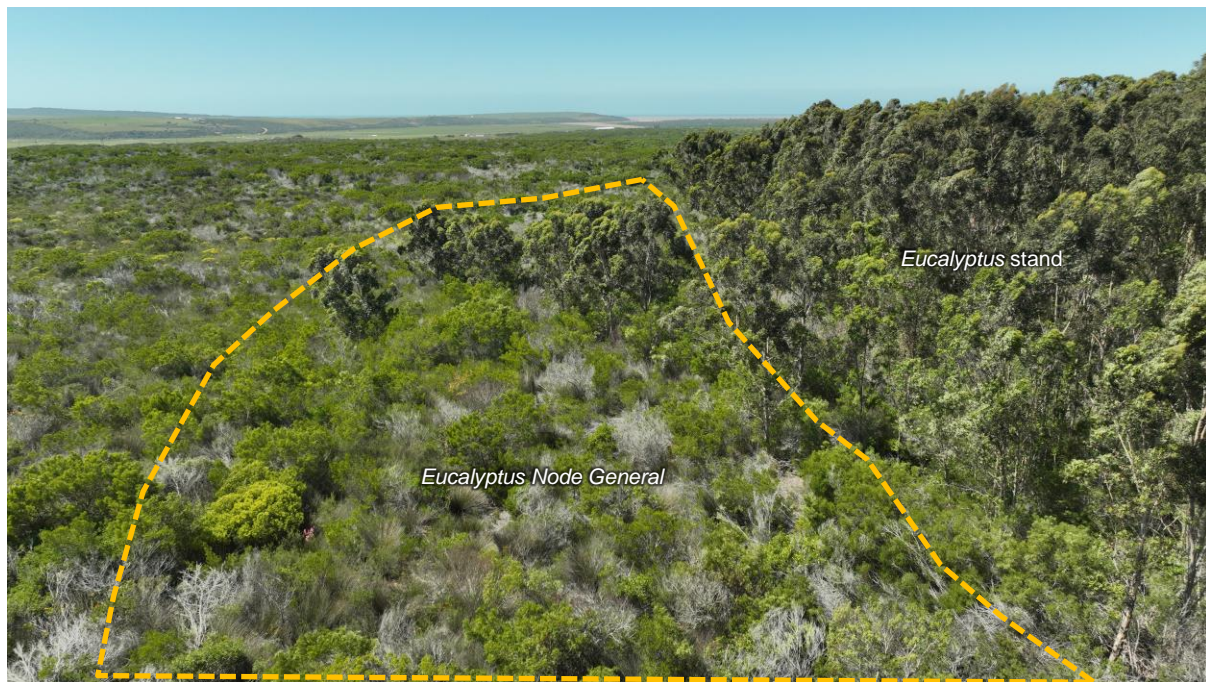
Figure 18. Drone photo showing the general area of Node 2 with *Eucalyptus* stand to the right and a Rooikrans-invaded (*Acacia cyclops*) edge beyond which is dominated by fynbos.

The site was visited on 28 September 2023 two days after a significant rainfall event caused by a cut-off low system (23-26 Sep 2023). The Gouritz River was still flowing strongly and the water level was high. At the time of the site visit the weather was clear and all mapped watercourses were visually assessed. The full extent of both Node 1 and Node 2 were assessed by walking extensively through the area (Figure 16), identifying any plant species indicative of wetland conditions and inspecting soil auger samples for signs of redoximorphic indicators of saturation. A drone was used to take photos providing an aerial overview of the two nodes and other relevant features (Figure 16, Figure 17, Figure 18).

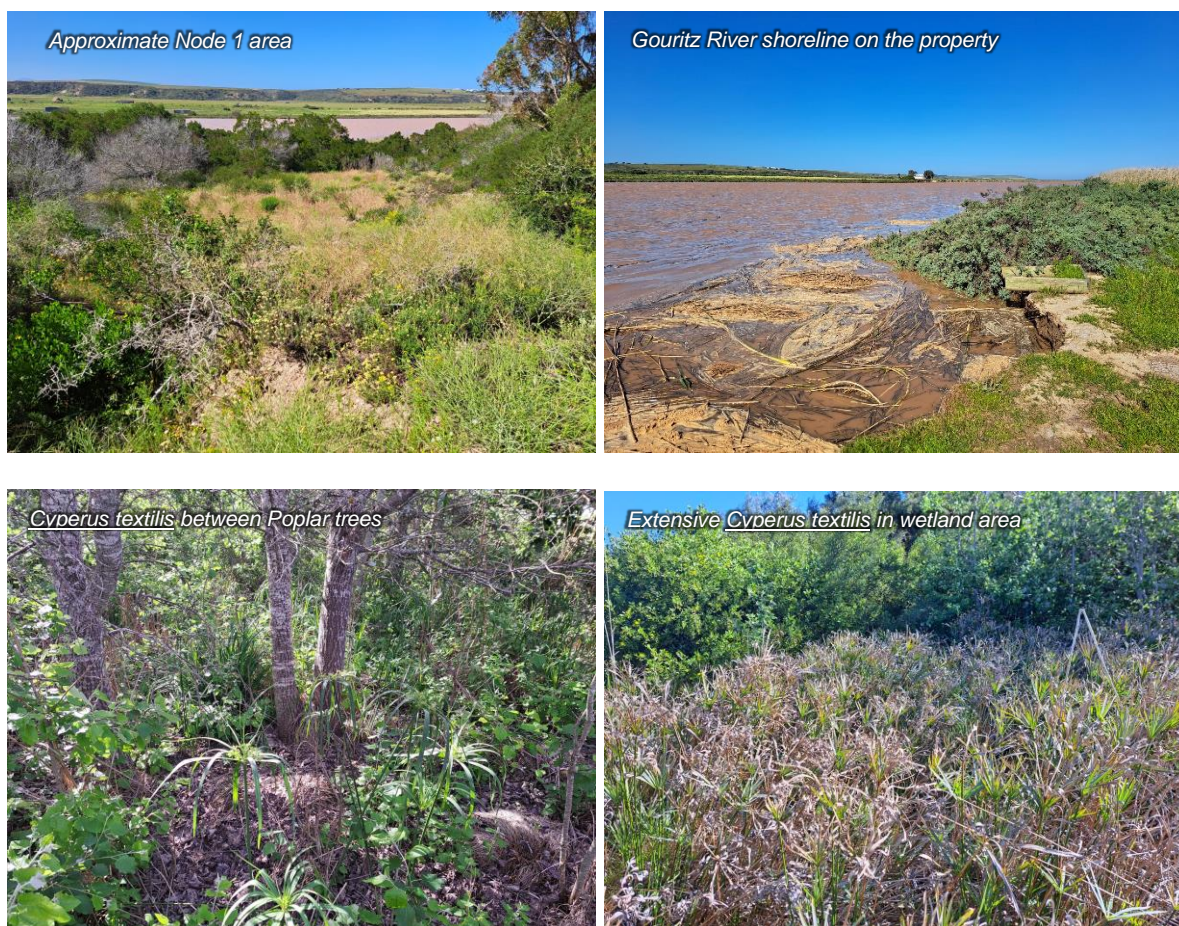
Figure 20. Photos in the vicinity of Node 1 showing wetland features of the channelled valley-bottom system and the Gouritz River.

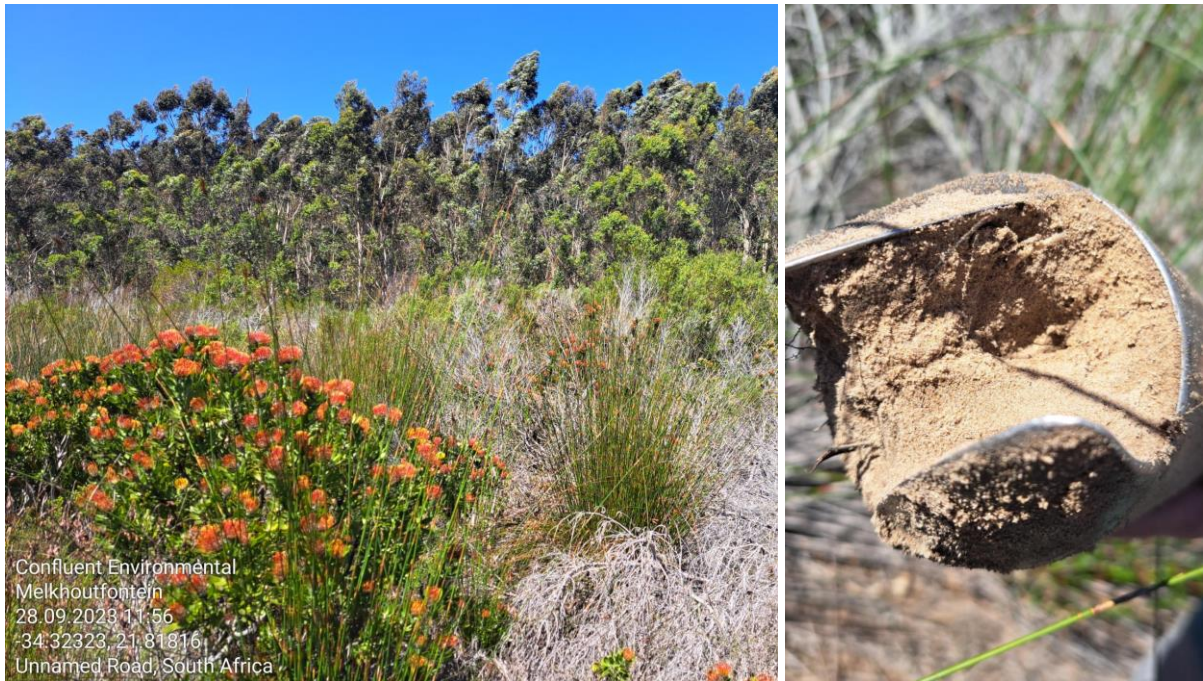
Figure 21. Terrestrial habitat in the vicinity of Node 2 north of the *Eucalyptus* stand and a typical soil auger result from the area indicating no reodoxymorphic features.

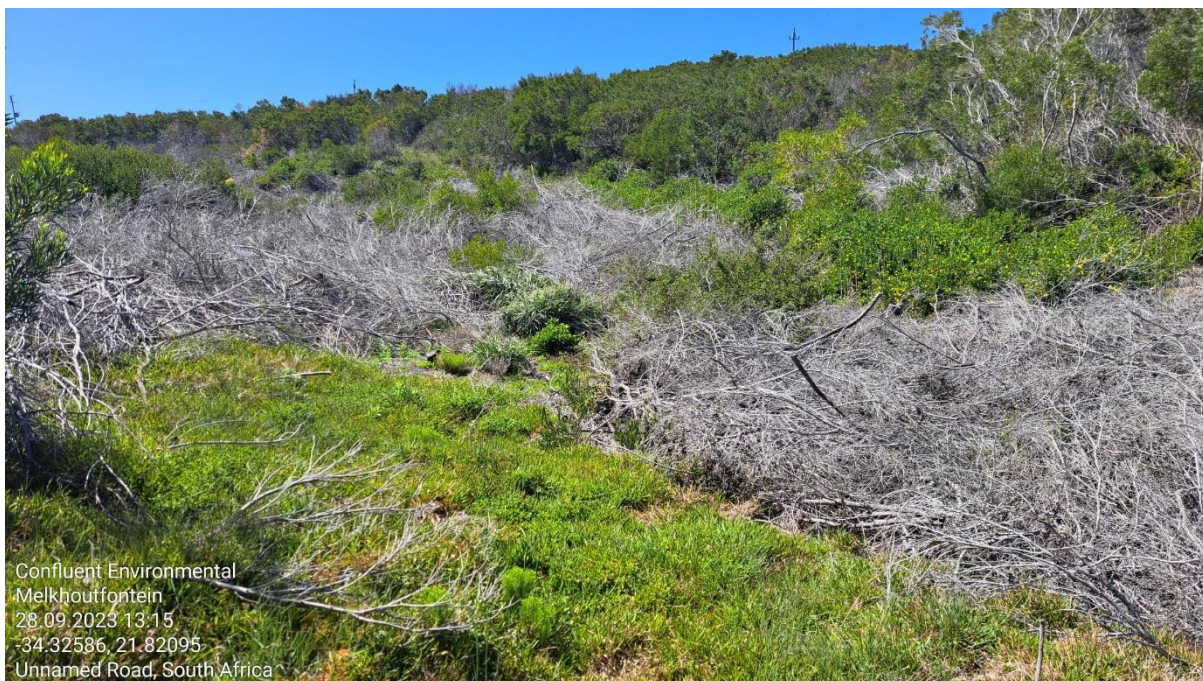
Figure 22. Unchanneled valley bottom wetland south-east of *Eucalyptus* in Eucalyptus Node. Piles of dead, cleared Rooikrans have been stacked through the wetland area.

The updated SDP places all 3 accommodation units to the north of the *Eucalyptus* stand with the closest unit 150 m from the wetland (Figure 22) (Figure 23).

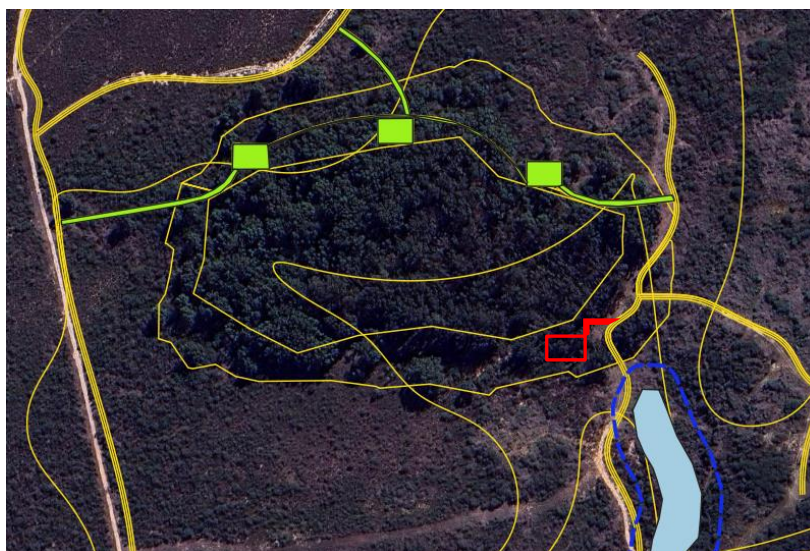
Figure 24. Eucalyptus Node development area showing the preferred layout (green units) and the non-mitigated layout showing the location of the unit proximal to the wetland and buffer (red unit).

The same construction phase impacts and proposed mitigation measures proposed for the Preferred Layout are applicable to the non-mitigated layout. These mitigation measures aimed to prevent unnecessary habitat destruction or loss resulting from construction of the units. The location of the 3rd unit was already positioned outside of the wetland and recommended 15 m buffer (Figure 24).

The primary reason for recommending that the unit proximal to the wetland in the *Eucalyptus* Node be relocated was to reduce/eliminate the risk of leaking sewage into the wetland. This impact requires no further assessment because the recommendation was supported by moving the unit out of this higher risk area.
