**RESIDENTIAL DEVELOPMENT ON THE REMAINDER  
OF PORTION 60 OF THE FARM PLATTEBOSCH NO.  
485, STILL BAY, WESTERN CAPE  
EA REF: 16/3/3/5/D5/19/0001/22**

**CONSTRUCTION PHASE  
ECO REPORT  
FOR FEBRUARY 2025  
(Submitted 28 February 2025)**

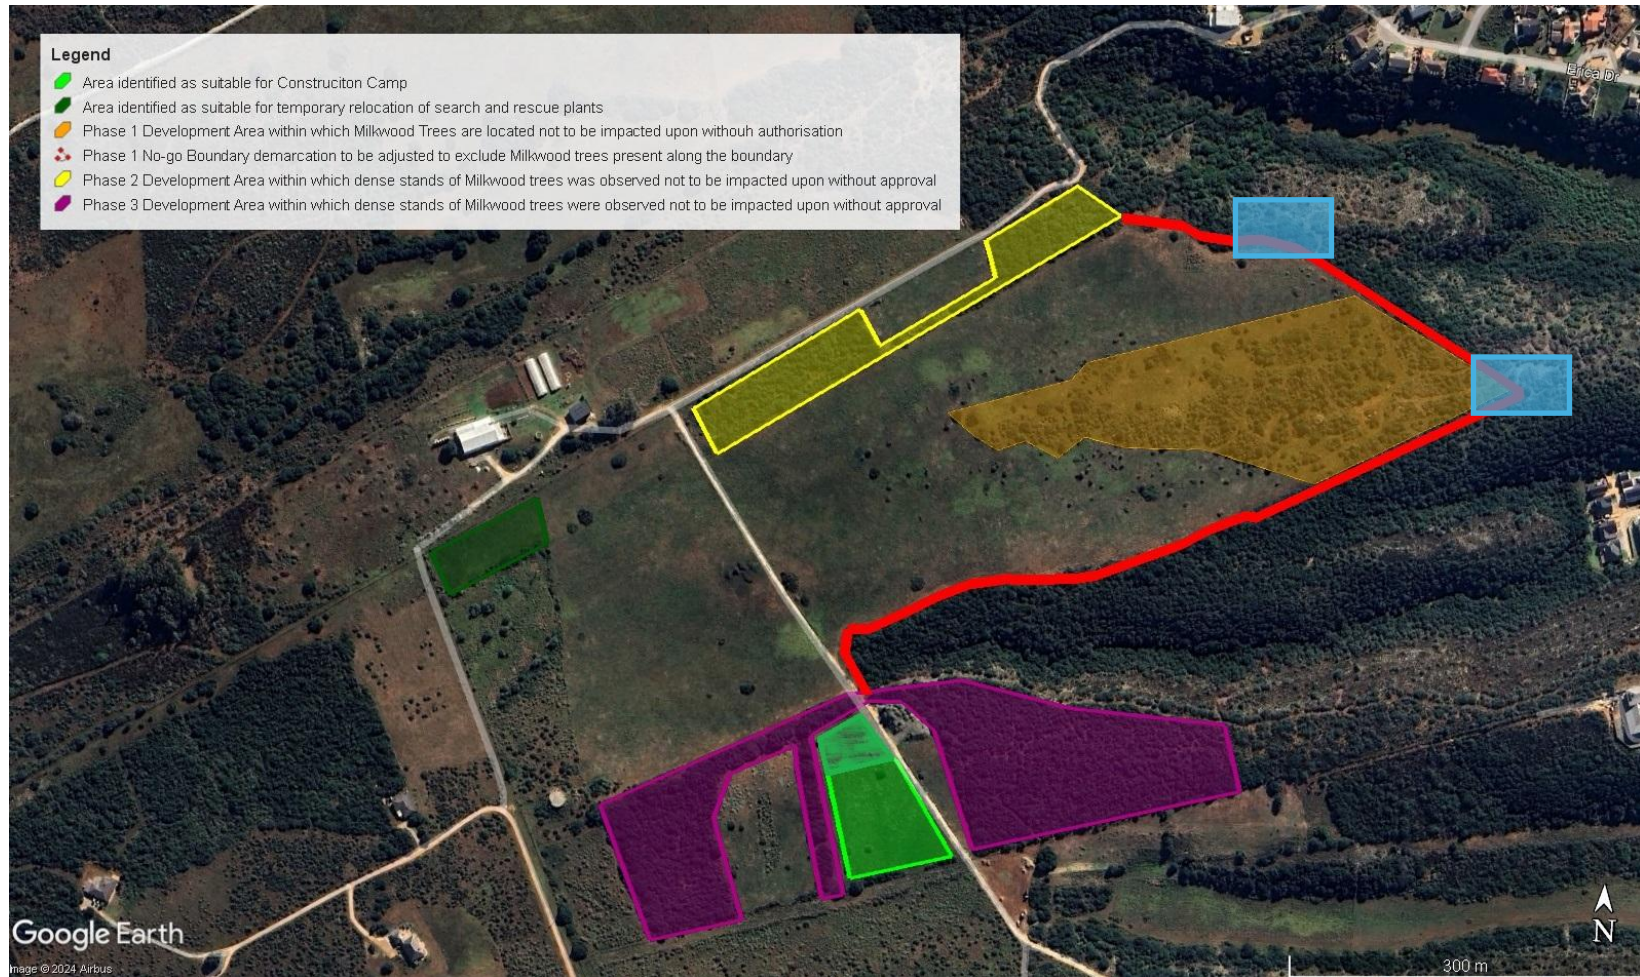
**Map 1:** July 2024 ECO map for indicating areas where Milkwood trees were observed and to be avoided; proposed construction camp placement; proposed search and rescue plants temporary placement. **The blue squares on the map above shows where encroachment into the no-go areas have occurred, as per the recommendations no-go demarcation must remain reinstated as per original demarcation done by the land surveyor and the impacted no-go area must be monitored for rehabilitated**

| | | <p>recorded to remain within the cleared area and no significant damage or removal of Milkwood trees observed within this area.</p> <p>To show how Milkwood trees are incorporated into the development layout and proof that observed Milkwood trees remain undamaged/are not removed within the development area throughout the construction and development phases all Milkwood trees falling within the development footprint area must be recorded and indicated on the approved development layout plan. This is required for all remaining Milkwood trees within the already cleared Phase 1 and 2 areas as well as clearly visible Milkwood trees along the boundaries of Phase 1 and 2 and Phase 3 areas which has also been cleared.</p> <p>Should removal, relocation or pruning (of more than 25% of the canopy) of any Milkwood trees be required application/s must be made to the DFFE for removal, relocation or pruning before any Milkwood trees may be impacted upon. As far as possible these trees must be accommodated within the layout and not removed.</p> <p><b>Refer to the map below.</b></p> |

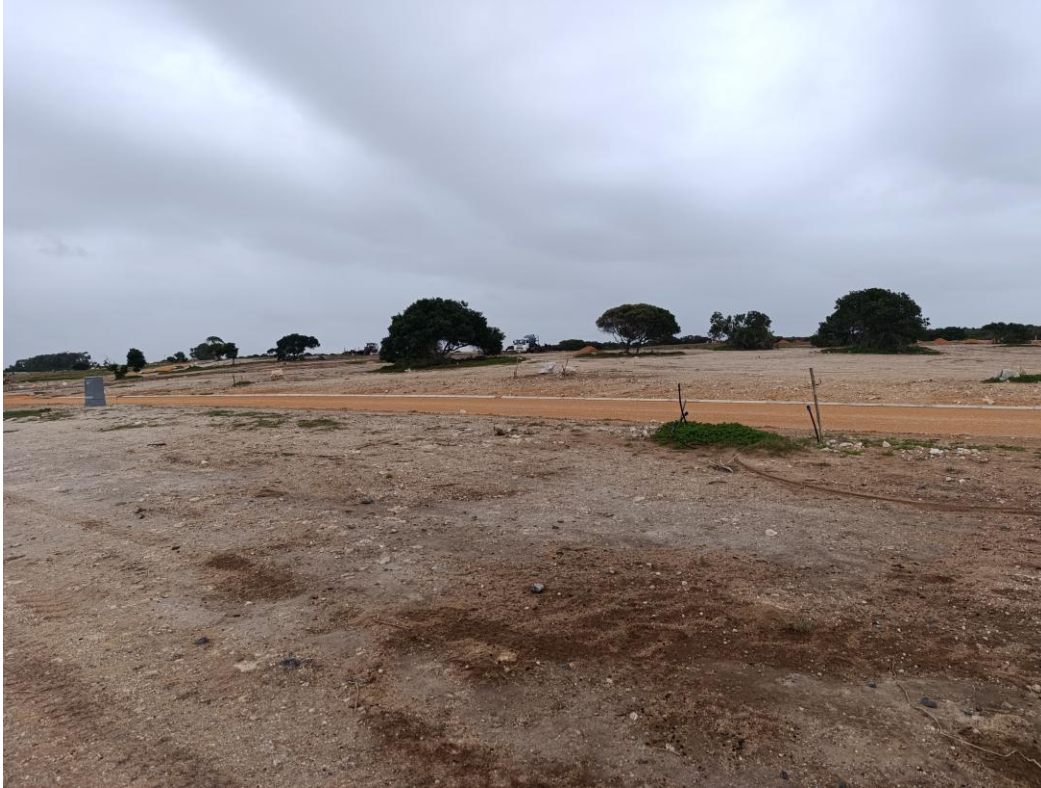
**Photo 1:** Remaining Milkwood trees om Phase 1 cleared area, to be recorded on layout plan (photo taken 25 February 2025).

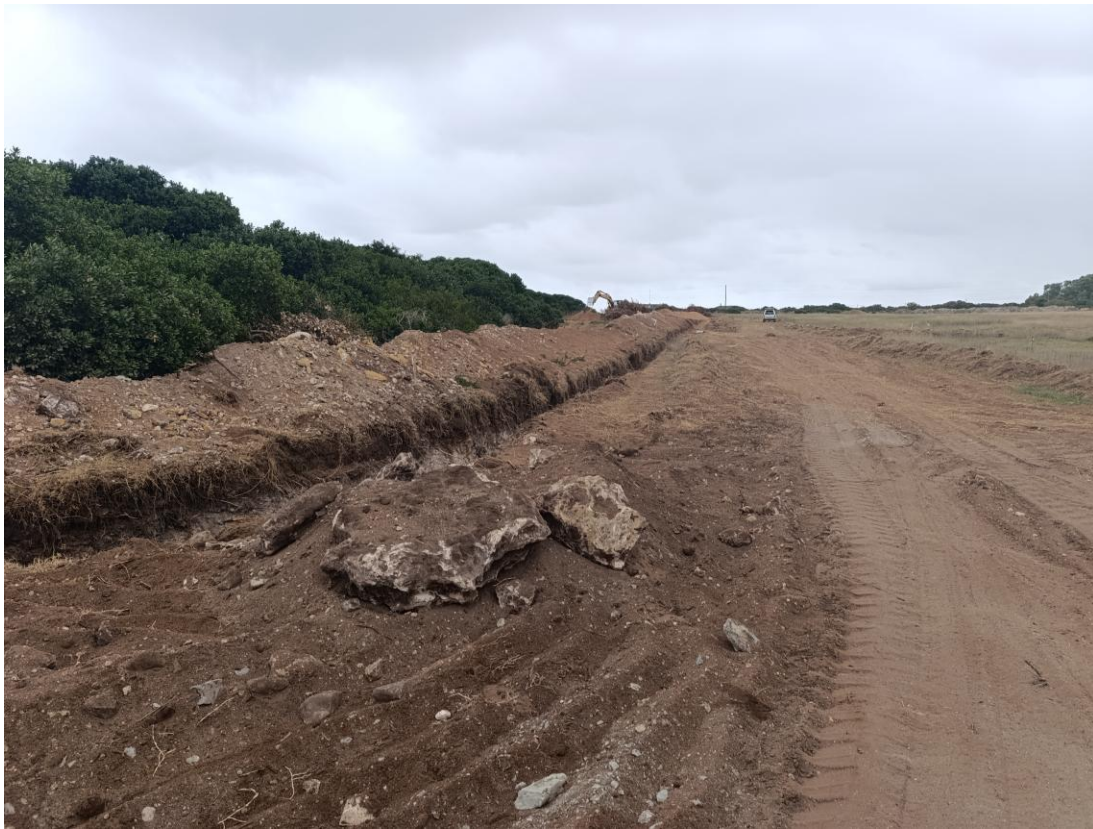
**Photo 2:** Construction along Phase 3 no-go areas, where the ECO was not provided with the opportunity to confirm correct demarcation before construction continued (photo taken 25 Feb 2025)

| F3 | Demarcation of No-go Areas | <p>During the time of the ECO inspection, it was observed that site clearance and construction activities along the boundaries of Phase 3 no-go areas commenced without providing the ECO opportunity to inspect the correctness of the no-go boundary demarcations.</p> <p>This has led to significant damage to at least two Milkwood trees observed along the no-go boundaries of phase 3. It was discussed with the site manager on site that rehab around the damaged Milkwood trees would take place same day to try and stabilise what remains of the trees to prevent the trees from dying.</p> |

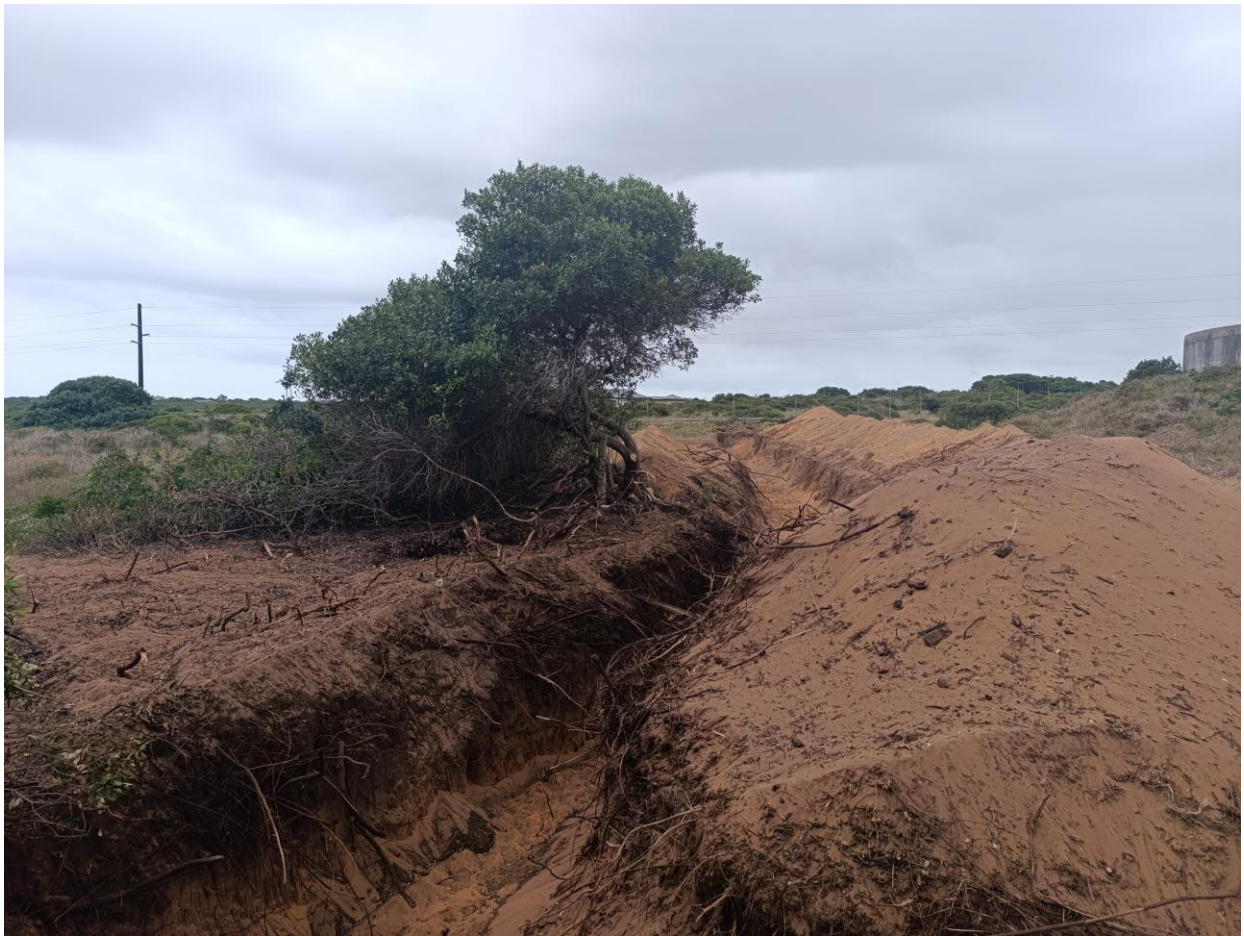
**Photo 4:** Damage to Milkwood trees along Phase 3 no-go boundary as observed by ECO (photo taken 25 Feb 2025)

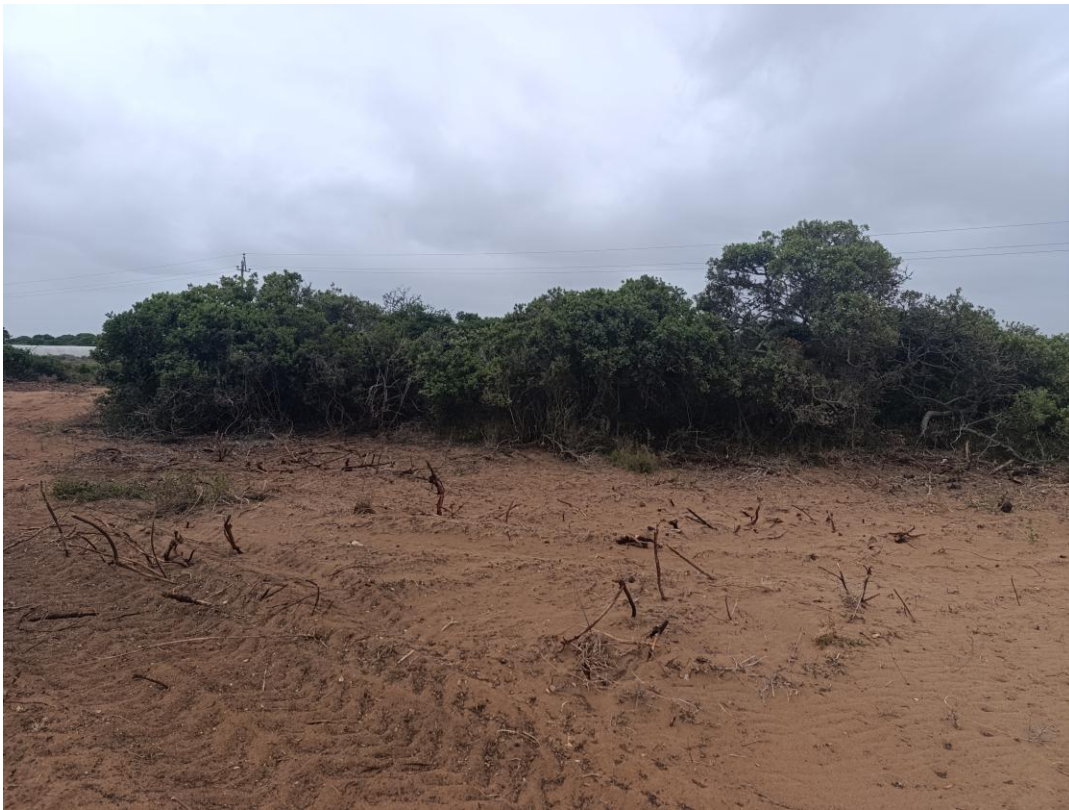
**Photo 5:** Milkwood tree clusters remaining within Phase 2 cleared areas (photo taken 25 Feb 2025)

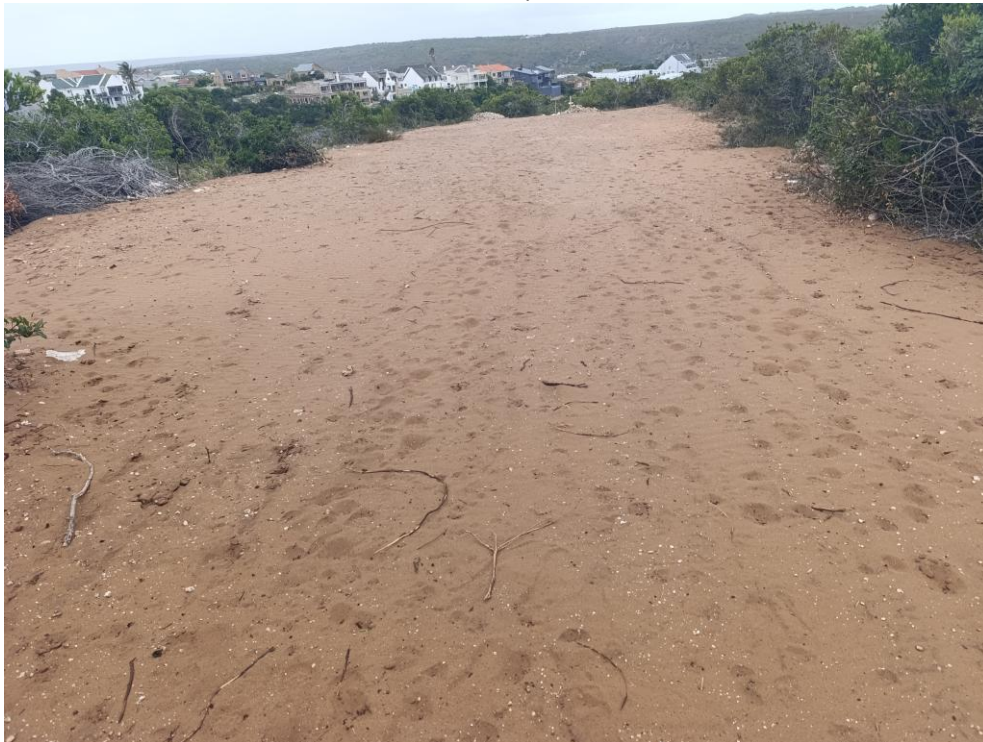
**Photo 6:** Backfilled first section of sewer pipeline within no-go area, to be rehabilitated (photo taken 25 Feb 2025)

- Once construction of the pipeline has been completed and all of the materials have been backfilled the impacted corridor must be monitored for rehabilitation by the ECO during the monthly ECO inspections.
- The ECO must keep a photographic record of rehabilitation progress.
- Should any erosion be detected the ECO must provide recommendations on rectifications and prevention measures to be implemented immediately.
- Should natural re-vegetation not take place at a satisfactory rate i.e. ongoing erosion or infestation with alien vegetation be detected the ECO must recommend suitable indigenous vegetation species to be planted within impacted areas.
- Alien and weed vegetation growth within impacted areas must be monitored by the ECO whom must recommend eradication and follow-up measures to be implemented should any alien or weed species be detected within impacted areas.

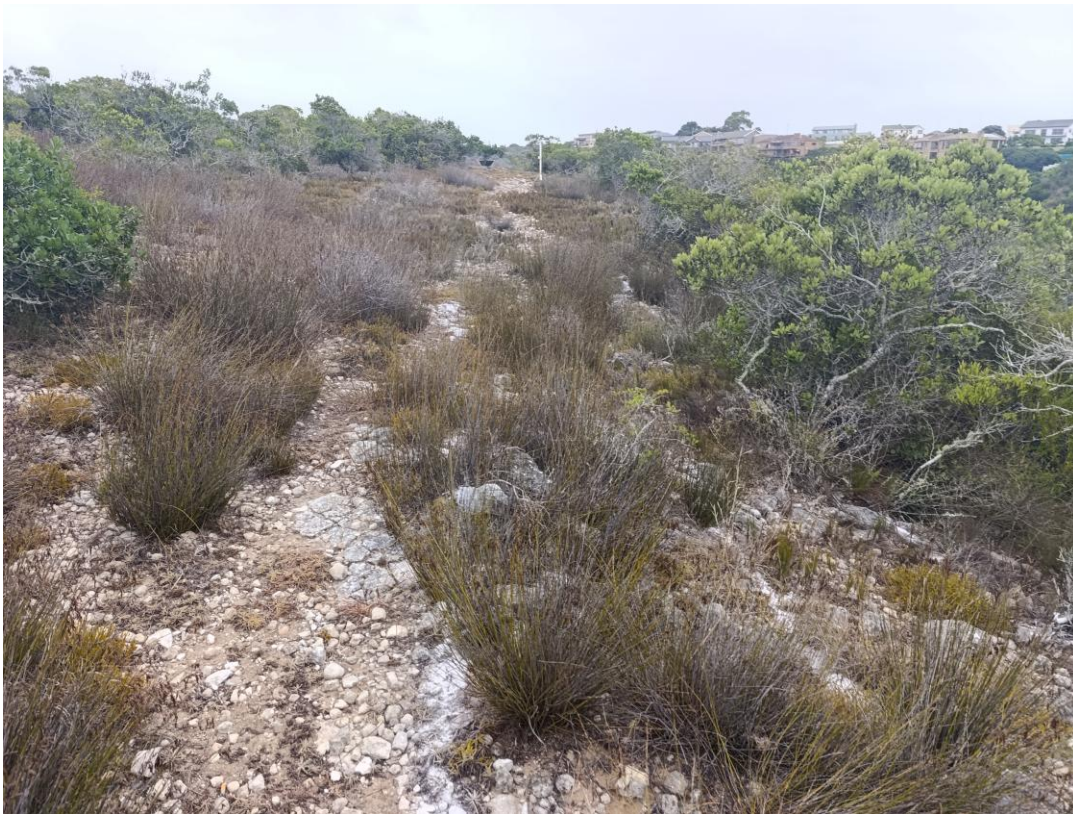
**Photo 7:** First 3m wide demarcated section of proposed sewer pipeline route within no-go area as inspected by the ECO, with Milkwood tree (nr 1) located within the route to be avoided (photo taken 25 Feb 2025).

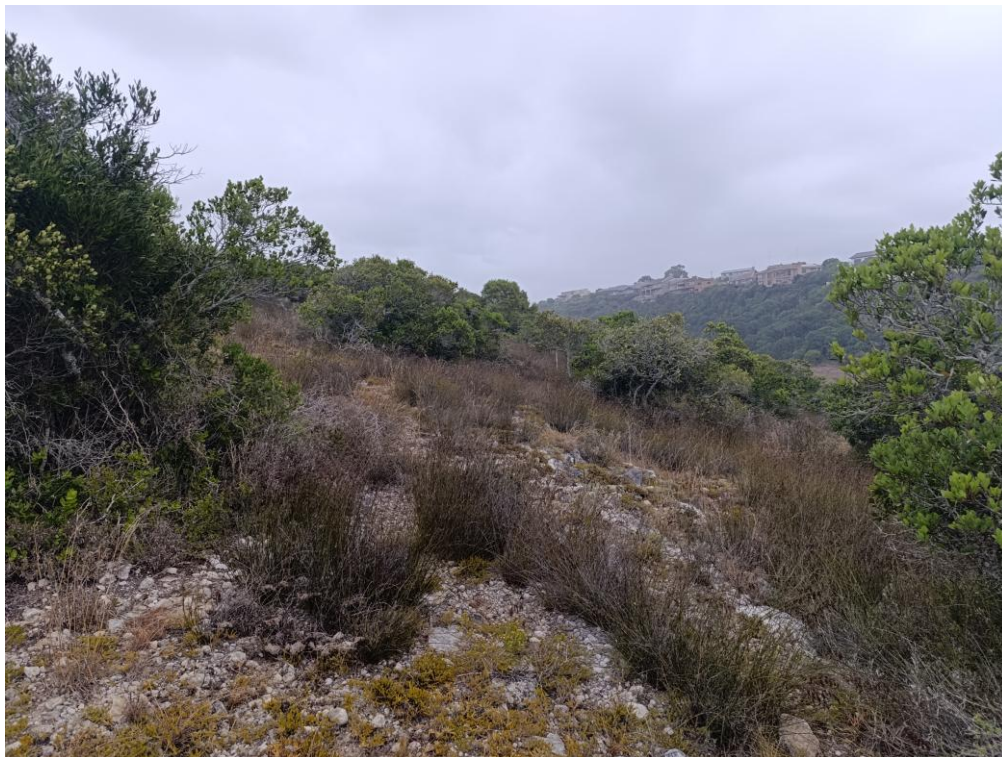
**Photo 8:** First 3m wide demarcated section of proposed sewer pipeline route within no-go area as inspected by the ECO, with Milkwood tree (nr 2) located within the route to be avoided (photo taken 25 Feb 2025).

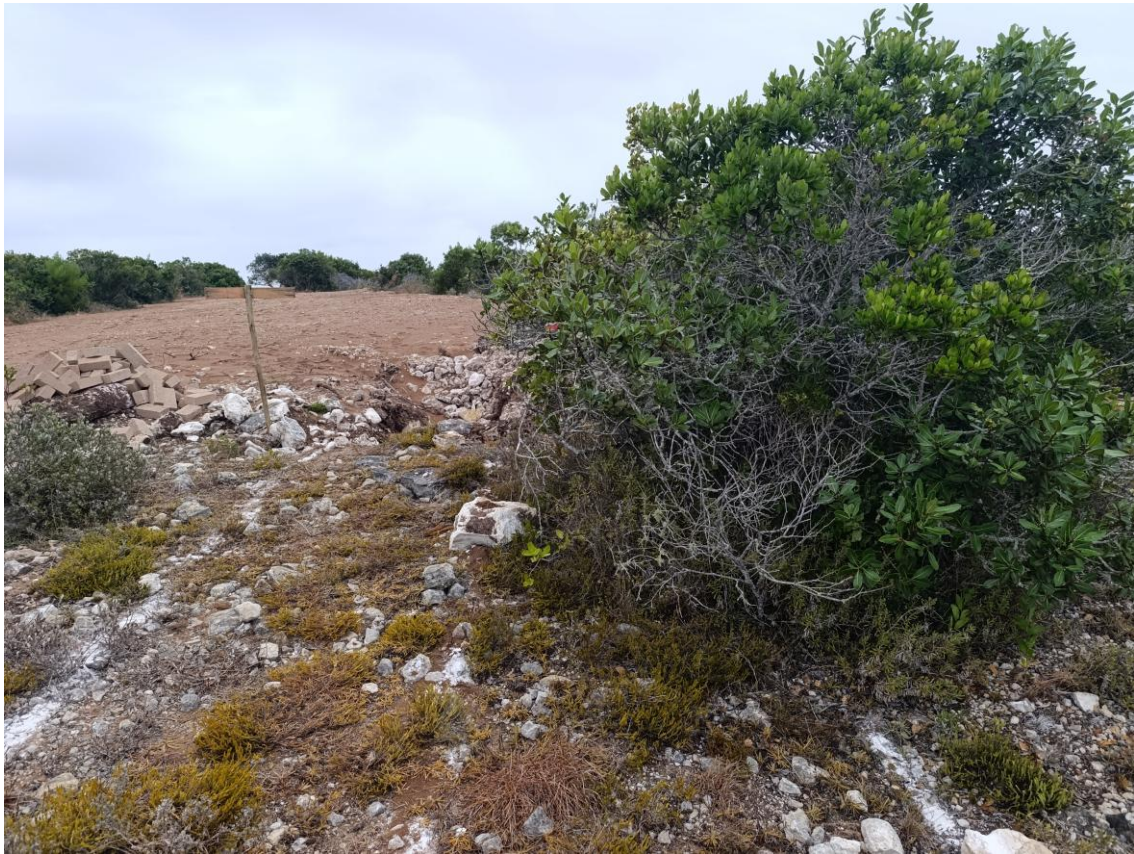
**Photo 9:** First 3m wide demarcated section of proposed sewer pipeline route within no-go area as inspected by the ECO, with Milkwood tree (nr 3) located within the route to be avoided (photo taken 25 Feb 2025).

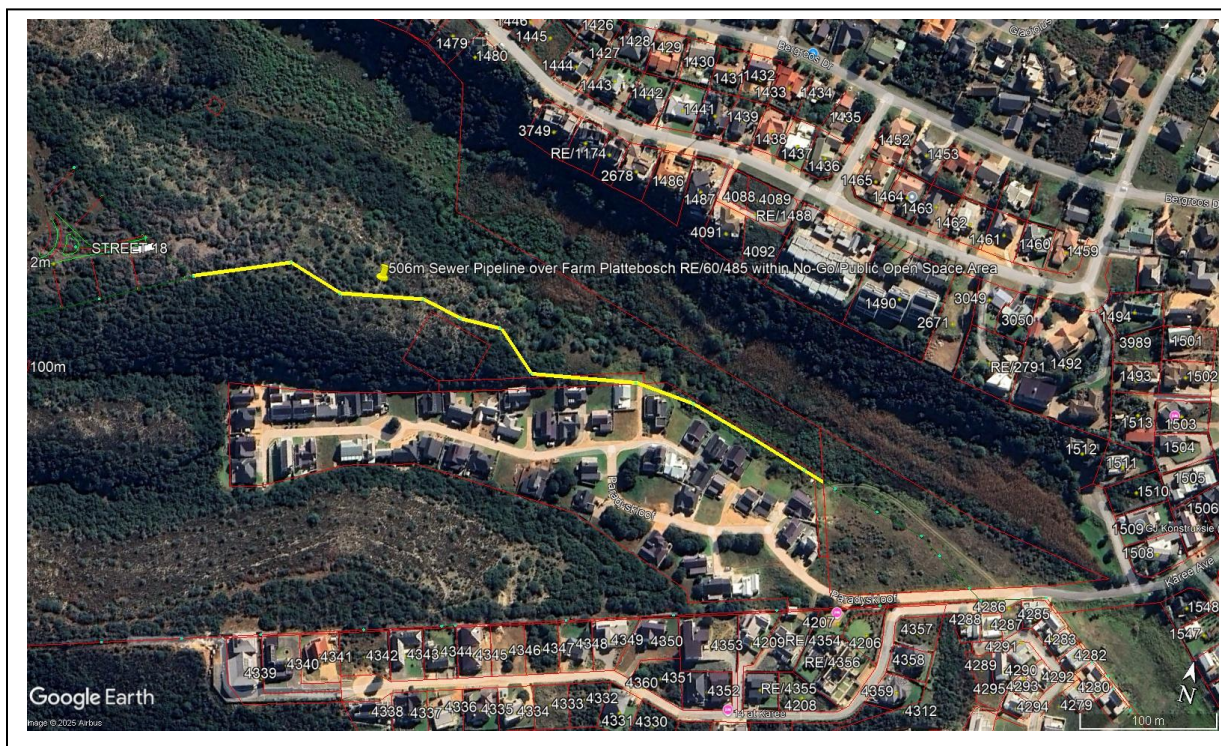
**WHERE ARE THE WORKS TO BE UNDERTAKEN** (where possible, provide an annotated plan and a full description of the extent of the works):

In accordance with the GLS report a 160mm diameter uPVC sewer pipe will be constructed from northeastern point of the development (Phase 1) to Erf 196.
