**RESIDENTIAL DEVELOPMENT ON THE REMAINDER
OF PORTION 60 OF THE FARM PLATTEBOSCH NO.
485, STILL BAY, WESTERN CAPE
EA REF: 16/3/3/5/D5/19/0001/22**

**CONSTRUCTION PHASE
ECO REPORT
FOR JUNE 2025
(Submitted 20 June 2025)**

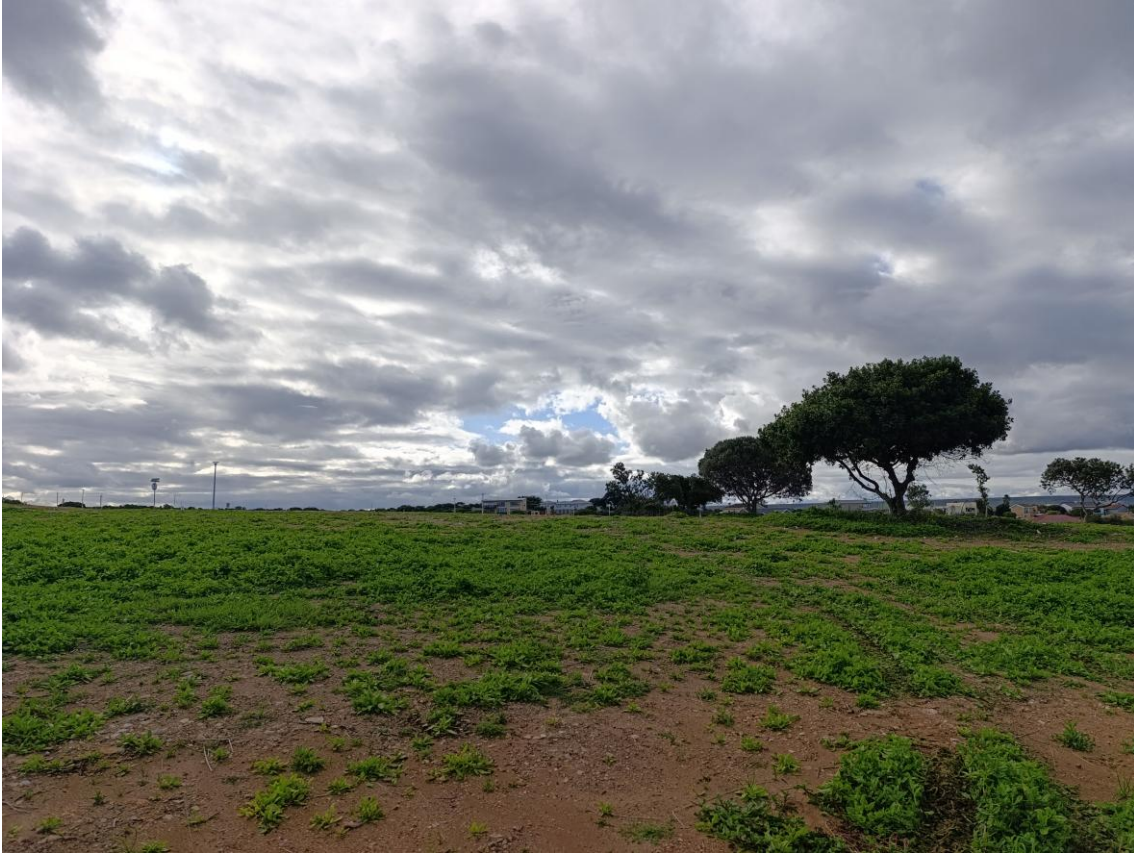
Photo 1: Remaining Milkwood trees om Phase 1 cleared area, to be recorded on layout plan (photo taken 10 June 2025).

Finding No.	Area of activity	ECO Findings and Recommendations
J1 (Finding since Sept 2024)	Milkwood trees within development area	<p>A total of 26 Milkwood trees were counted by the ECO located within the Phase 1 development area. The remaining presence of these Milkwood trees within the cleared Phase 1 development area was confirmed during the site visit conducted 29 January 2025. Within the northern corner of Phase 2 where vegetation clearance has already been conducted 7 clusters of Milkwood trees and 3 individual trees were recorded and photographed.</p> <p>During the February 2025 ECO inspection it was also observed that the developer continued with clearance activities around</p>

<p>stands of Milkwood trees falling within Phase 2 development area. Several individual and clusters of Milkwood trees were recorded to remain within the cleared area and no significant damage or removal of Milkwood trees observed within this area.</p> <p>To confirm that Milkwood trees are incorporated into the development layout and proof that observed Milkwood trees remain undamaged/are not removed within the development area throughout the construction and development phases all Milkwood trees falling within the development footprint area must be recorded and indicated on the approved development layout plan. This is required for all remaining Milkwood trees within the already cleared Phase 1 and 2 areas as well as clearly visible Milkwood trees along the boundaries of Phase 1 and 2 and Phase 3 areas which has also been cleared.</p> <p>Should removal, relocation or pruning (of more than 25% of the canopy) of any Milkwood trees be required application/s must be made to the DFFE for removal, relocation or pruning before any Milkwood trees may be impacted upon. As far as possible these trees must be accommodated within the layout and not removed.</p> <p>Refer to the map below.</p>

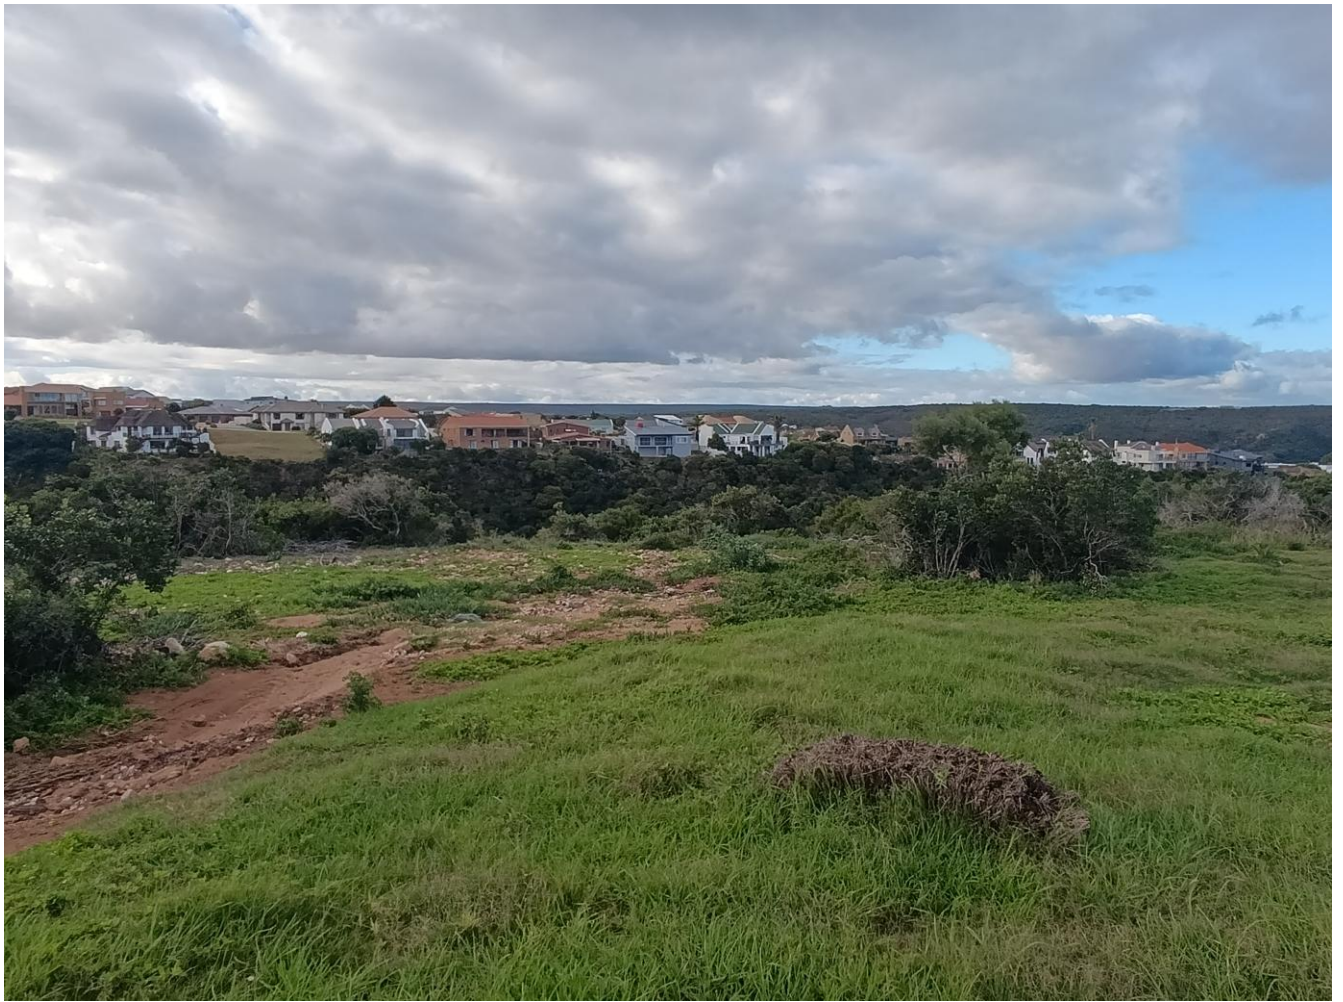
Photo 2: Impacted no-go/public open space area rehabilitation progress (photo taken 10 June 2025)

<p>As per the Feb, March and April 2025 ECO reports the site manager was instructed to record the location of the three Milkwood trees and amend the pipeline route accordingly to avoid these trees. The amended pipeline route with recorded Milkwood trees should have been provided to the ECO for approval before pipeline excavations commenced.</p> <p>During the May 2025 ECO inspection the ECO observed that the construction of the entire sewer pipeline located within the Public Open Space/no-go area was already completed. The site manager did not provide the ECO with the amended pipeline route as requested in previous ECO reports for approval. In accordance with the approved method statement the site manager also did not peg and demarcate the 3m construction area for the entire sewer pipeline route and did not inform the ECO accordingly to obtain written confirmation from the ECO that site clearance and construction could commence.</p> <p>The ECO therefore cannot confirm that Milkwood trees was avoided during construction of the sewer pipeline through the no-go/public open space area. The ECO can confirm that in some areas along the constructed sewer pipeline route section of more than 3m wide were impacted upon (vegetation completely removed).</p> <p>All impacted areas along the sewer pipeline route within the no-go/public open space areas must be rehabilitated with indigenous vegetation and monitored on a monthly basis (and after heavy rainfall) for signs of erosion. Should erosion be detected the ECO must be consulted for rehabilitation and stabilisation methods to be implemented.</p>

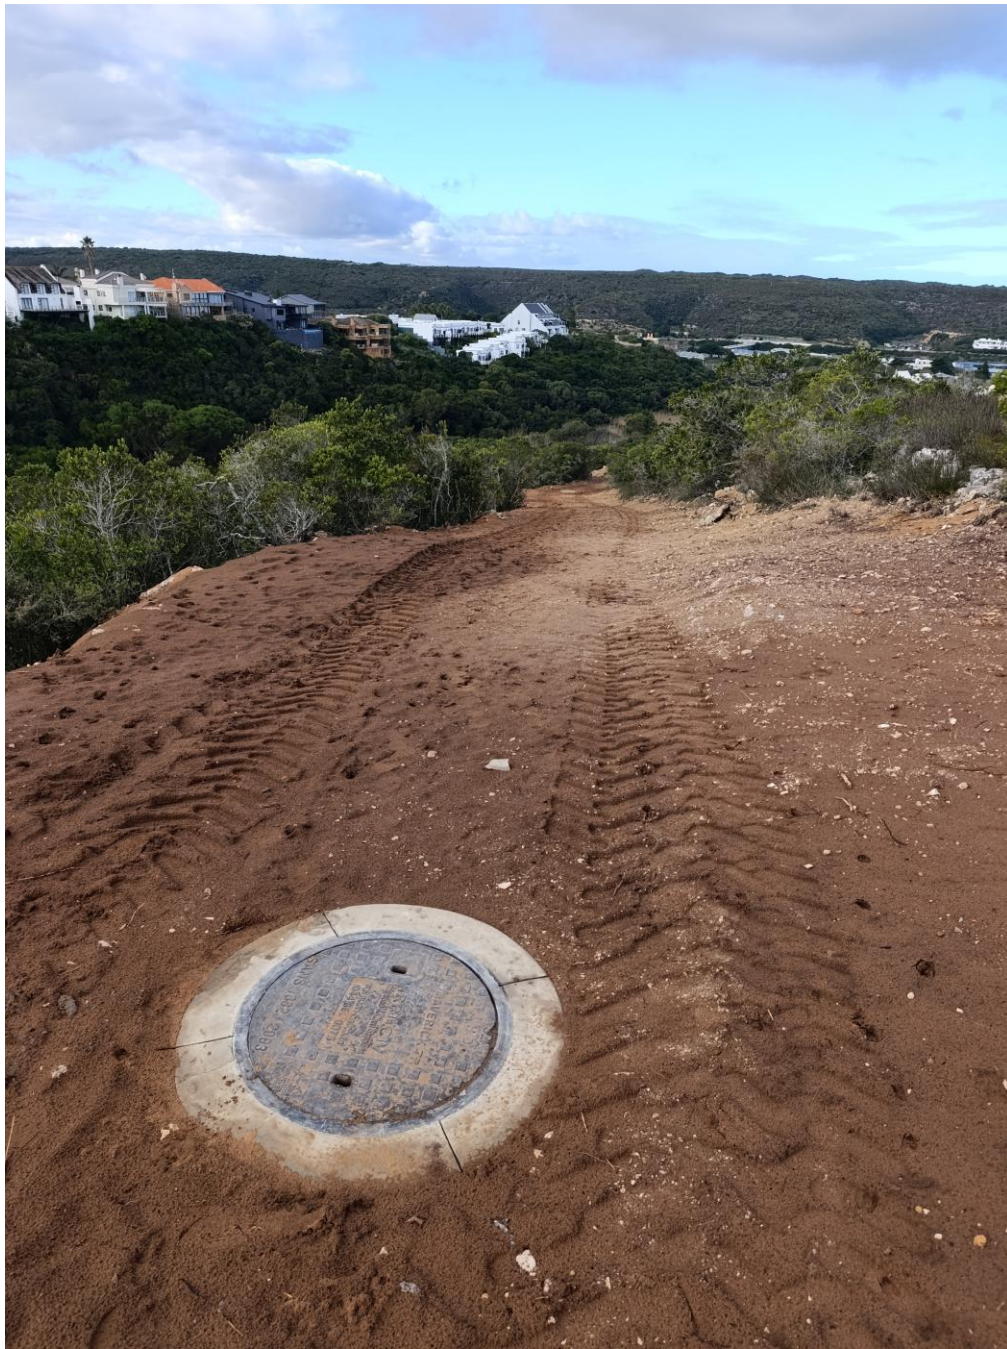
Photo 3: Rehabilitation progress of sewer pipeline completed through no-go/public open space area (photo taken 10 June 2025)

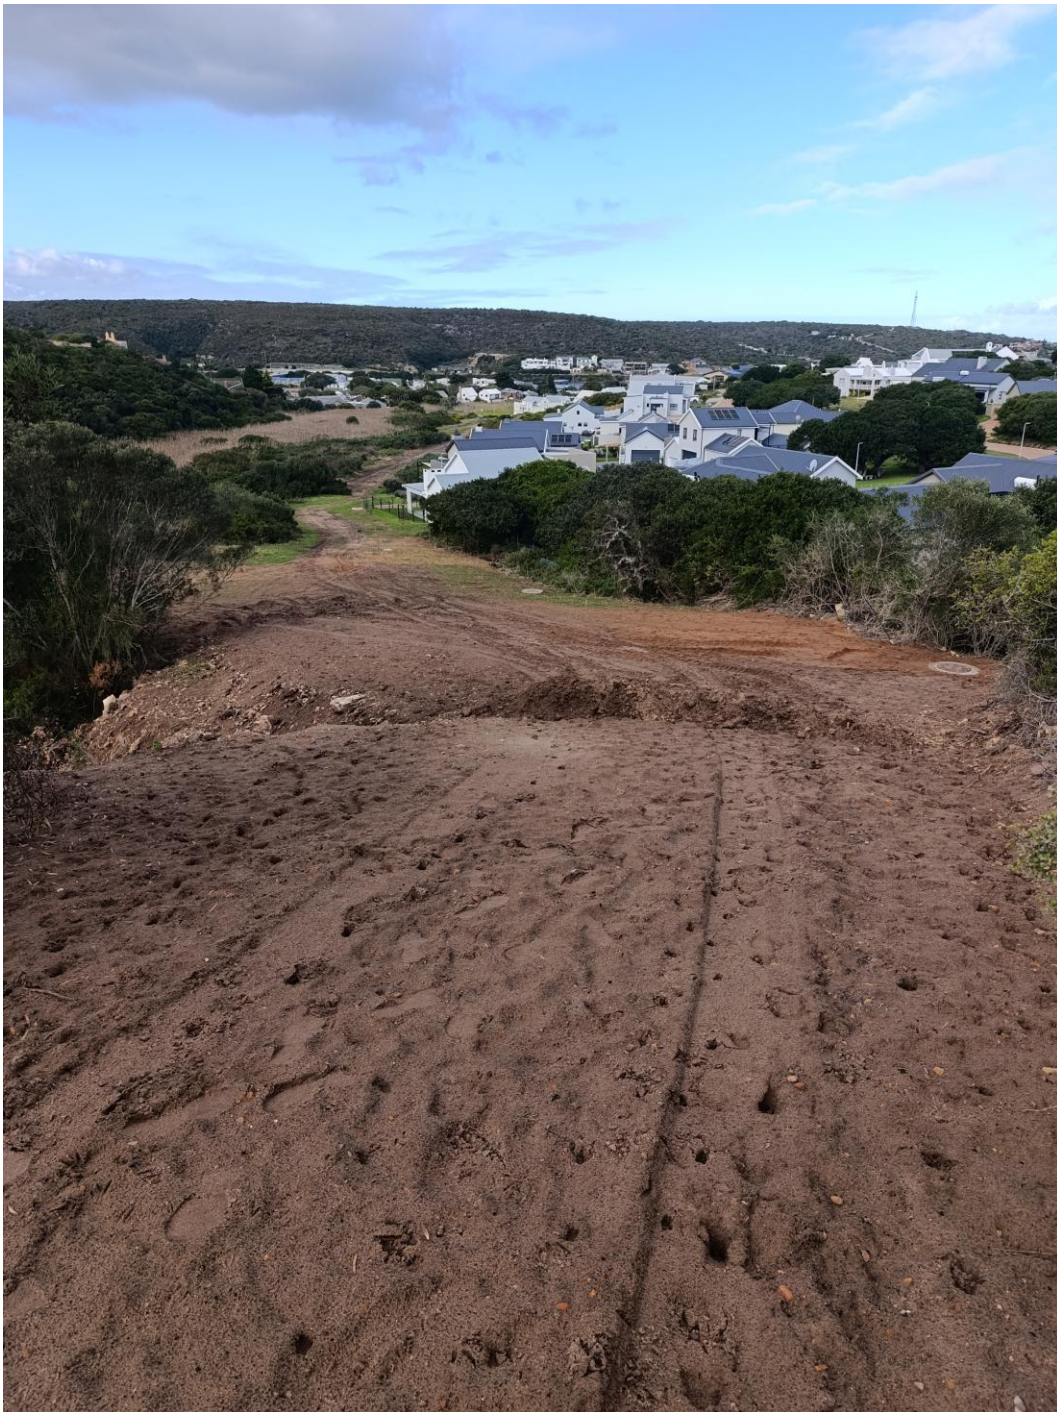
Photo 5: Rehabilitation progress of sewer pipeline completed through no-go/public open space area (photo taken 10 June 2025)
