OSCAE APPLICATION FORM

for
NEW PRIMARY DWELLING
on

Erf 729 The Woods, Brenton on Lake, Knysna

Report Reference: KNY679/01

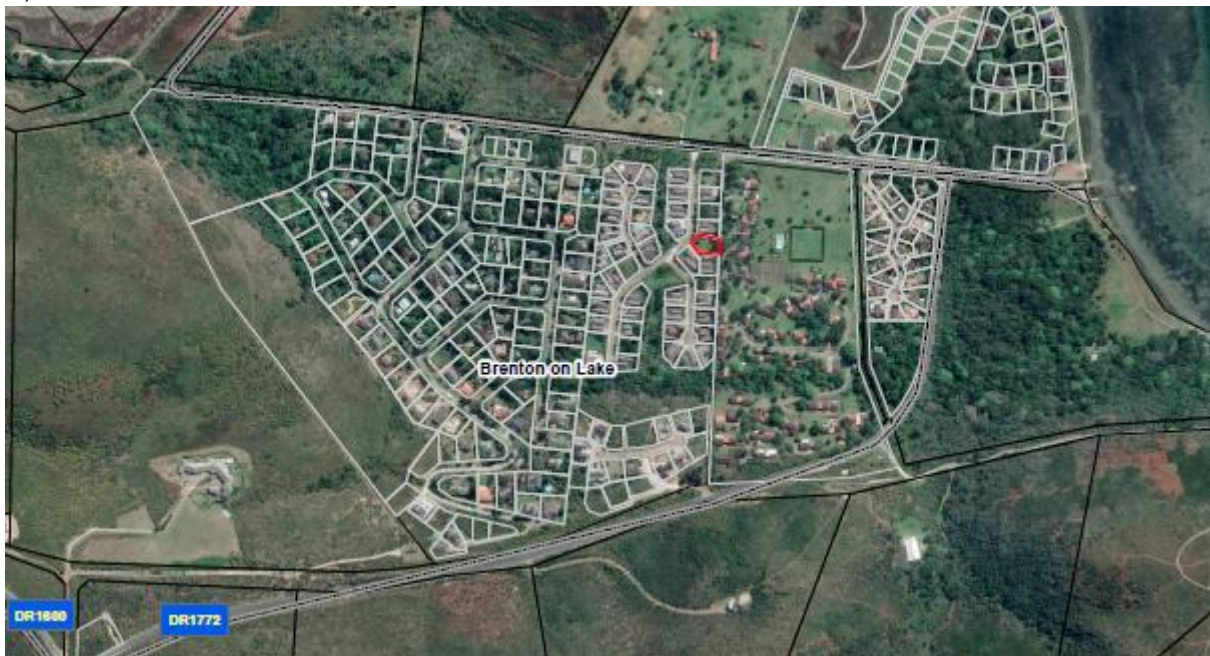
Figure 3: Aerial image indicating Erf 729 (red polygon) & neighbouring property cadastral boundaries (courtesy Google Earth Pro, 2021).

Grey cadastrals indicate residential erven, while the black lines indicate farm properties. The large open property to the east of Erf 729 (Erf 861) is the Brenton Park Holiday Cottages / Resort. The large, vegetated property to the east, adjacent to the Estuary, is the Skulite Private Nature Reserve.

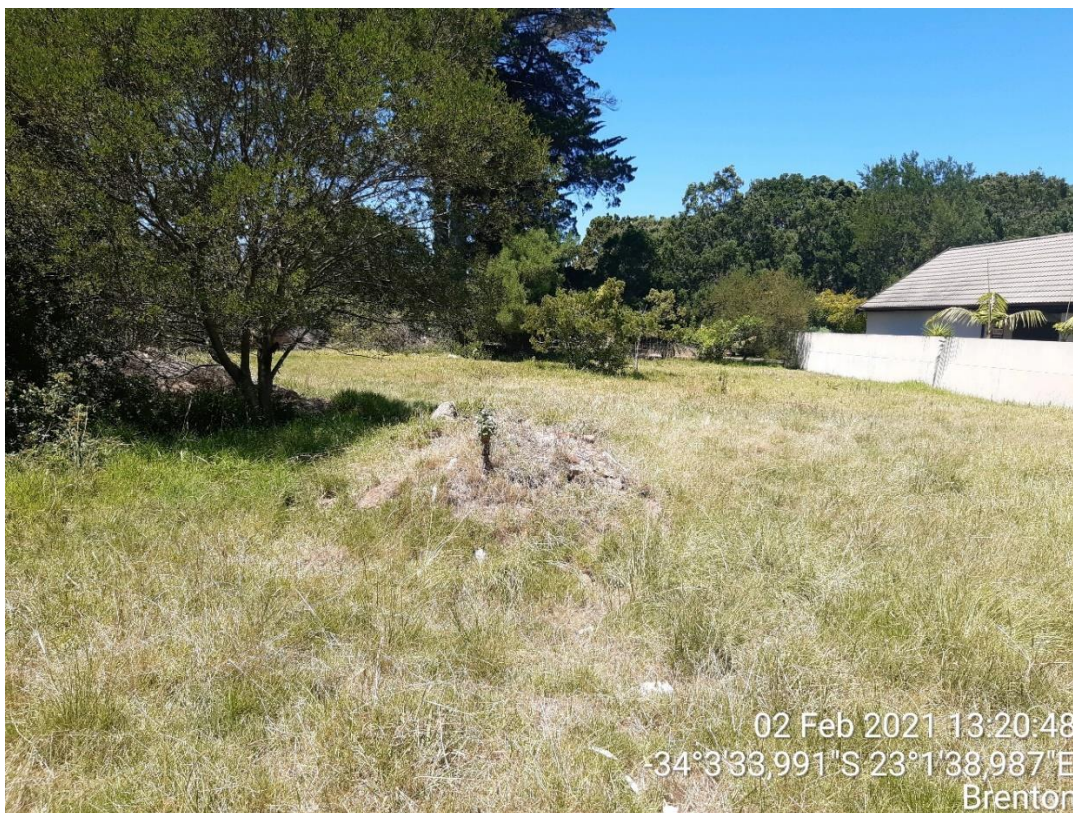
Figure 5: View east onto Erf 729 from road entrance. Note tree clump on north-west corner of erf (left of photo) and disturbed grassland (*Kikuyu* grass) on majority of property. Large Pine tree in background located outside Erf 729 within Brenton Park property (Erf 861).

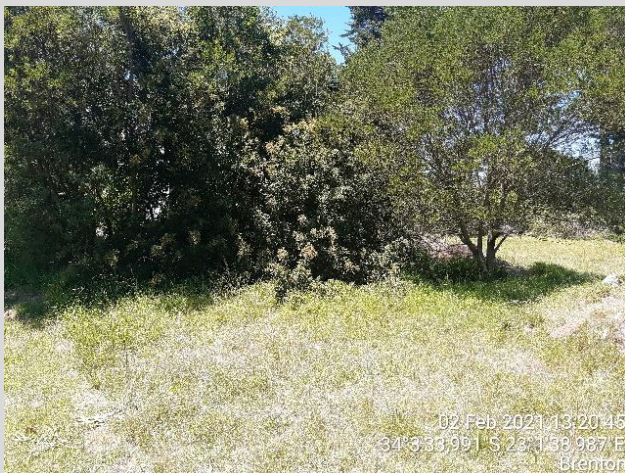
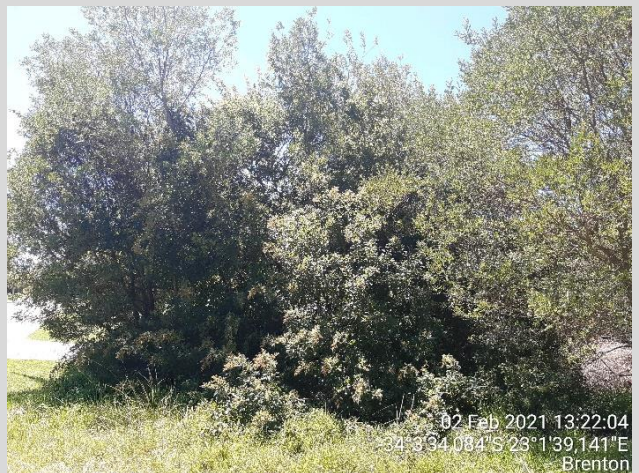
Figure 6: Group of trees within north-eastern corner of Erf 729 – Dominated by Keurboom & Wild Common Currant.

A small group of trees is located on the north-western corner of the erf (street boundary adjacent to Erf 730), including species: Keurboom (*Virgillia oriboides*), Common Wild-Currant (*Searsia pyroides*), Sand Olive (*Dodonaea angustifolia*), Port Jackson (*Acacia saligna*), Brazillian Pepper (*Schinus terebinthifolia*) etc. These trees have been avoided by the proposed house development area and should be demarcated as a no-go area prior to the commencement of site clearance / construction activities.

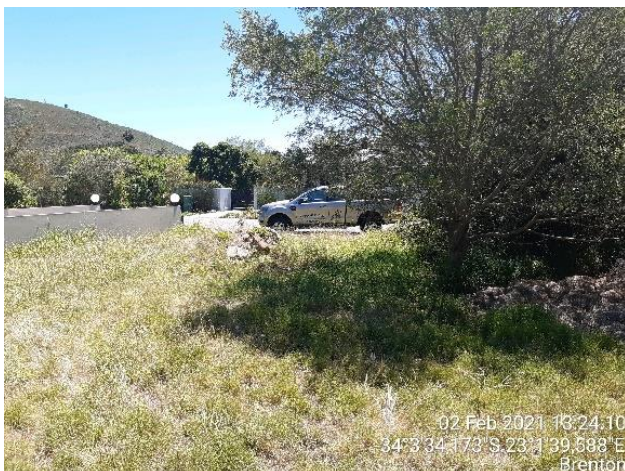
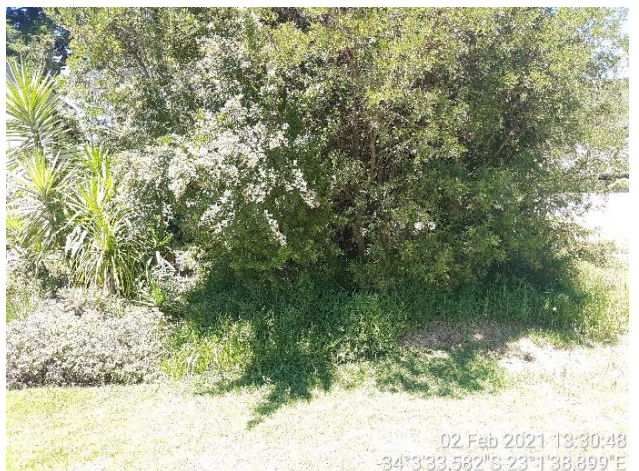
Figure 7: Keurboom & Wild Common Currant trees to be avoided by development. Yucca plants on image above located on neighbouring property, Erf 730.

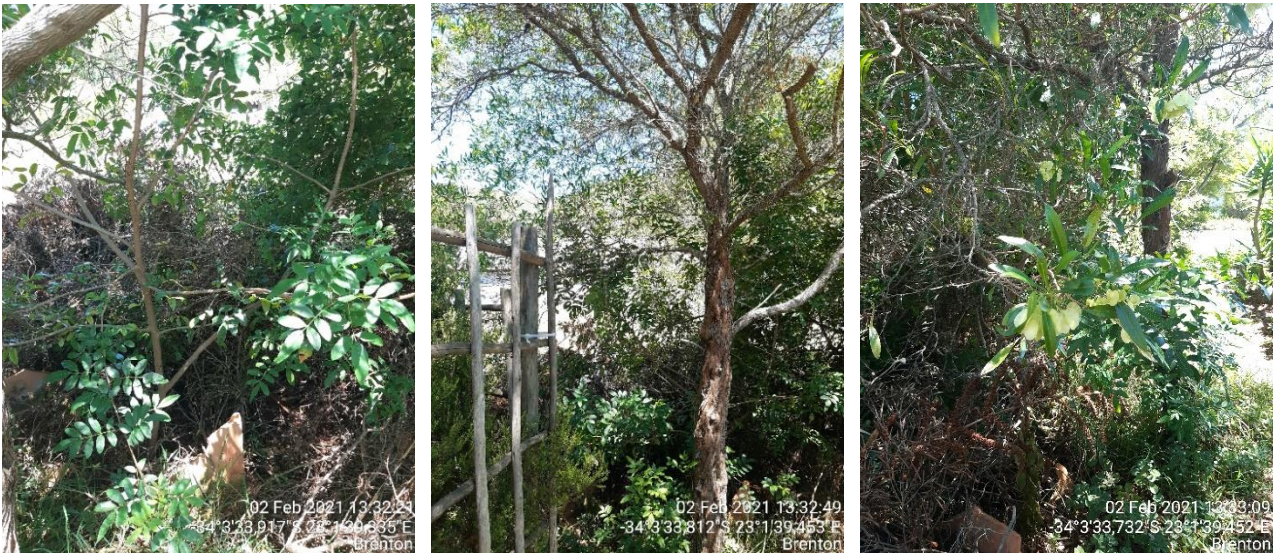
Figure 8: Brazilian Pepper, Port Jackson & Sand Olive trees on tree-clump on street corner of Erf 729, against boundary with Erf 730.

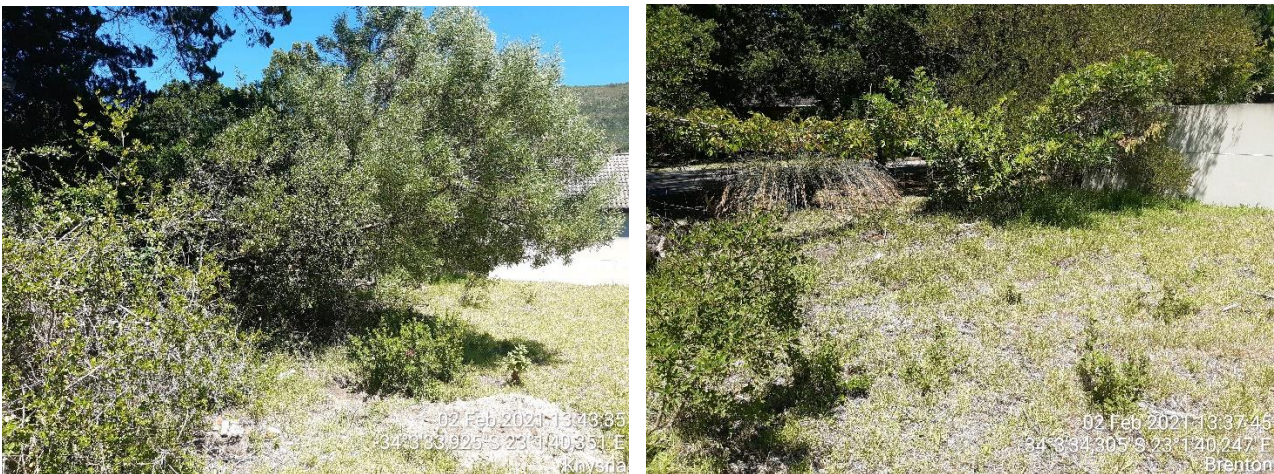
Figure 9: Eastern erf boundary (adjacent to Erf 861).

Vegetation along the back, eastern erf boundary includes Brazilian Pepper, Rooikrans, *Searsia lucida* and *Searsia pyroides* trees.

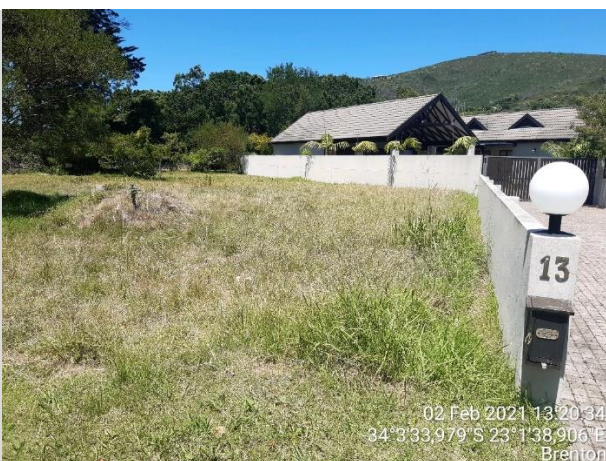
Given the limited space available on Erf 729, it is likely that the disturbance area associated with the future driveway, as well as the area between this driveway and the Water-tank yard located adjacent to Erf 728 (southern boundary) will be used as the Construction Site Camp, with temporary stockpile / material laydown areas etc.

Figure 10: Photo of driveway area to be used for access & construction site camp.

6.2. Storage area for stockpiled material: *As above in Figure 10 & 11.*

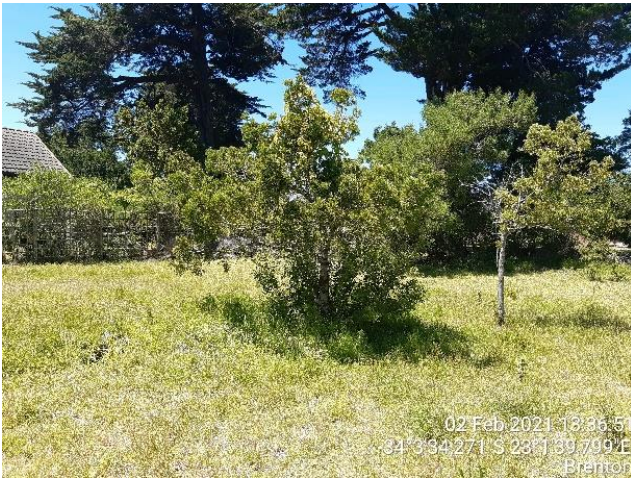
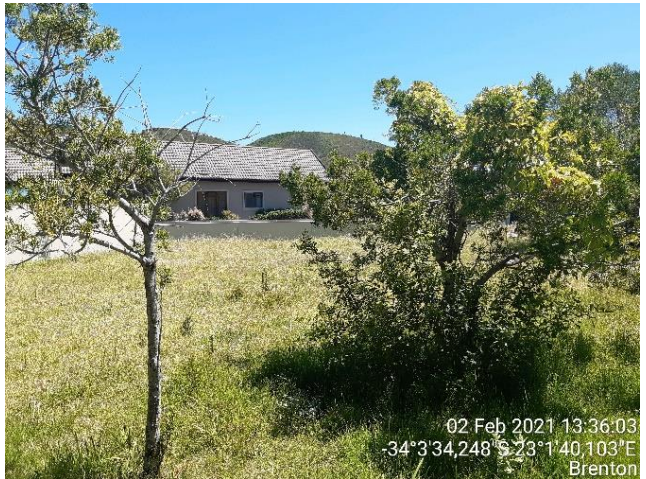
Figure 12: Two Yellowwood trees to be removed to allow for construction of the house.

Two small Outeniqua Yellowwood trees are located in the centre of the property / house footprint. A Forestry Licence Application will be submitted to the Department of Forestry to apply for the removal of these protected trees. As these tree are too large to survive transplant, the landowner intends to plant two new Yellowwood trees on the property as part of the post construction rehabilitation / landscaping efforts.
