# ERF 3122, HARTENBOS HEUWELS RESIDENTIAL DEVELOPMENT

## SCOPING ASSESSMENT OF FRESHWATER ECOSYSTEMS

Freshwater Consulting

**March 2021**

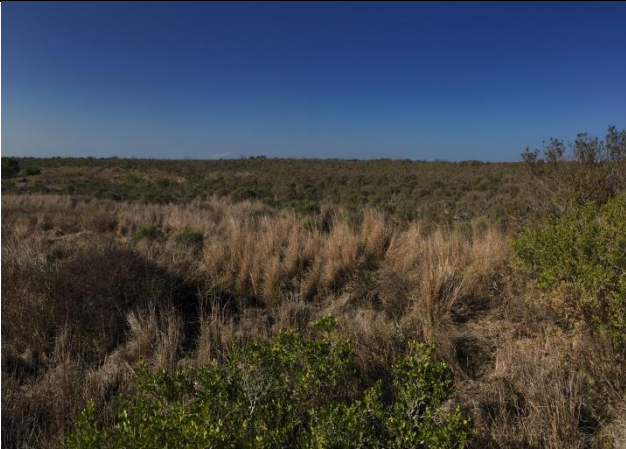
Wetland Type	Description	PES	Key existing impacts	
<p><b>Hillslope seep A</b></p> <p>Seasonal</p>	<p>Dominated by graminoids, particularly <i>Eragrostus curvula</i>, together with shrubs such as <i>Helicrysum pandurifolium</i> and <i>Hermannia Althaeifolia</i>. Besides <i>Conyza scabrida</i>, <i>Selago dolosa</i>, typically found in moist loamy sands, was also present as an indicator of saturation within this habitat. <i>Osteospermum monolifera</i>, together with <i>Searsia glauca</i>, which are both often found in the temporary zones of wetland habitats, were present in patches.</p>	<p>PES = A</p> <p>EIS = HIGH</p>	<ul style="list-style-type: none"> <li>• Sparse invasion by <i>Acacia cyclops</i> along margins</li> <li>• Burning (recent fires)</li> <li>• Previously farmed along outer margins (evidence of ploughing).</li> </ul>

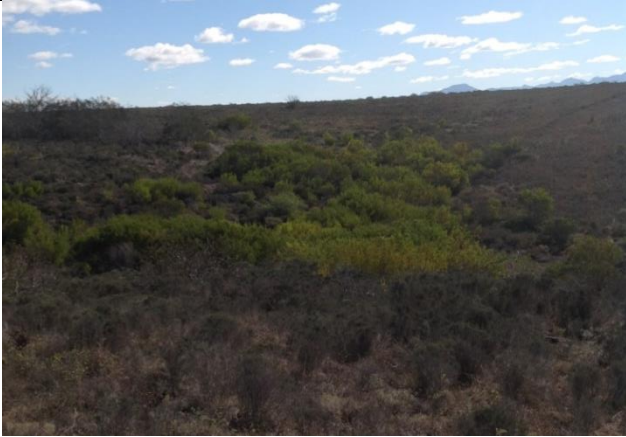
<p><b>Hillslope seep B</b></p> <p>Seasonal</p>	<p>Small seasonal seep with no clear channel. The habitat is invaded with <i>Acacia cyclops</i> but natural vegetation includes <i>Helicrysum cymosum</i>, <i>Helicrysum pandurifolium</i>, <i>Hermannia althaeifolia</i> and <i>Searsia glauca</i>.</p>	<p>PES = B</p> <p>EIS = HIGH</p>	<ul style="list-style-type: none"> <li>• Invasion by <i>Acacia cyclops</i> which has impacted on the hydrological and geomorphological functions</li> <li>• Burning (recent fires)</li> </ul>

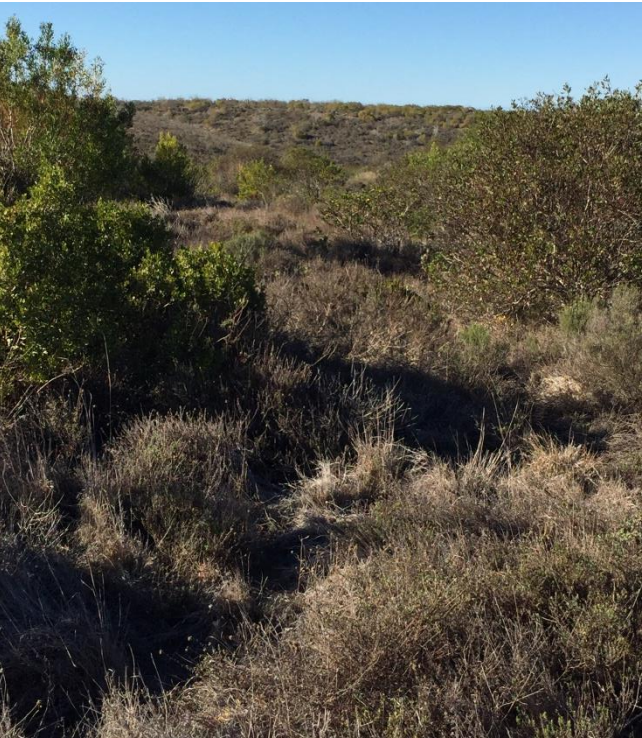
<p><b>Hillslope seep C</b></p> <p>Seasonal</p>	<p>This seasonal habitat is dominated by small scrubs, particularly <i>Helicrysum cymosum</i> and <i>Helicrysum pandurifolium</i>, together with larger shrubs such as <i>Osteospermum monolifera</i> and <i>Searsia glauca</i> along the margins. Other species included <i>Muralitia</i> sp. and <i>Erica</i> sp. with some graminoids such as <i>Eragrostus curvula</i>. Although not limited to the seep habitat, <i>Bobartia robusta</i>, characteristic of the south facing hillslopes of the region was growing densely at the downstream extent of the habitat where it transitions to a channel at the head of the watercourse.</p>	<p>PES =A</p> <p>EIS = HIGH</p>	<ul style="list-style-type: none"> <li>• Sparse invasion by <i>Acacia cyclops</i></li> </ul>

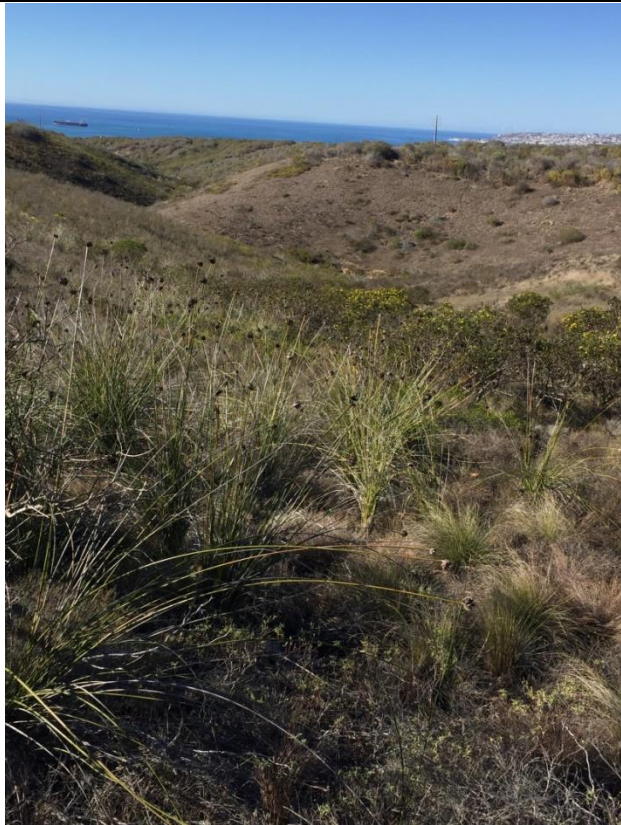
<p><b>Hillslope seep D</b></p> <p>Seasonal</p>	<p>This is a narrow, relatively steep wetland dominated by shrubs, particularly <i>Osteospermum monilifera</i>. Although not limited to this habitat, relatively dense stands of <i>Bobartia robusta</i> were evident at the upstream extent of the habitat. No invasion by alien <i>Acacia cyclops</i> was evident within this habitat.</p>	<p>PES = A</p> <p>EIS = HIGH</p>	<ul style="list-style-type: none"> <li>• Burning (recent fires along the margins)</li> </ul>

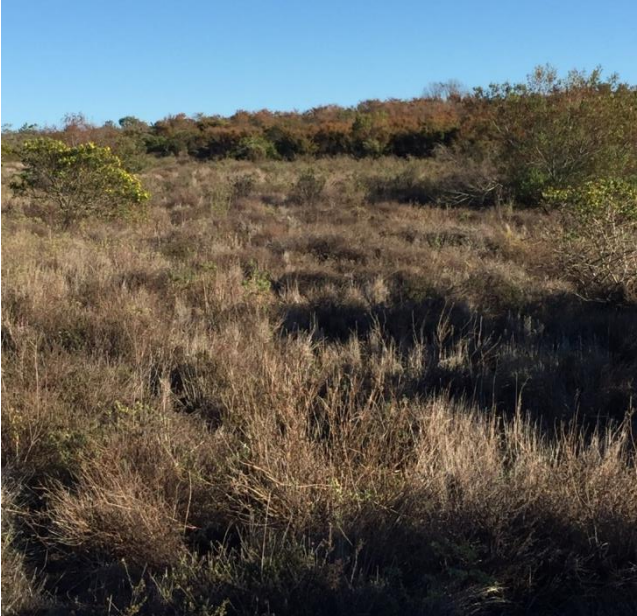
<p><b>Hillslope seep E</b></p> <p>Seasonal</p>	<p>This habitat is dominated by graminoids such as <i>Eragrostus curvula</i> interspersed with shrubs such as <i>Helicrysum pandurifolium</i> and sparse individuals of <i>Conyza scabrida</i> and is thus similar in character to Seep A. Patches of <i>Osteospermum monolifera</i> and <i>Searsia glauca</i> were evident, particularly near the source of the seep. Unlike seep A, invasion by <i>Acacia cyclops</i> was greater and other invasives such as <i>Hakea sericea</i> were also present along the margins. Also, the downstream extent of the wetland is impacted somewhat by a dirt road which traverses the site. Besides loss of habitat, the road impedes runoff and thus impacts on the hydrological functioning of the habitat. Access to the area via the road has led to localised dumping which has also impacted on the habitat.</p>	<p>PES = B</p> <p>EIS = HIGH</p>	<ul style="list-style-type: none"> <li>• Invasion by alien trees along margins</li> <li>• Change in hydrological functioning due to road through the habitat</li> <li>• Some localized dumping of building rubble</li> <li>• Road crossing</li> </ul>

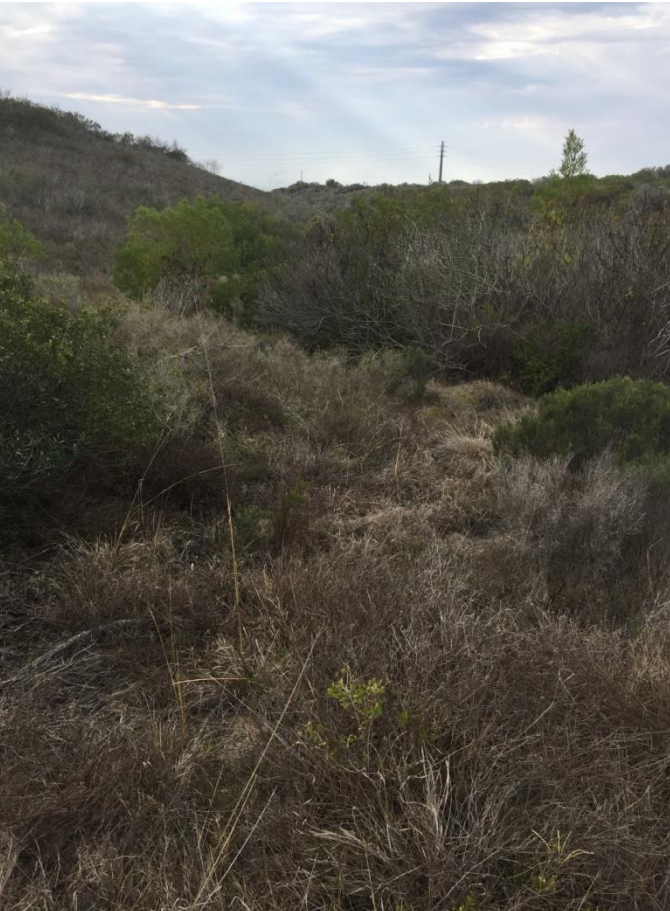
<p><b>Hillslope seep F</b></p> <p>Seasonal</p>	<p>This habitat supports a mixture of shrubs such as <i>Osteospermum monolifera</i> and <i>Searsia glauca</i> and grasses such as <i>Thamnochortus fruticosus</i>. Other species include <i>Metalasia densa</i> and <i>Hyperrhinia Hirta</i> with dense stands of <i>Bobartia robusta</i> at the downstream extent where the seep enters the water course and flows are more concentrated. Some alien invasion by <i>Acacia cyclops</i> is evident but limited and thus impacts minimally on the ecological integrity of the system. Similar to Hillslope seep E, the seep is traversed by a dirt road which impacts to some extent on its hydrological functioning. Some dumping close to the road has impacted on the quality of habitat but this is limited</p>	<p>PES = B</p> <p>EIS = HIGH</p>	<ul style="list-style-type: none"> <li>• Invasion by aliens (mostly <i>A. cyclops</i>)</li> <li>• Change in hydrological functioning due to road through the habitat</li> <li>• Rubble dumping</li> <li>• Road crossing</li> </ul>

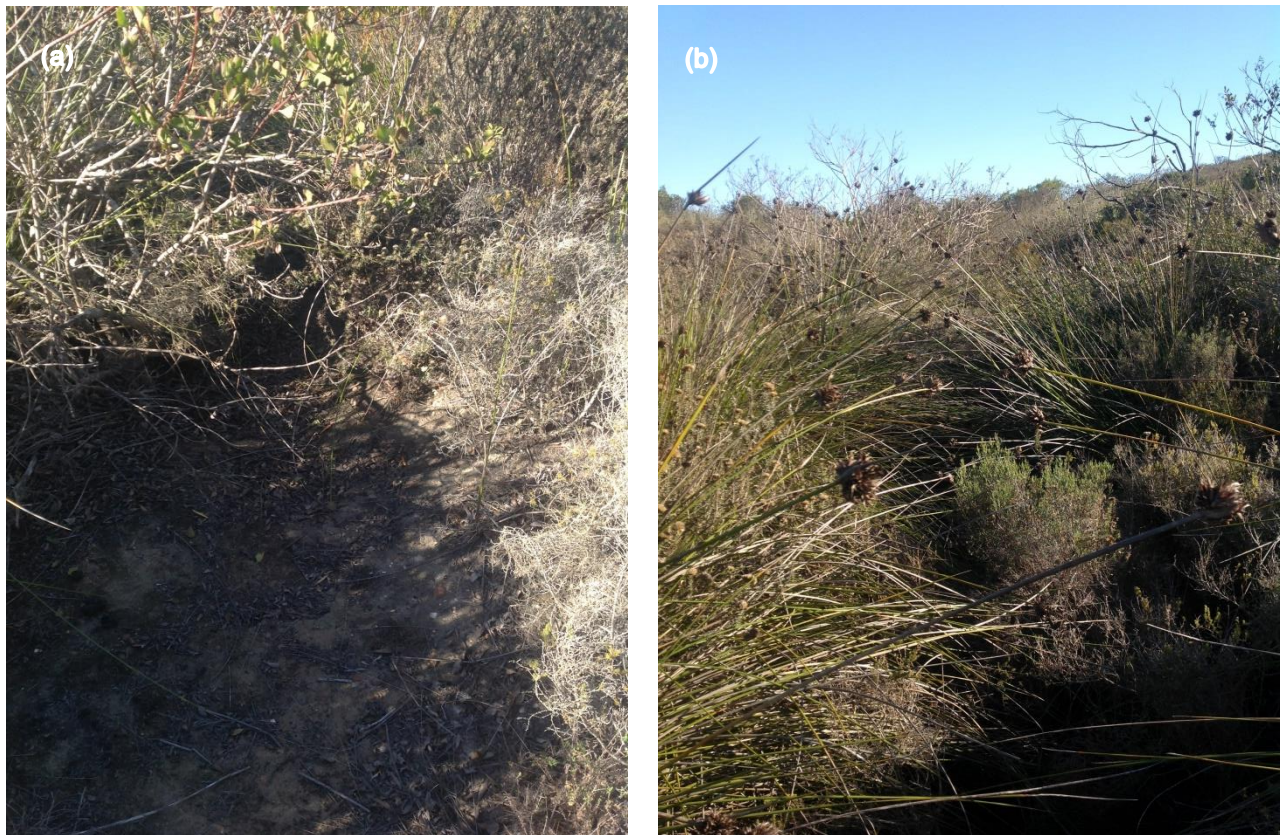
**Figure 5 Watercourse immediately downstream of Hillslope Seep C (i.e. WC 4) showing a) the shallow active channel of the ephemeral stream with a sandy loam substratum that remains unvegetated due to intermittent, intense runoff and b) the intact riparian fringe of the active channel.**

Watercourse (WC) 2, WC4, and WC5 (Figure 4) are largely unimpacted ephemeral systems characterised as narrow (<1 m wide), shallow (<50 cm deep) channels with stable banks due to a dense, intact riparian fringe (Figure 5). Of these, WC 2 and WC 4 were rated as Category A (i.e. unmodified or near natural) in terms of their ecological condition (Table 2), although their riparian status scores were rated as a Category B, largely due to some invasion by alien *Acacia cyclops* and slight changes to the channel associated with loss of indigenous riparian fringe components.

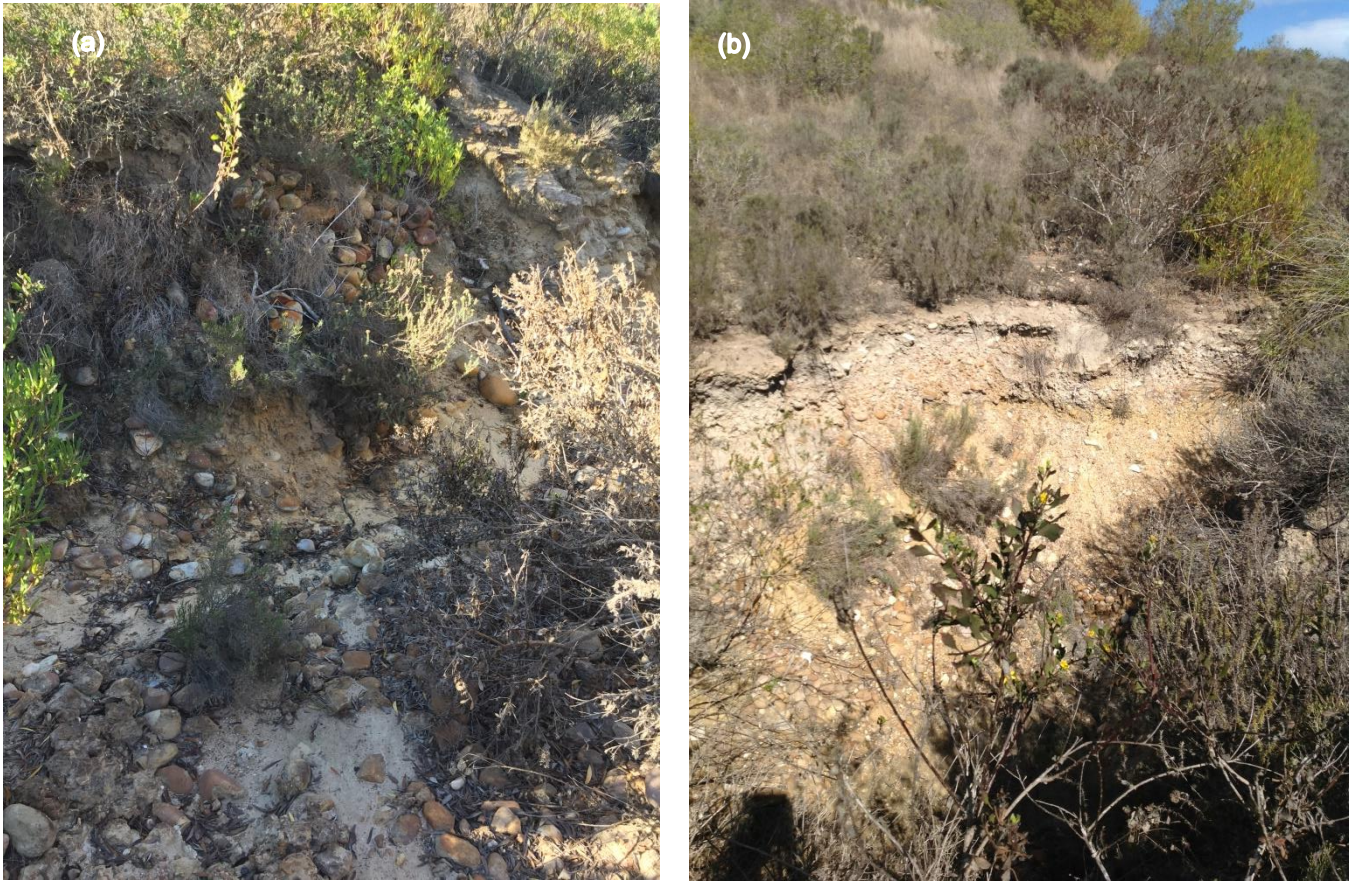
**Figure 6** Severe gully erosion within a) WC 1 and b) WC 6 has led to a significant change in the hydraulic and geomorphological character of these watercourses. These ephemeral systems are also impacted by alien invasion (mostly *Acacia cyclops*) and the loss of natural riparian fringing vegetation which has affected their habitat integrity.

By contrast, WC 1, WC 3 and WC 6 (Figure 4) are significantly impacted by erosion which has promoted invasion by alien *Acacia cyclops* and the loss of natural vegetation typical of the riparian fringe. In particular, watercourse 1 (WC 1) fed by hillslope seep E is characterised as a deep (approximately 2 m) gully with steep unstable banks. *Acacia cyclops* has invaded the riparian fringe with a loss of natural riparian species and there is evidence that the headcut of the channel is moving upstream towards the seep habitat (Figure 6). This system was rated as a Category C watercourse due to large channel and bed modifications associated with erosion (Table 2).
