**FRESHWATER ASSESSMENT FOR THE PROPOSED  
ESTABLISHMENT OF AVOCADO ORCHARDS ON PORTION 4 AND  
8 OF 55 AND REMAINING PORTION OF 57, KLEINBOS**

**Final Report**

**Prepared for Cape EAPrac**

**Confluent Environmental**

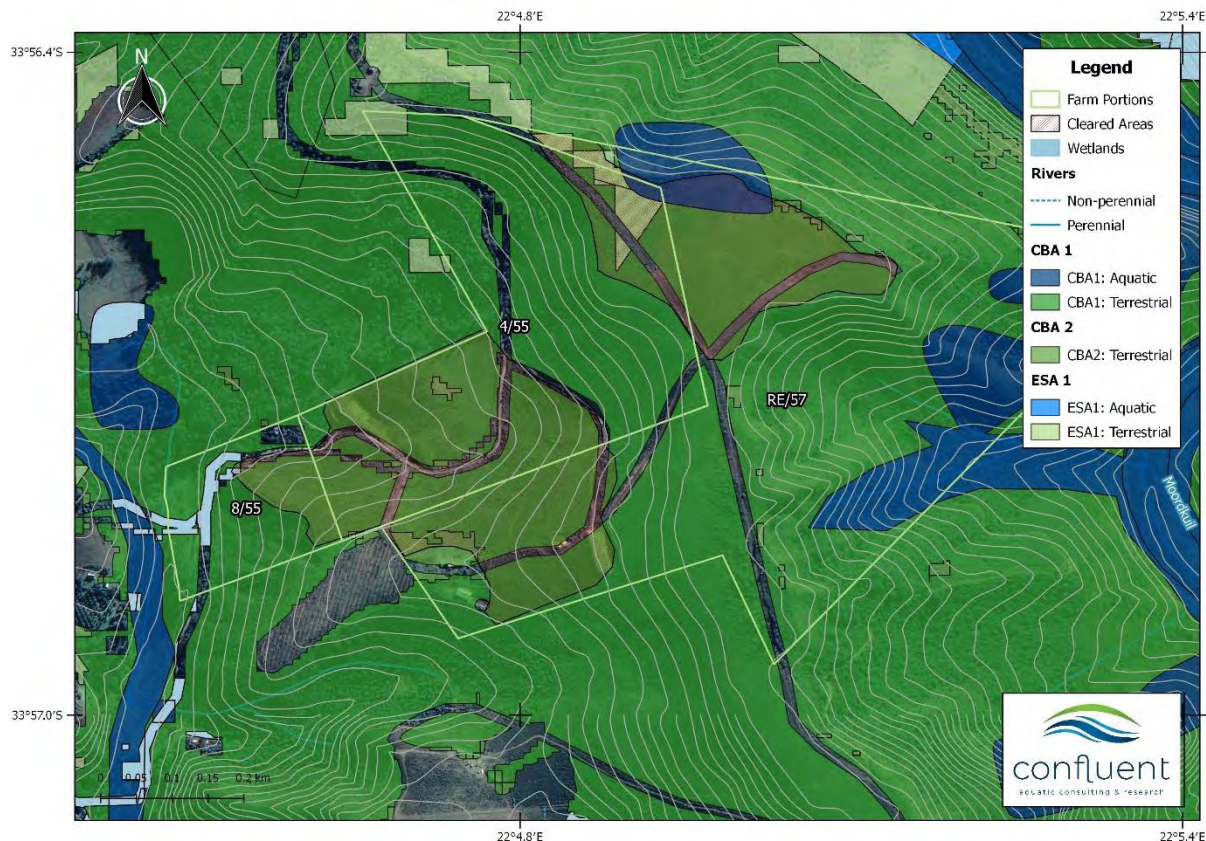
Figure 1: Map illustrating aquatic and terrestrial areas of conservation importance in relation to the property boundaries and cleared areas.

The site falls within Primary Catchment K (Kromme) and in quaternary catchment K10E. The WCBSP and NFEPA wetland maps both identify a wetland flat occurring on top of the flat escarpment area on Portion 4 of 55 and the RE/57 (Figure 1) which partly overlaps with the

footprint of the cleared area. The wetland is indicated to occur on the edge of the flat escarpment and falls away down the northern steep slopes of the mountain, in the direction of the Moordkuil River to the north. It is important to note here that wetlands featured within the WCBSP were derived from the NFEPA wetlands layer which was the most recent and reliable source of information at the time the WCBSP for Mossel Bay was developed.

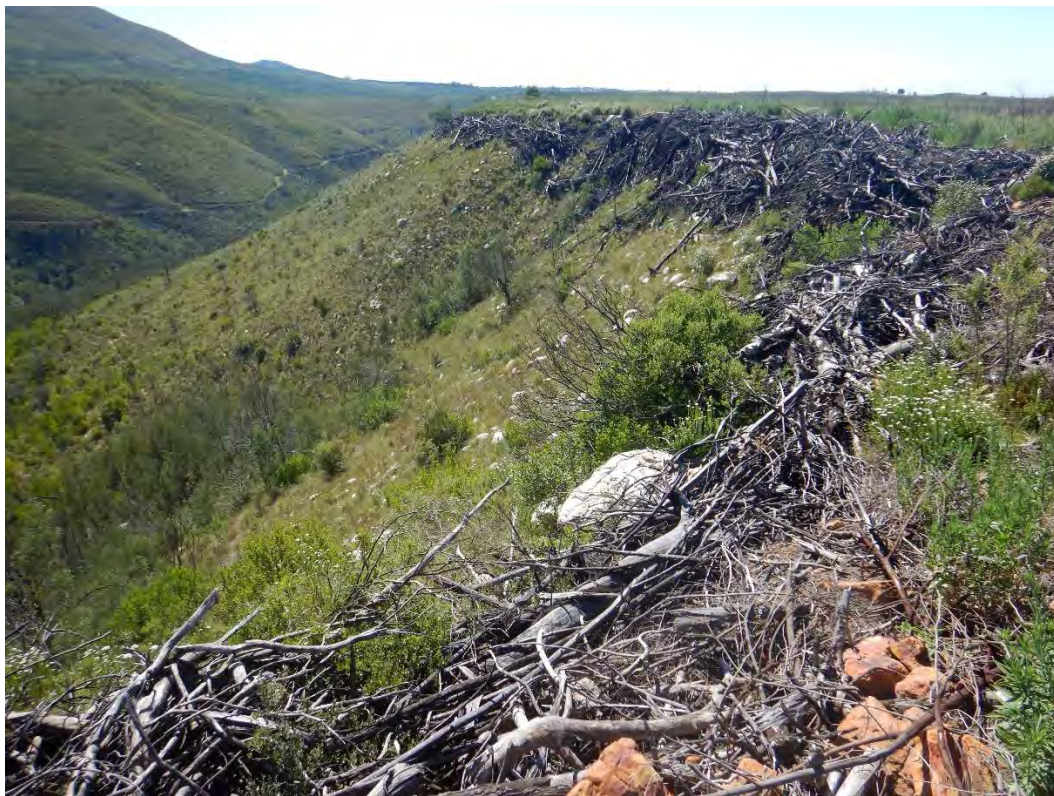
The area in which the CBA wetland is indicated to occur is characterised by a flat hilltop bench (or plateau) which drops off steeply into the river valleys below. The entire area had been cleared of trees which had been scraped to the edge of the perimeter of the plateau (Figure 5). The area was experiencing regrowth of vegetation which was dominated by pioneer weed species, grasses and numerous wattle saplings. No hydrophilic plant species indicative of wetland conditions were observed and no reliable soil cores could be obtained due to the rocky nature of the soil profile. The regrowing vegetation was relatively uniform throughout the plateau. The plateau is flat and there were no topographical features indicative of wetland formation present. The steep topography of a large section of the area indicated as a wetland is also not consistent with a wetland flat which is typically situated on a hilltop bench with little to no gradient across the entire wetland area. Site observations are therefore in agreement with the most recent wetland inventory map for South Africa which does not indicate the presence of any wetland situated on the hilltop bench plateau of 4/55 and RE/57 (Figure 2). The entire plateau is however an important area of drainage into wetlands and watercourses that drain towards the Moordkuil River to the north. Given the location of the properties in a SWSA, it is therefore important that proposed orchards are not located too close to the edge of this escarpment so as to prevent erosion of the escarpment area and degradation of watercourses and wetlands in the valleys below.

Figure 5: Photograph illustrating cleared vegetation scraped to the edge of the plateau on Portion 4/55 and RE/57.

- Orchards must be withdrawn from 15 m away from the edge of the plateau on Portion 4 of 55 and RE/57 to avoid erosion and deterioration of watercourses in the Moordkuil River valley below. This 15 m area must be treated as a buffer which should be rehabilitated and revegetated to provide protection to watercourses located down the steep slopes of the escarpment;

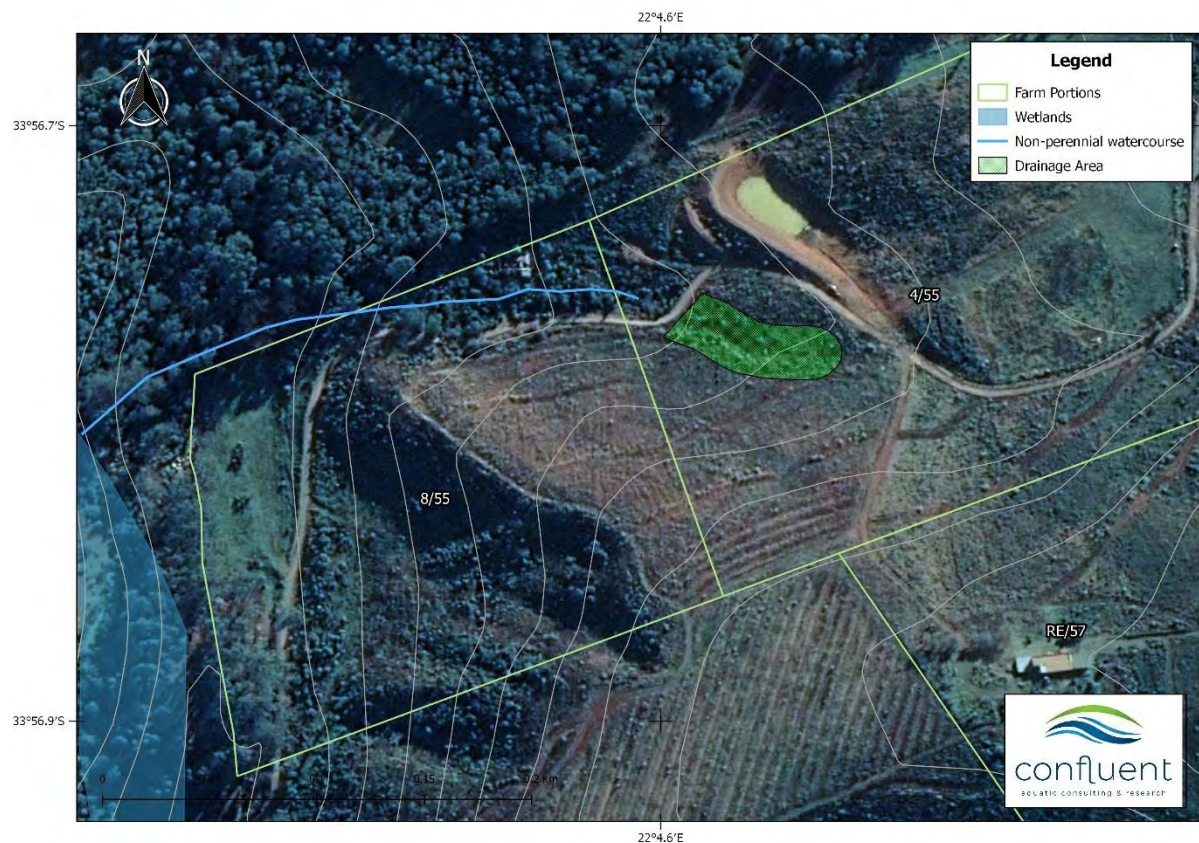
Contours result in a natural area of drainage that runs to the south of the main road through 4/55, below a newly constructed dam (Figure 6). The area in Figure 5 was delineated by drawing a 15 m buffer either side of the lowest path along the drainage. The area was completely cleared of vegetation (Figure 7) but has now become revegetated over time (Figure 8). This drainage crosses the road (via a culvert) and eventually becomes a more discernible non-perennial watercourse, that flows into the perennial Leeukloof River. This drainage area upstream of the road has been accentuated by the clearing of vegetation and earth moving which has resulted in relatively steep slopes either side of the drainage. The steep slopes (parts of which are not well vegetated) either side of the drainage do however present an erosion risk to watercourses located further downstream. Apart from a possible difference in elevation between the northern and southern sides of the drainage, historical images do not show any clear indications of the presence of a natural watercourse at this location (Figure 7). These images neither confirm the absence or presence of a watercourse prior to the clearing of vegetation. Other than the obvious contours, the area of drainage upstream of the road did not show any clear indications of being a watercourse (i.e. there was no discernible channel or bed or banks characteristic of a non-perennial river/stream that receives intermittent flow) – this four years after the clearing took place. The drainage area is choked with vegetation and does therefore not appear to receive regular flow in its current state. While the historical presence of a watercourse cannot be confirmed, this area does form an important part of the

catchment area of downstream watercourses and it is therefore important that this area is managed and impacts mitigated so as to prevent erosion and degradation of downstream watercourses. This is particularly important in light of the fact that the area falls within a SWSA.

Figure 6: Map indicating area of drainage upstream of a non-perennial watercourse.

- Orchards must not be established within the drainage area indicated in Figure 6. The delineated area provides sufficient protection for the steep embankments and an additional buffer (approximately 10 – 15 m) beyond the top of the embankments;

- Exposed sections of embankments in the drainage area indicated in Figure 6 must be revegetated with an indigenous fynbos reclamation mix;
- The culvert at bottom of the drainage area must be cleared and erosion protection placed at the outlet;

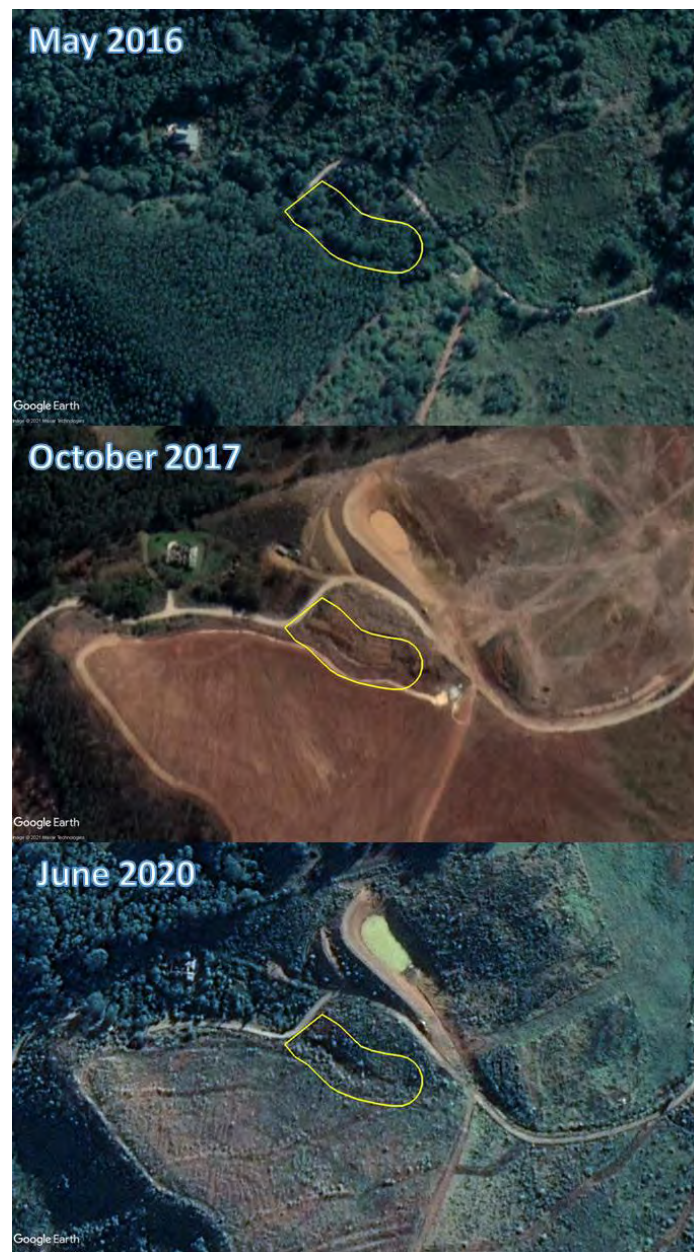
Figure 7: Time series of drainage area before, during and after vegetation clearing.

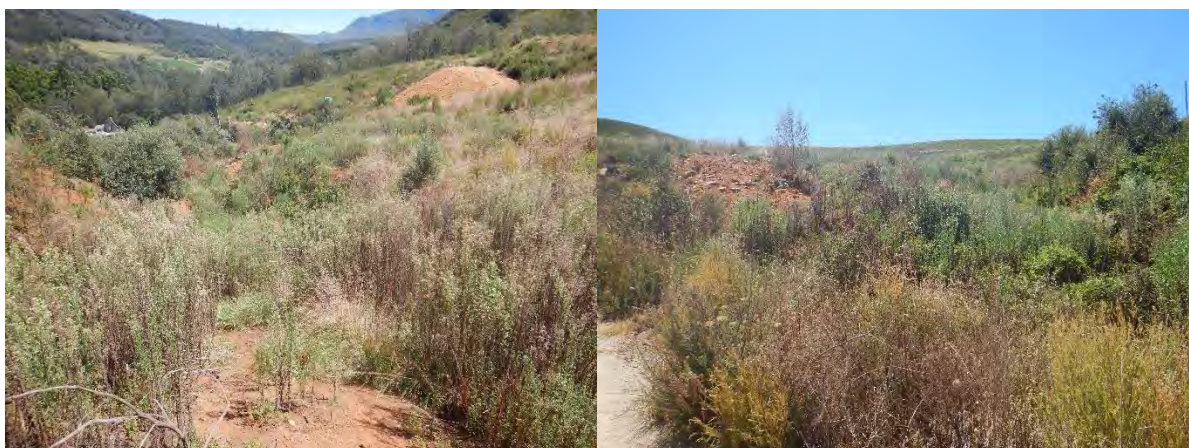
Figure 8: View of drainage area from up-(left) and down-(right) slope.

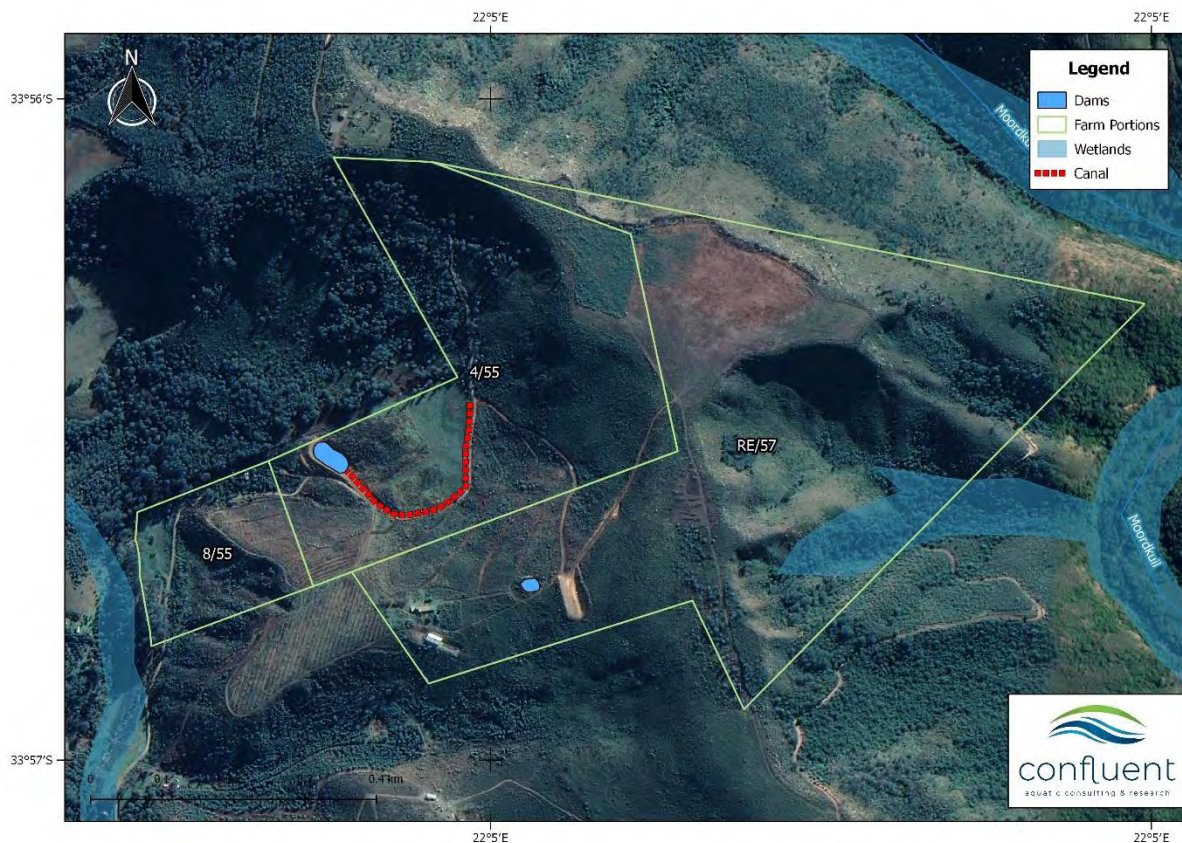
Artificial freshwater features include a constructed drainage canal that runs parallel to the main road that traverses Portion 4 of 55 and discharges into a dam constructed towards the western most corner of Portion 4 of 55. The purpose of the canal is to drain surface runoff from the road and also to intercept runoff from the upper slopes of the catchment and divert it into the dam for storage. The canal was eroded in sections and extensive signs of gully erosion was also visible at the inlet into the dam. Apart from the dam located on 4/55 another small dam is located on RE/57. Both dams are artificial and are not natural freshwater features.

Figure 9: Map indicating artificial freshwater features identified within property boundaries.

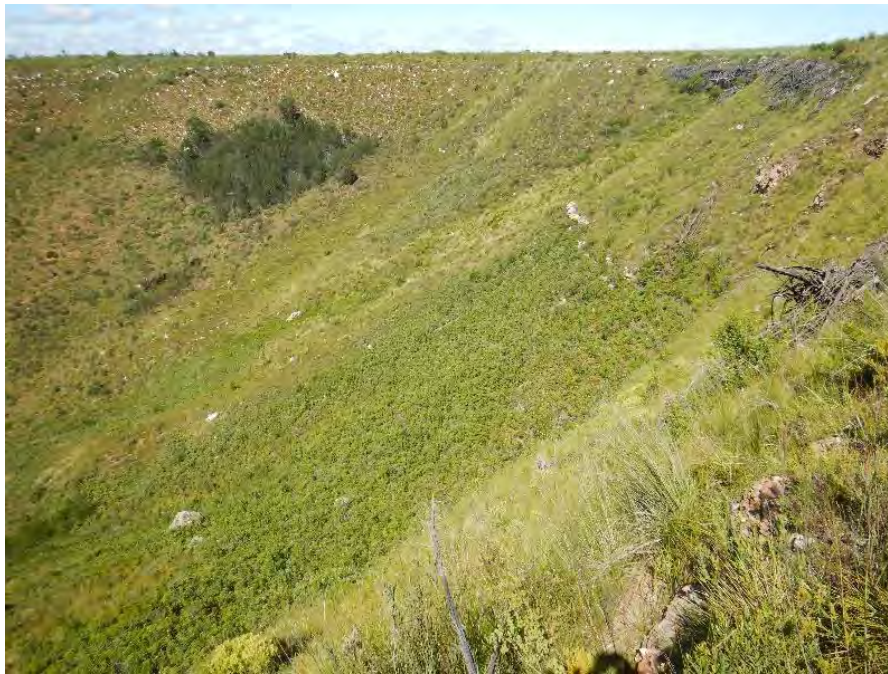
While no watercourses fall within the footprint of the development there are two wetland areas that fall within 500 m of the property. According to the NWA, the establishment of orchards is therefore considered a Section 21 (c) and (i) water use. A seep grading into a channelled valley-bottom wetland is located to the east of the plateau (as indicated in Figure 2 and Figure 10). This wetland is situated at a lower elevation than the plateau which falls away steeply along its perimeter. The upper part of this wetland is in a relatively natural state but becomes increasingly invaded by black wattle further downstream in the channelled section of the wetland.

Figure 10: Photograph of the wetland seep against the steep slopes below the plateau.

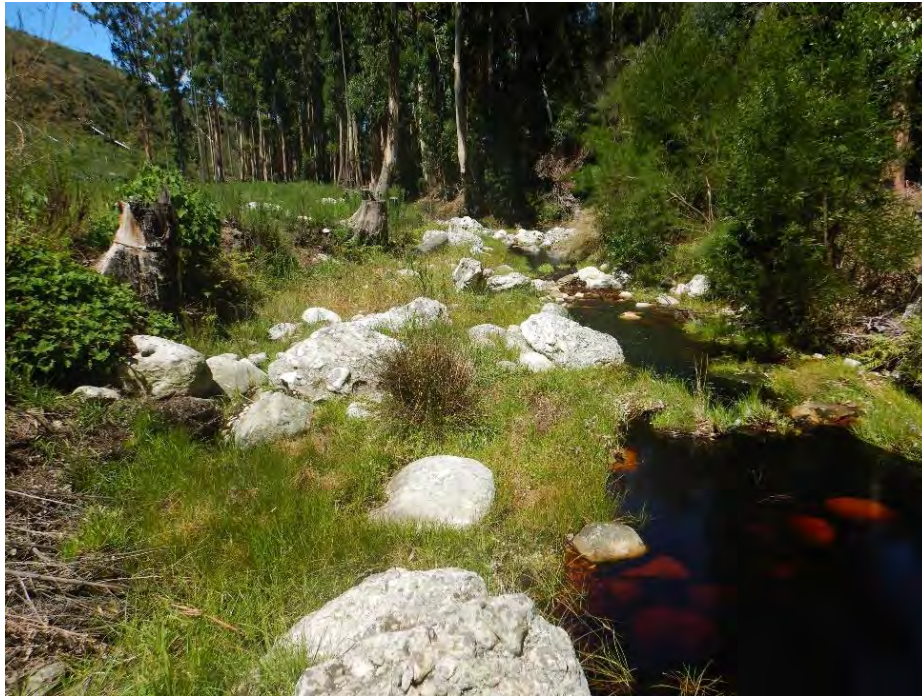
In addition, the section of the Leeukloof River adjacent to Portion 8 of 55 is indicated as a channelled-valley bottom wetland by the latest national wetland map layer (Figure 2). The site visit confirmed that sections of the Leeukloof River do indeed grade into a channelled-valley bottom wetland characterised by wetland habitat and temporary floodplain on the eastern side of the river channel (Figure 11). The river channel runs through wetland areas that are characterised by several wetland plant species including *Centella asiatica*, *Juncus effusus*, *Juncus oxycarpus*, *Isolepis prolifera* and *Pycnus polystachos*. This wetland has been impacted by several activities, most notably invasion by alien invasive vegetation (*Eucalyptus* sp. and *Acacia mearnsii*), increased abstraction (by invasive vegetation and farming). The high intensity of invasive plant species, together with the relatively high concentration of agriculture within the catchment area (and associated abstraction) most likely results in reduced base flows, which is the most severe hydrological impact. There was little sign of increased sediment deposition, although erosion and incision of the river channel due to invasive tree species was evident. Water quality is likely to be relatively unimpacted due to its position high up in the catchment, with low concentrations of nutrients and pesticides from farming activities likely.

Figure 11: Channelled-valley bottom wetland in the Leeukloof River.
