Proposed Residential Development on Erf 23731 in Aalwyndal, Mossel Bay, Western Cape.

Aquatic Biodiversity Site Sensitivity Verification and Impact Assessment

Date: April 2025, Updated November 2025

Version: Draft 3 for Public Participation

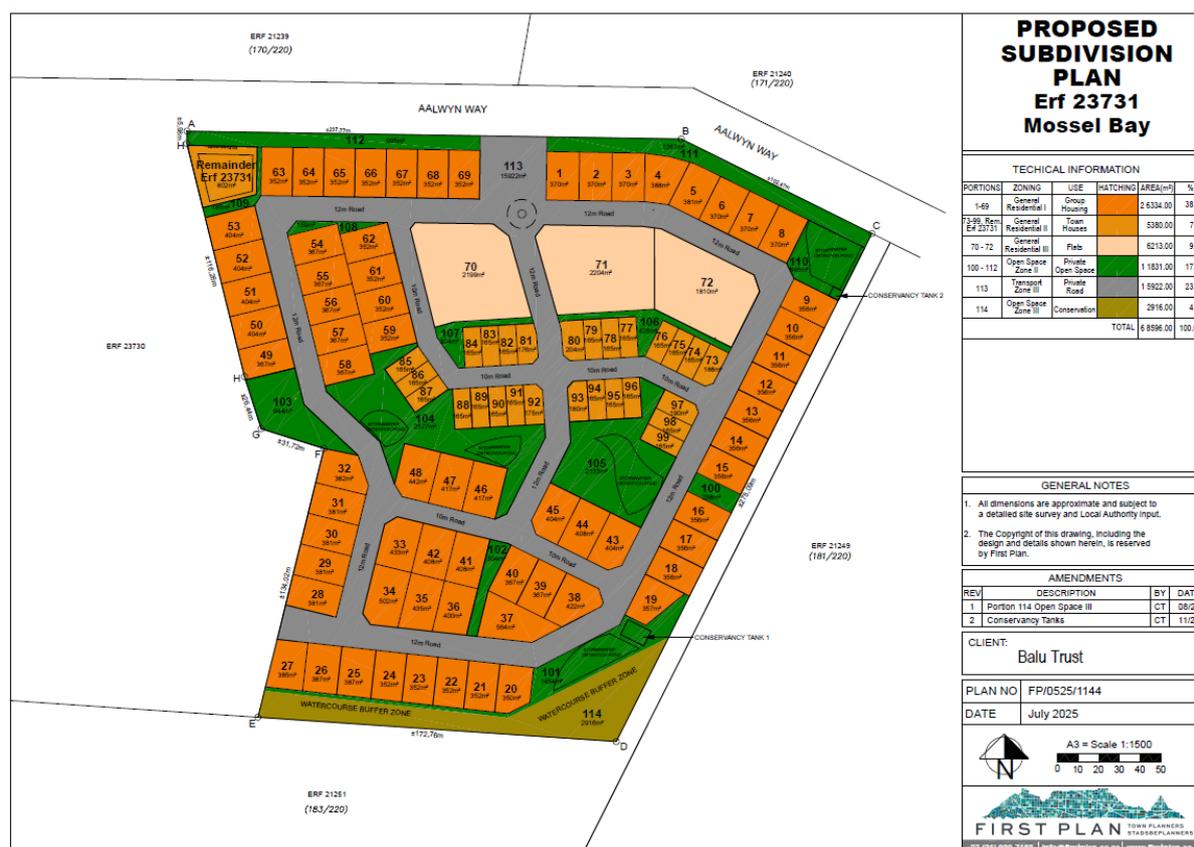
Figure 1. Proposed sub-division of Erf 23731 from Erf 21250 (Rev. 2, Nov 2025).

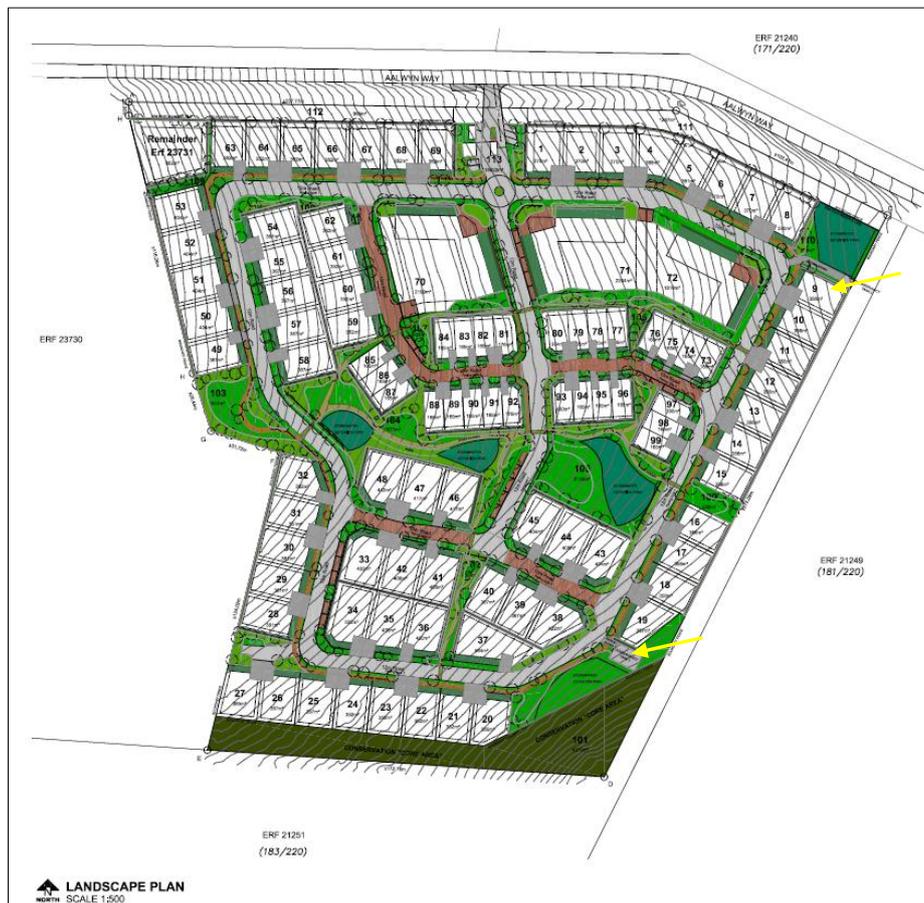
Figure 2. Site Development Plan (SDP; Rev 10) proposed for Erf 23731, Aalwyndal showing the series of stormwater attenuation ponds and Conservancy Tanks indicated by the yellow arrow.

The development provides for a 40m road servitude (20m from the road centre line, for future expansion) along Aalwyn Way. A series of stormwater detention ponds are positioned in the central green space, south eastern corner and north eastern corner. A conservancy tank is located in the south-eastern corner adjacent to the final stormwater pond.

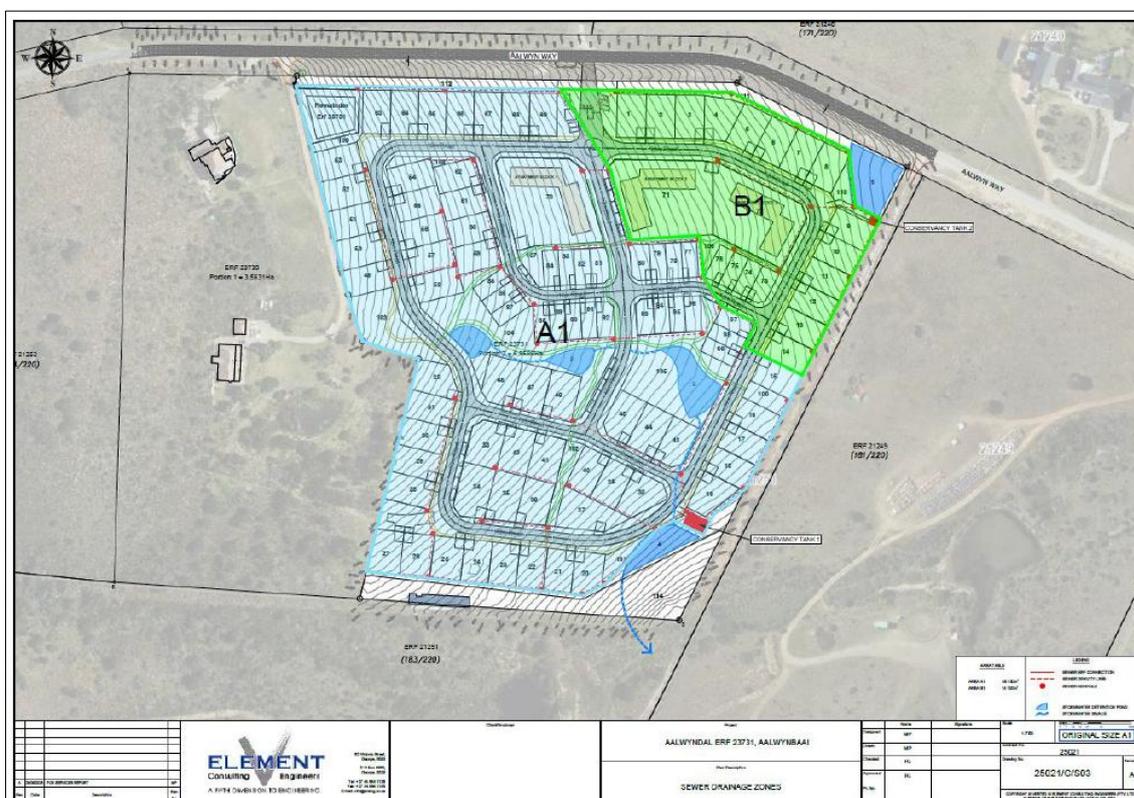
Figure 3. Natural drainage zones identified in the engineering services report (Element, 2025).

The Stormwater Management Report (Element, 2025) was compiled for the proposed development. The property spans a watershed, with approximately 60% drainage towards the general south east direction and 40% draining towards the north east (Figure 3).

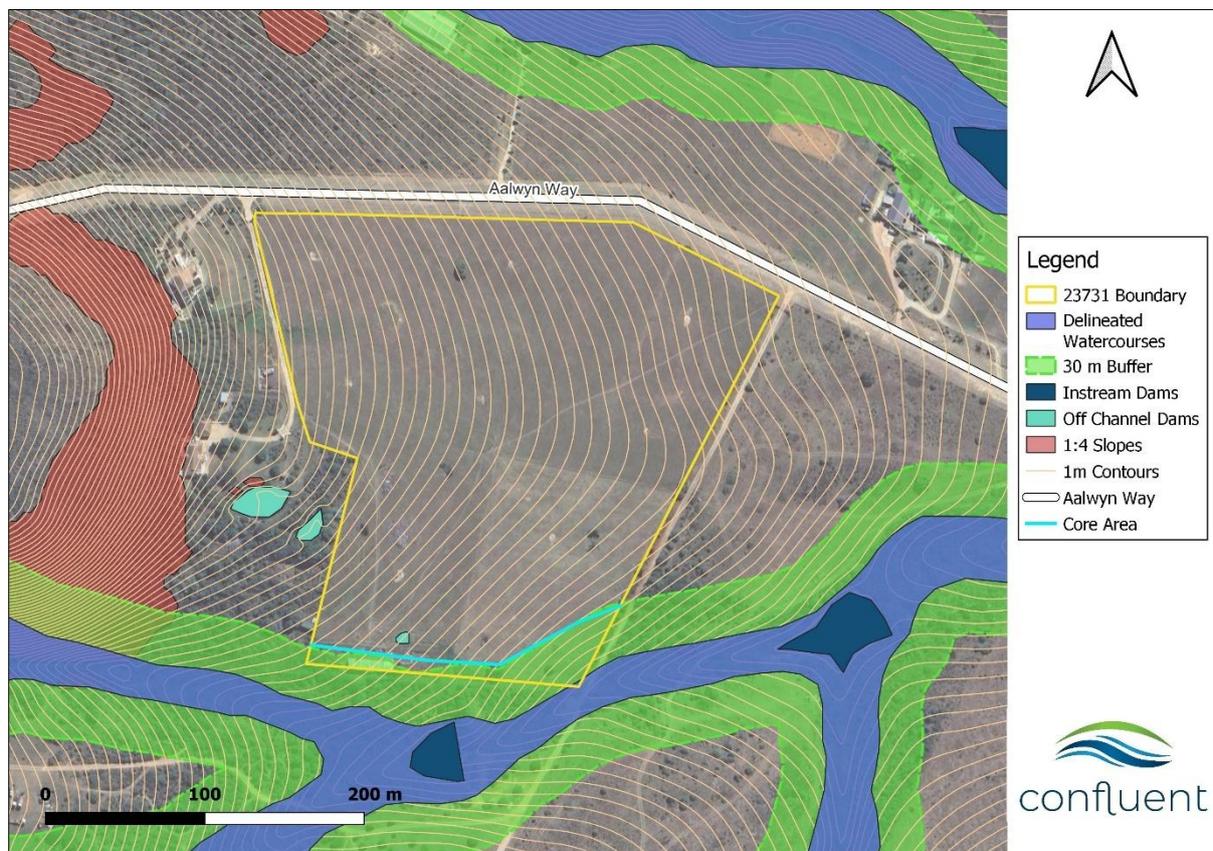
Figure 6. Delineated watercourses and 30m buffer around Erf 23731 (using spatial layers from WCDEDT, 2025).

Erf 23731 is located on Aalwyn Way on historically transformed and grazed land which slopes gently to the south towards a non-perennial drainage line on the neighbouring property. The only mapped intersection between Erf 23731 and any aquatic features is along the southern boundary and the south-eastern corner where the buffer extends into the erf. The watercourses and associated 30m buffers indicated in Figure 6 were delineated in Report 1 of the series, and therefore no further delineation or classification of watercourses is required.

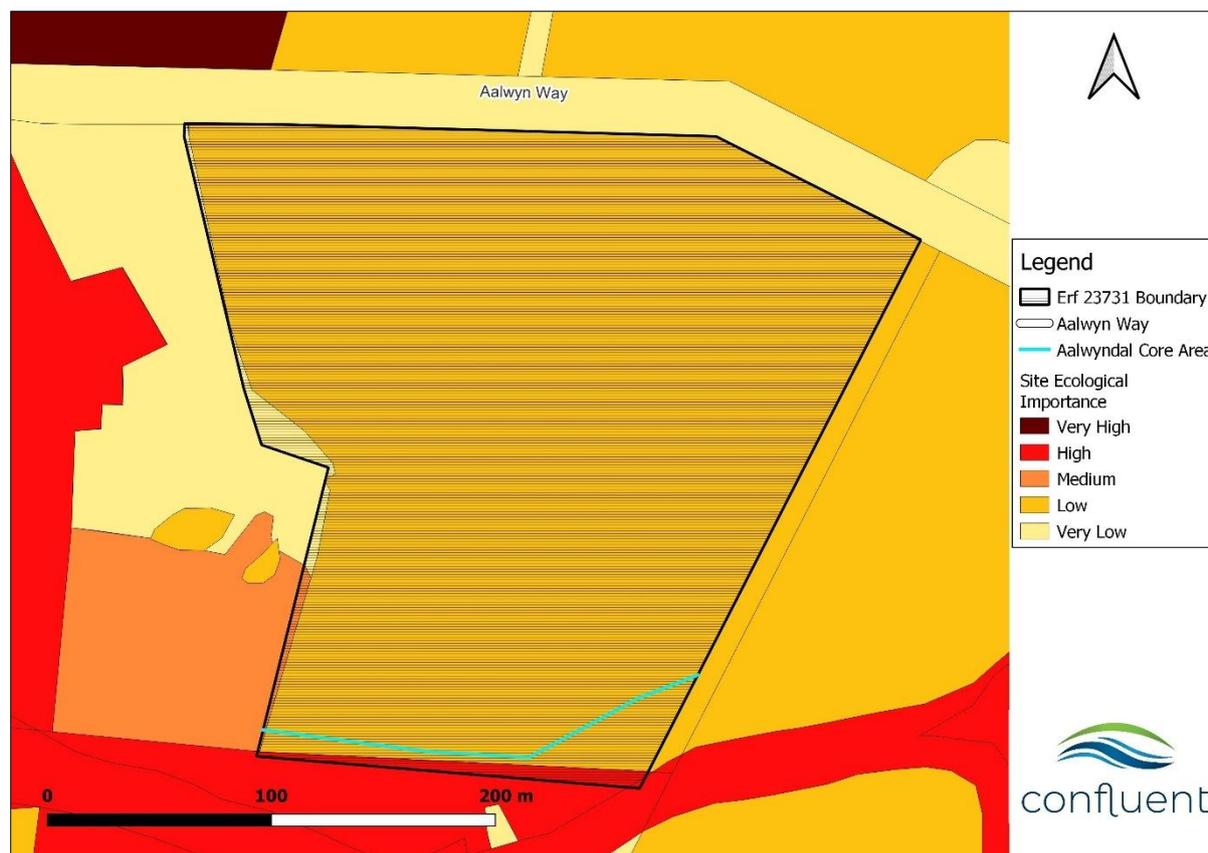
Figure 7. Site Ecological Importance (SEI) determined for Erf 23731 and immediate surroundings (from WCDEDT, 2025).

Site Ecological Importance (SEI) was determined for the Aalwyndal precinct in Report 1 of the WCDEDT (2025) series. The SEI integrated the most sensitive ratings for each of the biodiversity sensitivity themes, covering Aquatic, Terrestrial, Botanical and Fauna. The mapped SEI for Erf 23731 indicates the majority of the sub-divided area as Low Sensitivity. The very small strip of High Sensitivity was left out of the proposed development area in the SDP (Figure 2). Areas of Low and Very Low SEI do not require biodiversity offsets.

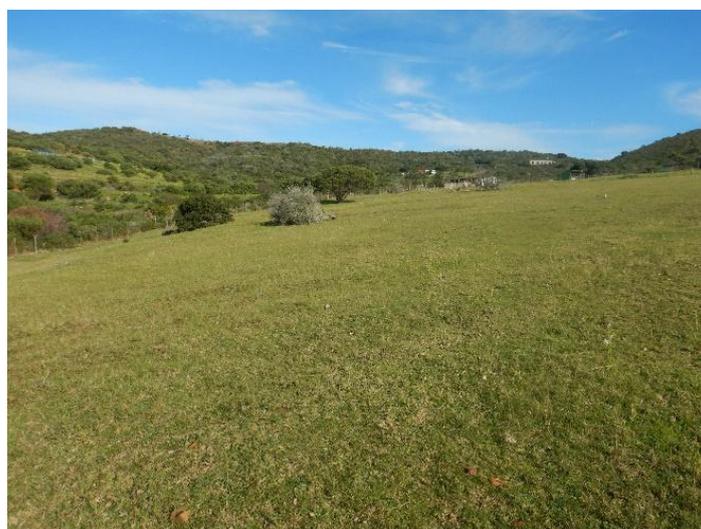
Figure 12. Representative photo of typical terrestrial vegetation cover on the general area of Erf 23731 (photo B. Fouche).

The vegetation type on Erf 23731 is mapped as Mossel Bay Shale Renosterveld which is listed as Critically Endangered. In the proposed development footprint on Erf 23731, the natural vegetation has been historically cleared and presently supports a range of graminoid (grass) species which are grazed lightly by sheep. A more detailed assessment of the vegetation type is provided in the botanical specialist report by B. Fouche (Confluent Environmental, 2025; Figure 12).

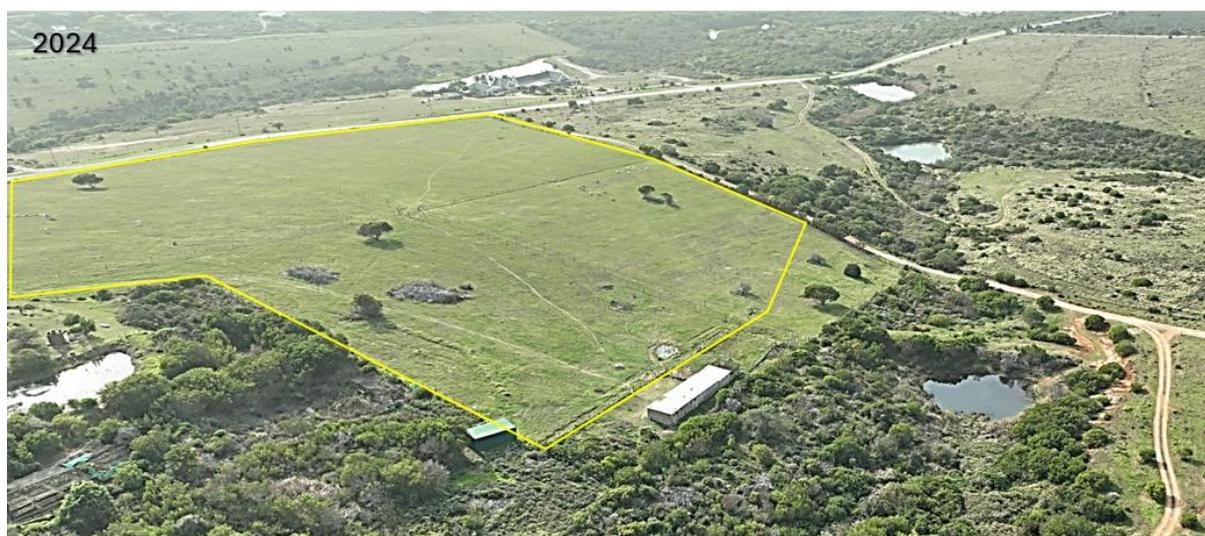
Figure 15. Recent drone photo of the Erf 23731 showing grazed vegetation and the approximate development footprint which excludes the designated proposed Core Area associated with the watercourse.

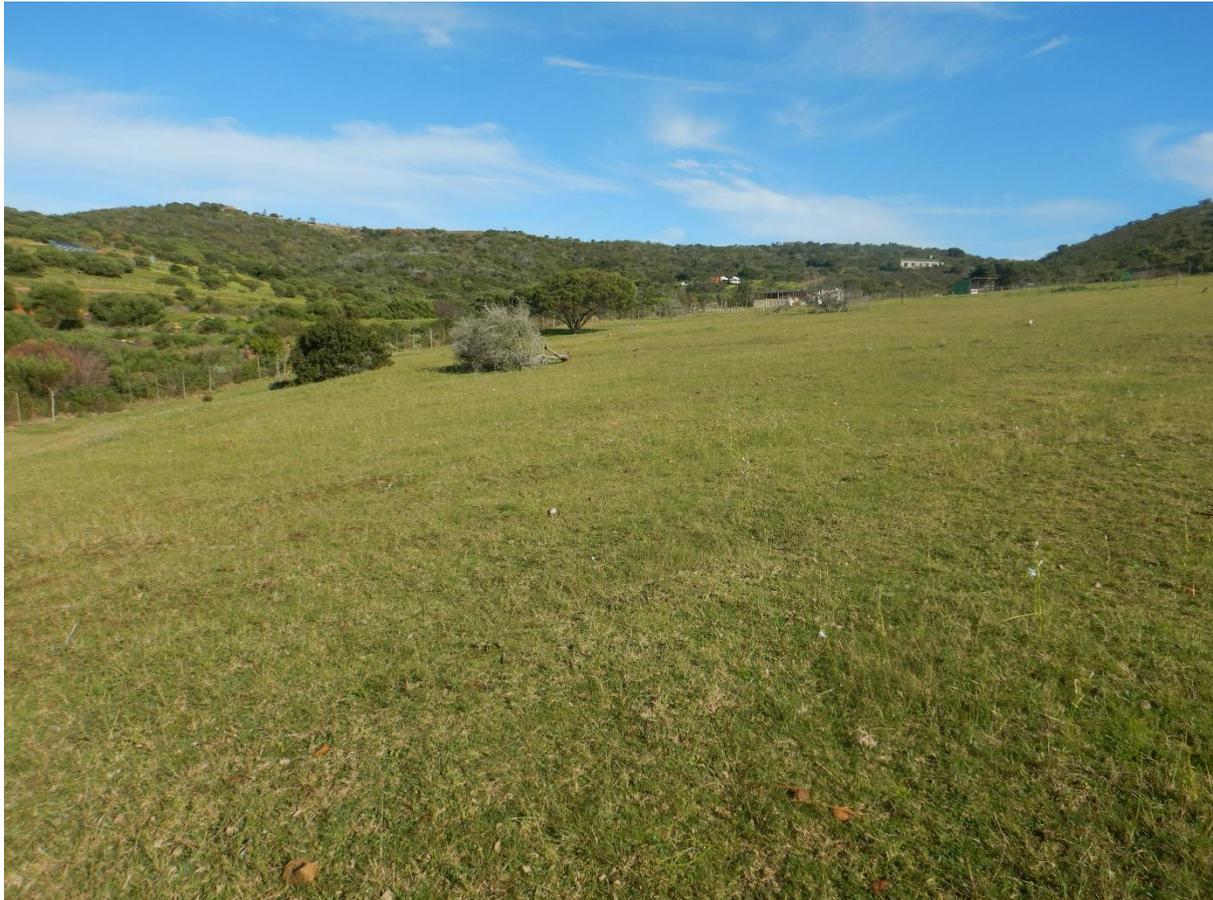
Figure 16. Sloped grazed grass typical of the development footprint with dense, busy vegetation along the valley-bottom watercourse on the neighbouring property.

The full extent of the proposed development footprint is grazed grass with no indication of any wetland features within the site itself. The photo in Figure 16 shows the sloping grass area viewed in a westerly direction towards the watercourse in the valley-bottom. The watercourse is located on the neighbouring property, Erf 21251. The faunal specialist at Confluent Environmental set a camera trap adjacent to the dam near Erf 23731 and identified domestic livestock such as a horse and cows, along with a Black-crowned Night Heron (*Nycticorax nycticorax*) utilising the watercourse. Several other species (e.g. Bushbuck, porcupine, mongoose) are expected to utilise the watercourse as a corridor for movement, feeding and breeding, which is one of the reasons it has been included in the proposed Core Area for Aalwyndal.

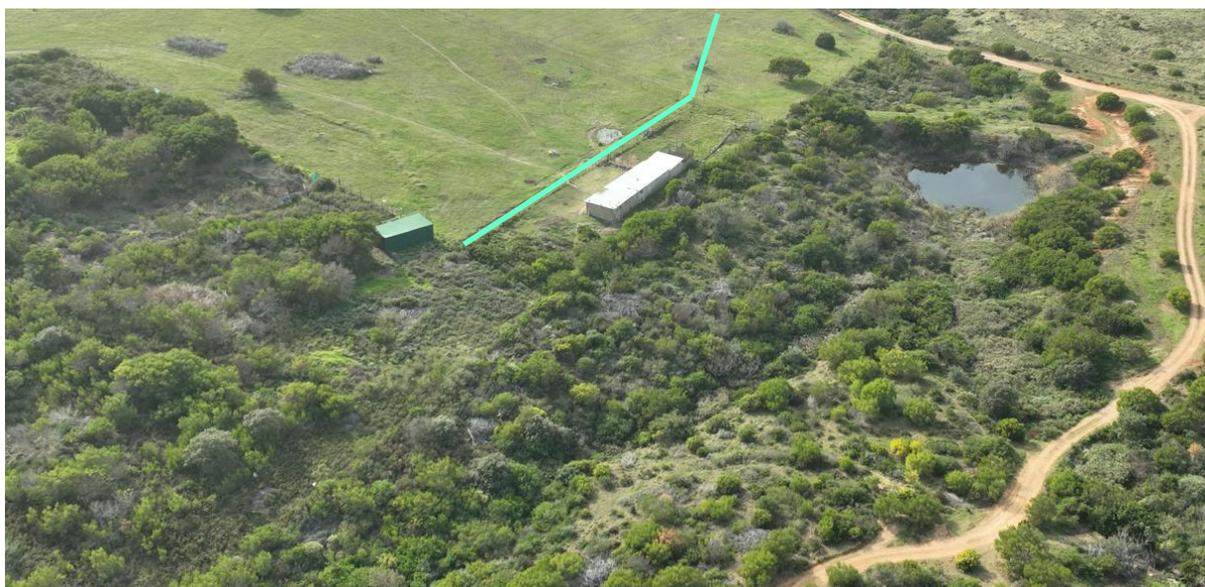
Figure 17. Channelled valley-bottom wetland on property neighbouring Erf 23731. Turquoise line is the approximate limit of the development footprint.

The edge of the delineated channelled valley-bottom wetland is > 32m from the development footprint on Erf 23731 (Figure 17).

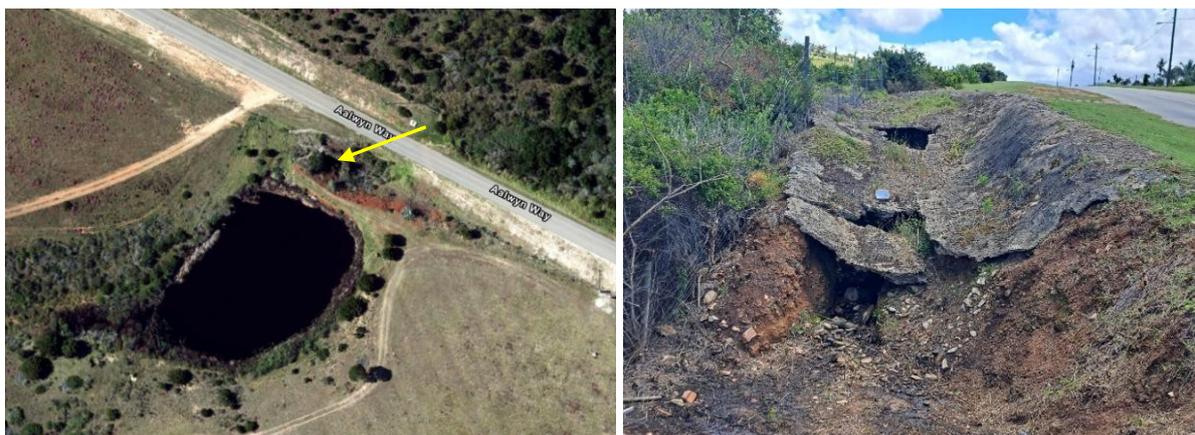
Figure 18. Location (yellow arrow) of the proposed stormwater outlet upgrade to the wetland downstream of an existing dam (left photo). The existing outlet / dam spillway was concreted over but has been scoured out, leaving large holes under the concrete surface (right photo).

Currently, a grassed swal carries street runoff to an outlet in to the watercourse downstream of Erf 23731. The outlet is about 220m east of the Erf 23731 on Aalwyn Way. Part of this development proposal includes an upgrade of the swale to a V-drain and gabion protection at the outlet (Figure 5), which is currently badly eroded. The outlet also forms the spillway of a small instream dam immediately upstream (Figure 18).

It is very likely that Aalwyn Way will be widened and upgraded in the future, in which case this improvement to infrastructure will be replaced. However, it cannot remain in its present condition and receive any increase in stormwater inputs, as it is already failing with the current runoff. Although it is likely that dam overflow events (however infrequent) would have had more of an impact on eroding the outlet / spillway than runoff from Aalwyn Way.

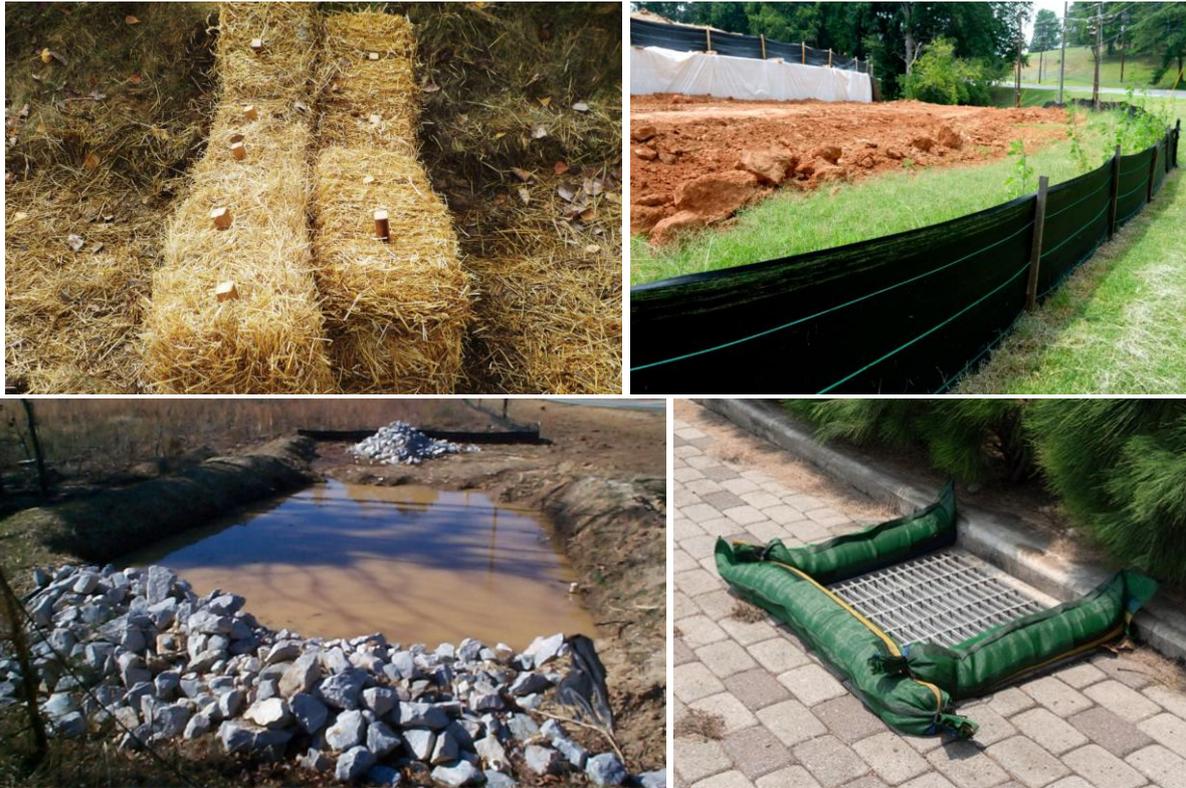
Figure 20. Examples of sediment control measures that are recommended during the construction phase: A = hay bale check dams; B = silt fencing; C = sediment control dam; D = drain protection sandbags.

- Protect any inlets to stormwater drains (once constructed) to ensure silt can settle out before discharging to attenuation dams.
- Progressively revegetate disturbed areas of bare soil once works have concluded. Suitable plant species listed in Table 4 of Report 3 of the Biodiversity Offset Framework Plan should be used in rehabilitation of disturbed areas, as well as recommended for gardens and landscaped areas throughout the development.

- Maintain and regularly clear out silt-laden structures to ensure they remain functional for the duration of the construction phase.

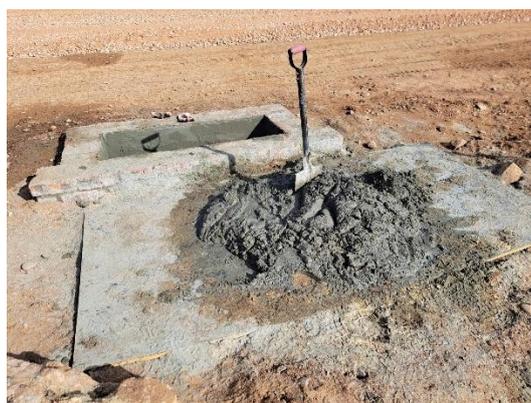
Figure 21. Example of cement being mixed on a board instead of on bare/vegetated soil.

- The ECO must conduct regular (weekly) inspections along the fence line of the Core Area to ensure that no dumping or access to this area has occurred resulting in habitat degradation.
- Any dumped materials must be removed by hand by the relevant contractor, and the site rehabilitated under supervision of the ECO if damage to vegetation has occurred. Suitable plants for rehabilitation are provided in Table 4 of Report 3 of the Biodiversity Offset Framework Plan.
- To reduce the risk of washing materials into the watercourse all construction materials (topsoil, subsoil, building sand) must be stockpiled as far from the watercourse as practically possible.
- Materials no longer required must be removed from the site without delay to reduce the risk of washing downslope or into the watercourse.
- Any cement mixing must be done on a wooden board and not on open ground (Figure 21).
