# Botanical Impact Assessment

## Proposed farm dam on Portions 3 & 13 of Farm Klipheuvel 143, Mossel Bay

25 February 2026

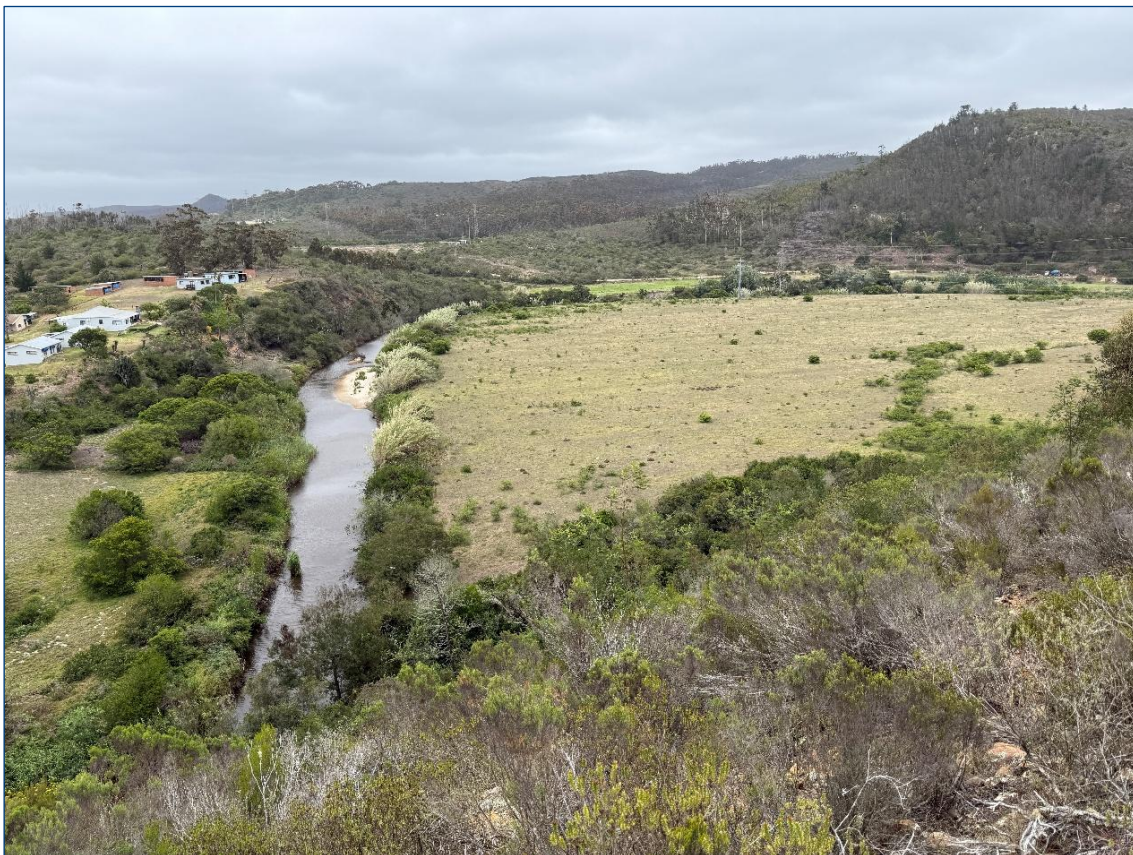
**Figure 4-2: Moordkuil River as viewed from koppie south of the proposed dam wall.**

According to CapeFarmMapper, the dam site is drained by three seasonal watercourses, all of which were dry at the time of surveys (**Figure 4-1**). A NFEPA wetland (channelled valley-bottom wetland) was mapped on the south-eastern side of the site. However, no evidence of a wetland was found during the site survey. The mapped wetland area lies on a low saddle and watershed separating the proposed dam site from the Klipheuwel Dam. The National Freshwater Ecosystem Priority Areas (NFEPA) project provides strategic spatial priorities for conserving South Africa's freshwater ecosystems and supports sustainable use of water resources. These priority areas are referred to as NFEPA's. The proposed two-way pipeline also crosses the Moordkuil River, a perennial river located to the west of the dam site (**Figure 4-2**).

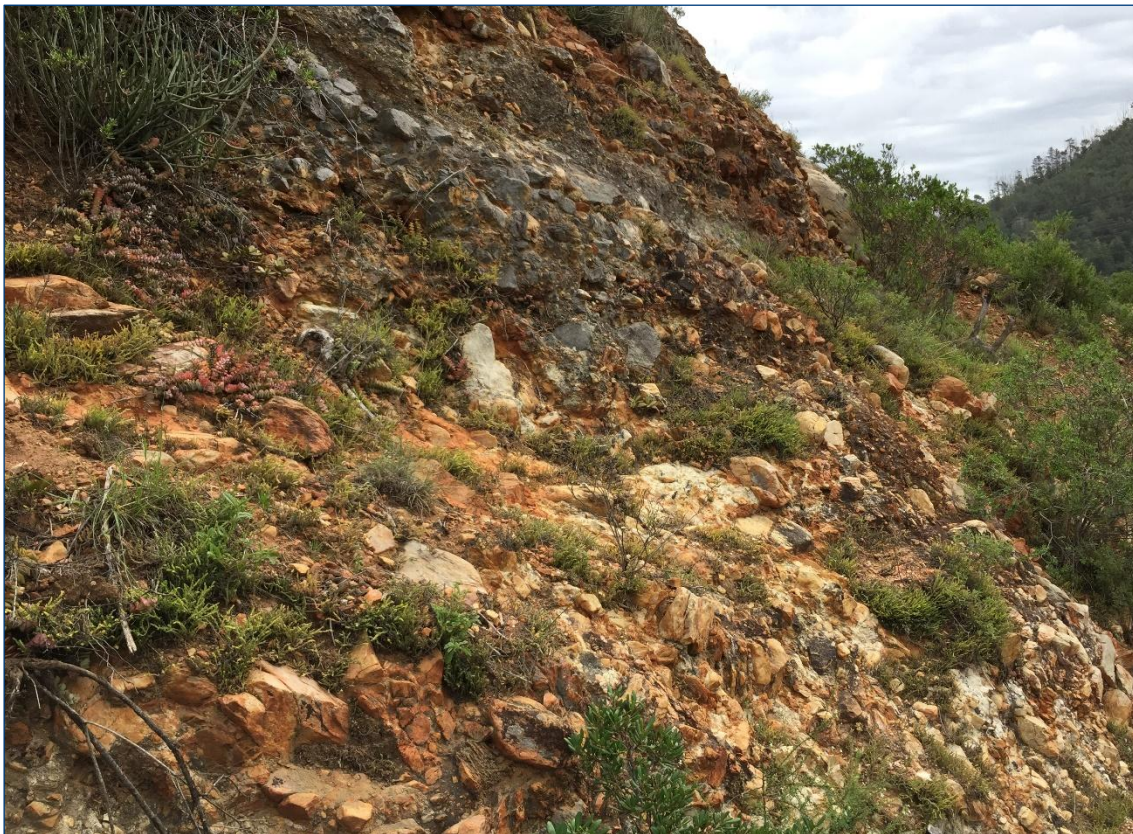
**Figure 4-3: Exposed Enon conglomerate on the koppie in the western part of site, covered with succulents such as *Euphorbia mauritanica*, *Crassula perforata* and *C. cultrata*.**

According to the 3422 AA Mossel Bay 1:50 000 geological map, the main geological formations underlying the site are the Enon Formation (reddish conglomerate) (**Figure 4-3**) in the western part and Kirkwood Formation (mudstone, sandstone with subordinate conglomerate lenses) in the eastern part. Both belong to the Uitenhage Group (Jurassic to Cretaceous age) of sediments. Also present on the southwest-facing slope on the northern side is quartzitic sandstone of the Peninsula Formation. The latter belong to Table Mountain Group. The cobblestones found in the local Enon conglomerate originate from the Table Mountain Group (Viljoen, 1993). Enon conglomerate is an important source of stone aggregate, which is mined at several quarries found in the area (Viljoen, 1993). The latter typically supports renosterveld in the Mossel Bay area.

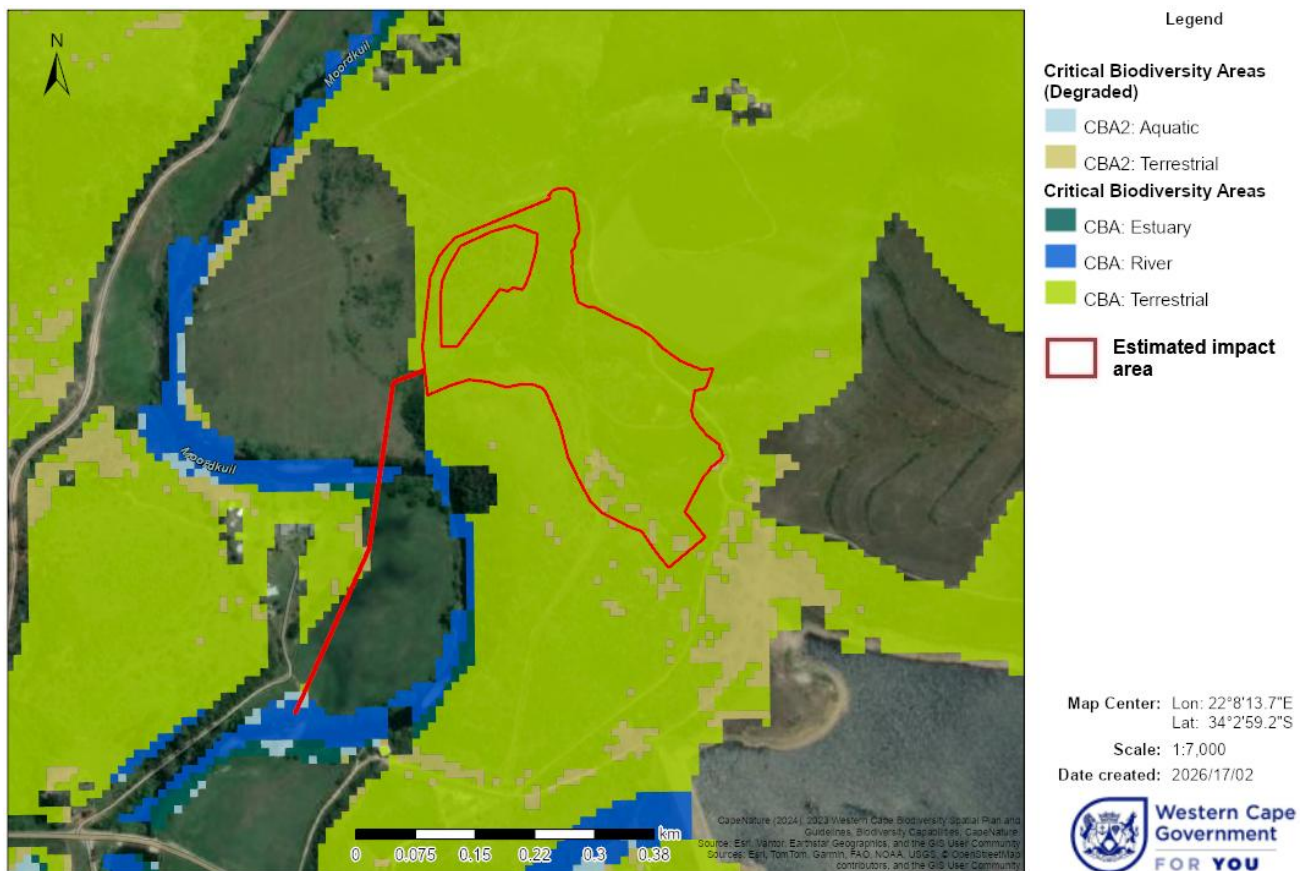
**Figure 4-5: Extract of the Western Cape biodiversity network map.**

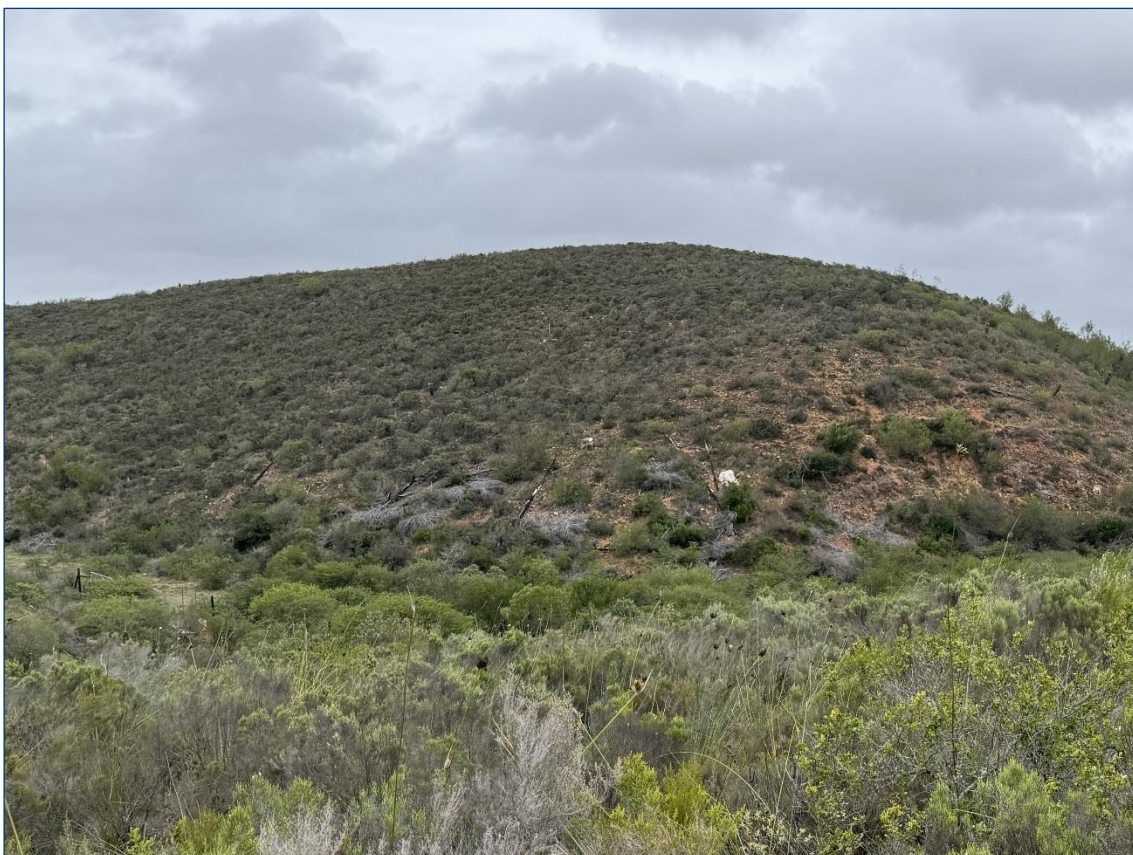
**Figure 5-1: Koppie covered by renosterveld on the south-western side of dam site.**

The site lies on the boundary between South Outeniqua Sandstone Fynbos and Mossel Bay Shale Renosterveld (**Figures 5-1 & 5-2**). Embedded thicket is also present in the above units, mainly along the watercourses and smaller patches inside the renosterveld (**Figure 5-3**). South Outeniqua Sandstone Fynbos extends up the hillslope on the north-eastern side of the site, while the renosterveld covers most of the south-western part of the site. Typical fynbos species recorded inside the fynbos include *Erica peltata*, *E. unicolor* ssp. *mutica*, *Metalasia acuta* and *Bobartia robusta*. The renosterveld is mainly populated by

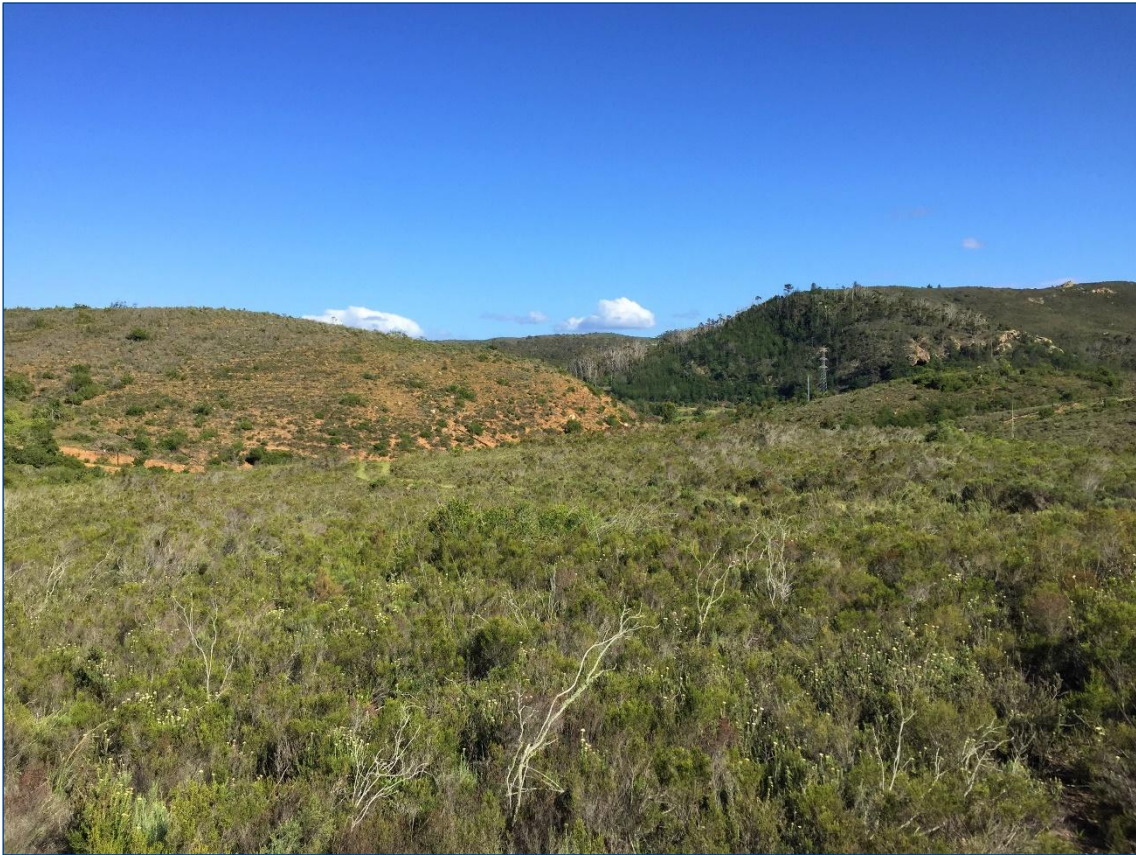
**Figure 5-2: Fynbos (regrowth!) covered slope in the centre of site.**

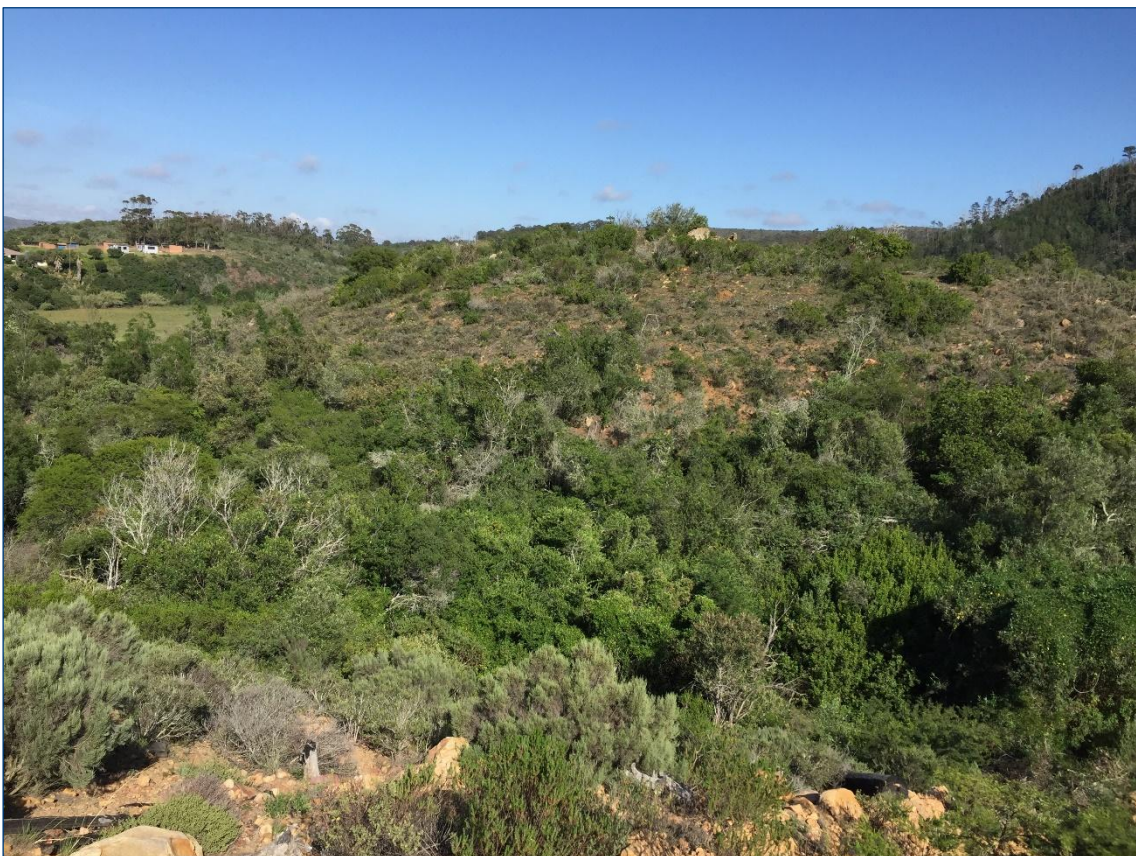
**Figure 5-3: Thicket in a fire-protected kloof in the northern part of dam site.**

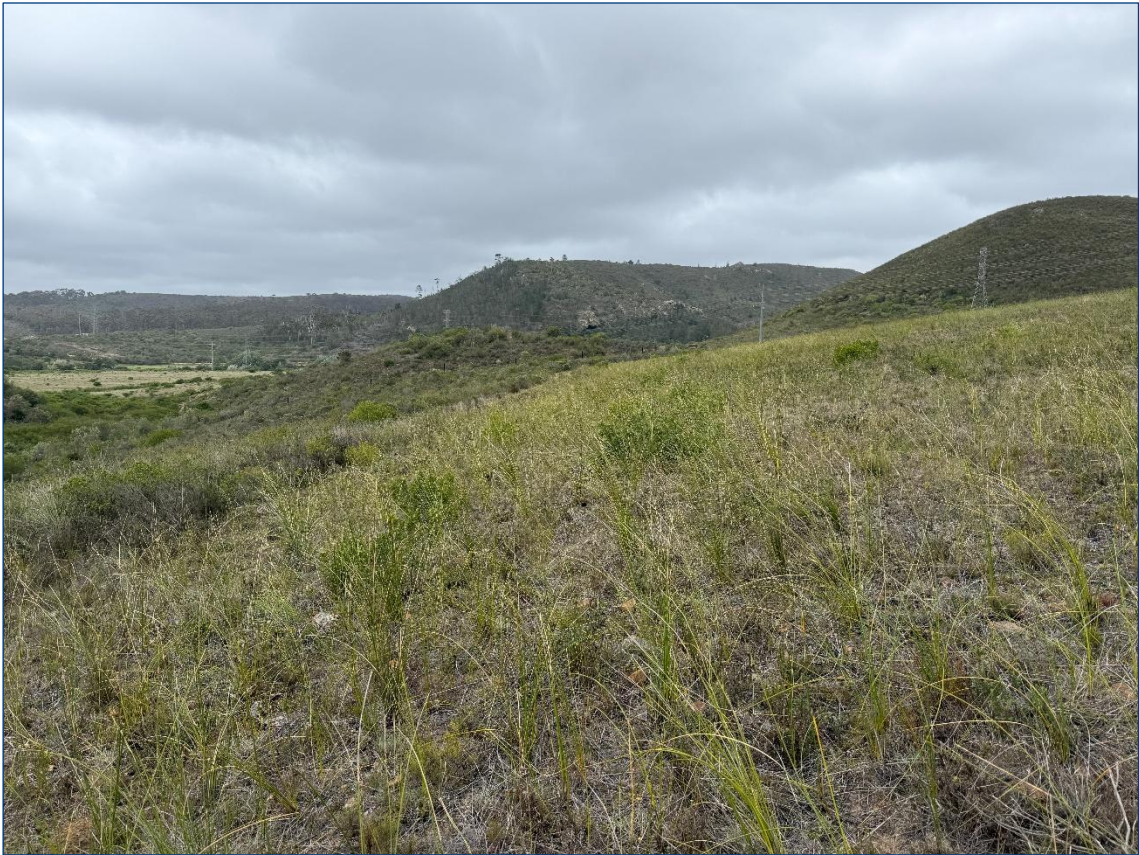
**Figure 5-4: Brush-cut pasture on the north-eastern side of dam site.**

The area earmarked for the farm dam have been disturbed by past farming activities (**Figures 5-4 to 5-6**). Pastures and regrowth (secondary fynbos) were recorded on the site, notably on the southwest-facing slope on northern side. Historical Google Earth photographs also show significant alien infestation in the lower parts of the site (**Figure 5-7**). Most of the latter was subsequently cleared by the farmer. Despite the above past disturbances, significant tracts of renosterveld (albeit degraded) and fynbos (mostly regrowth) remain. The regrowth areas also show different stages of succession with the return of fynbos and renosterveld species. The proposed two-way pipeline runs mainly through farmland (pastures), with a short section crossing the Moordkuil River. The embankment of the latter is covered by *Searsia rehmanniana* var. *glabrata*, *Grewia occidentalis*, *Leonotis leonurus*, *Rubus pinnatus*, *Pteridium aquilinum*, *Arundo donax* and *Cyperus textilis*. *Arundo donax* is an invasive reed. The passage through the river is of little botanical interest. Remains of a small farm dwelling are also present on the koppie in the north-western corner of the site. The botanical attributes of the site are presented in **Figure 5-8**.

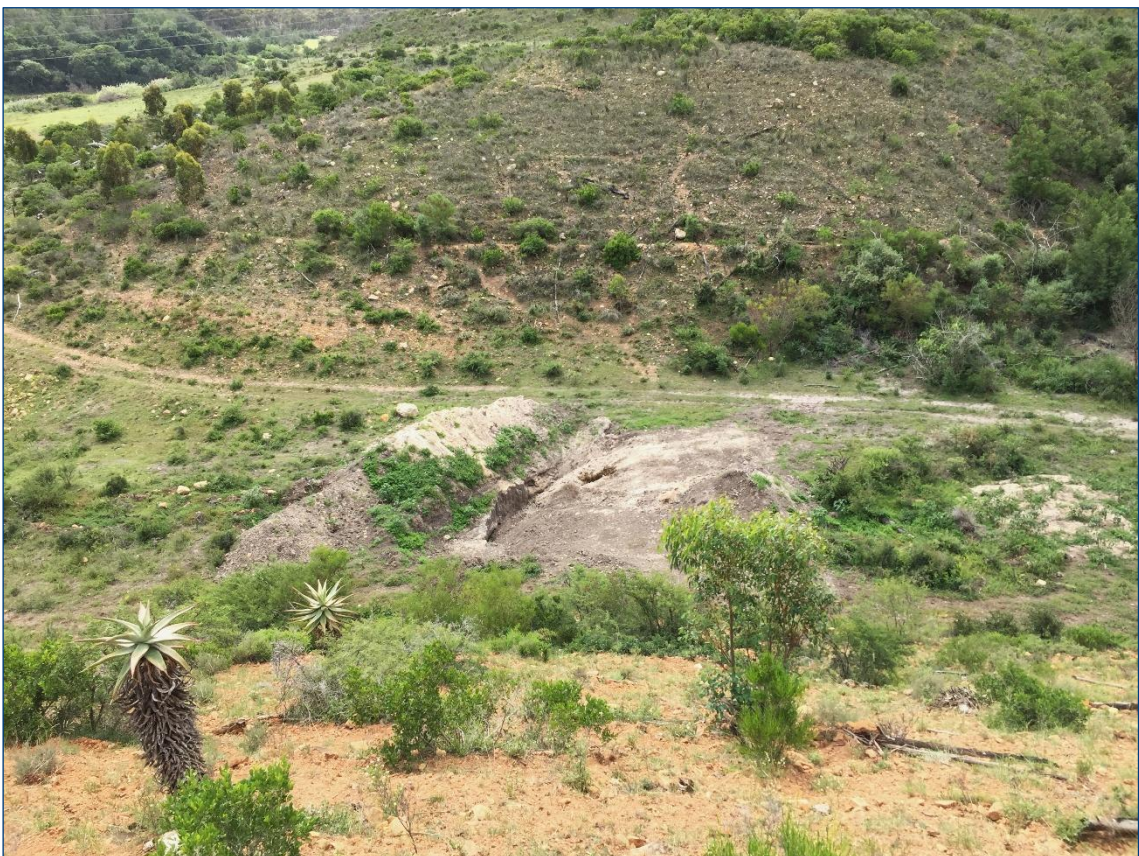
**Figure 5-5: Degraded lower end of site and position of the proposed dam wall.**

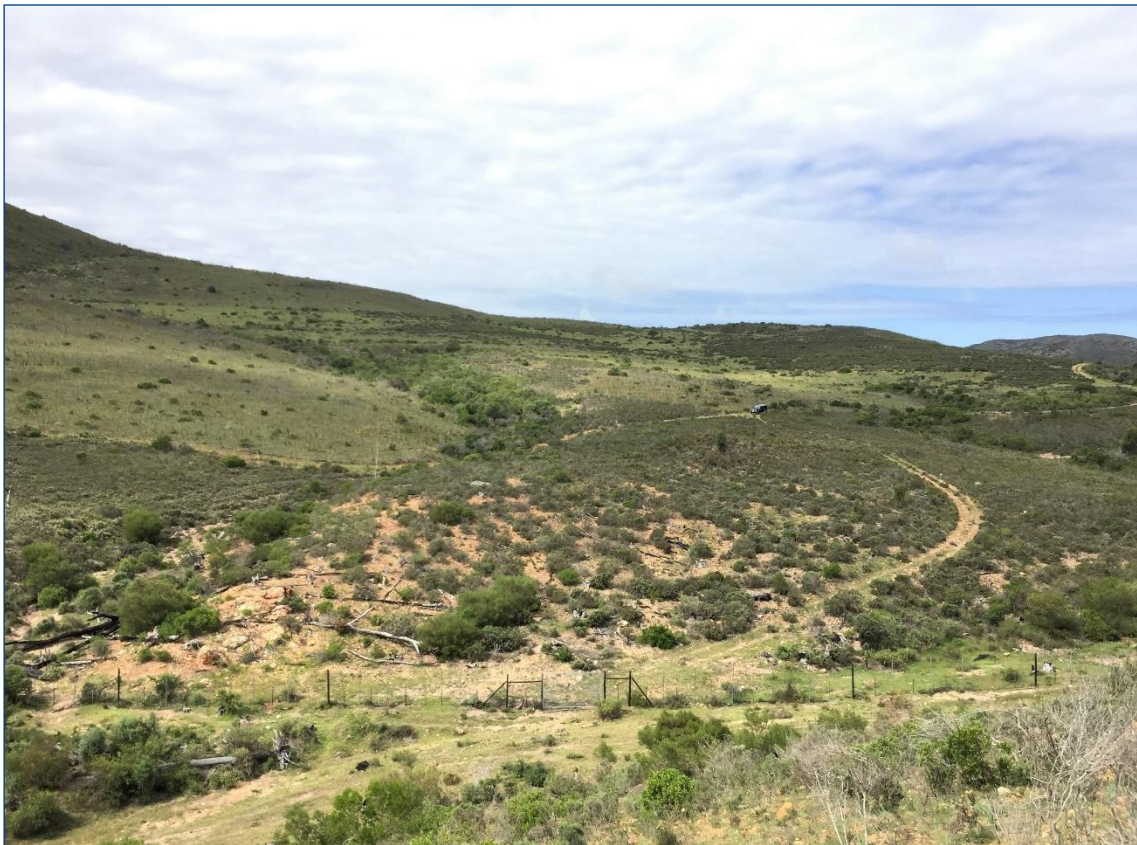
**Figure 5-6: View from koppie eastwards across the proposed dam site.**
