# Proposed New Bulk Sewer Pipelines in Pienaarstrand, Great Brak, Western Cape.

Aquatic Biodiversity Impact Assessment.

**Prepared For:** Cape EAPrac  
**Author:** Franco de Ridder  
Confluent Environmental Pty (Ltd)  
7 St. Johns Street,  
Dormehls Drift,  
George, 6529  
**SACNASP:** Cand. Sci. Nat. (Aquatic Science – 166398)  
**Reviewer:** Dr. J. Dabrowski (PhD) Pr.Sci.Nat (Aquatic  
Science & Ecological Science) – 115166  
**Date:** November 2025  
**Version:** Draft

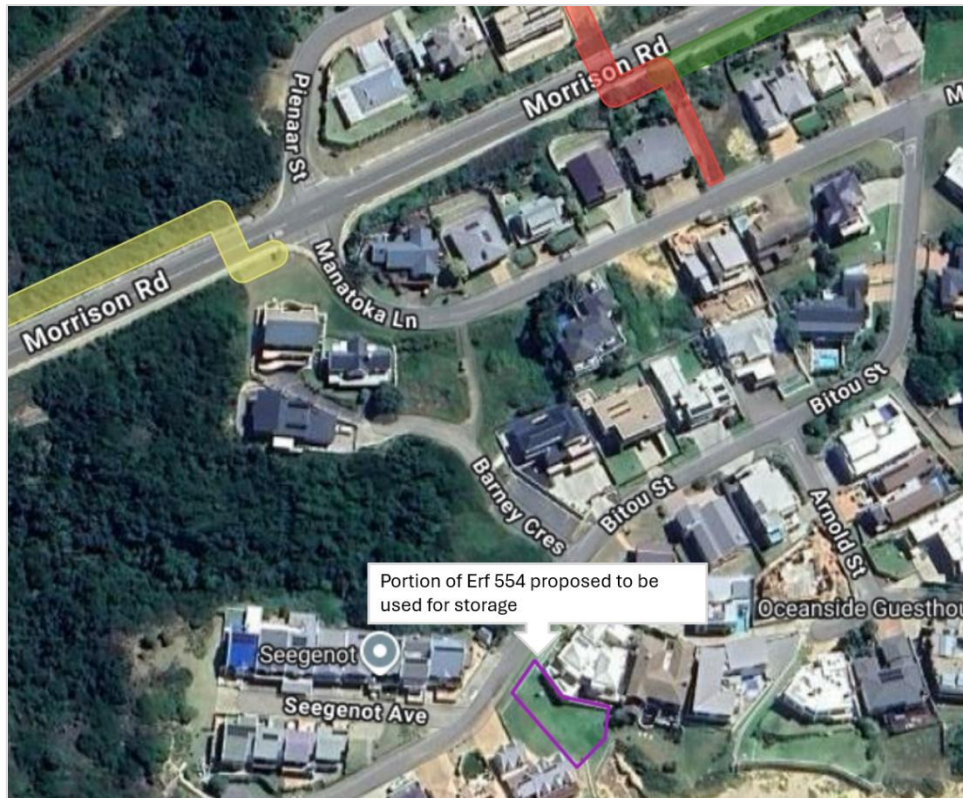
Figure 3: Temporary site camp (indicated as storage) on a portion of Erf 554 (purple). Pipelines, as proposed, and the 7m buffer are included in red, green, and yellow.

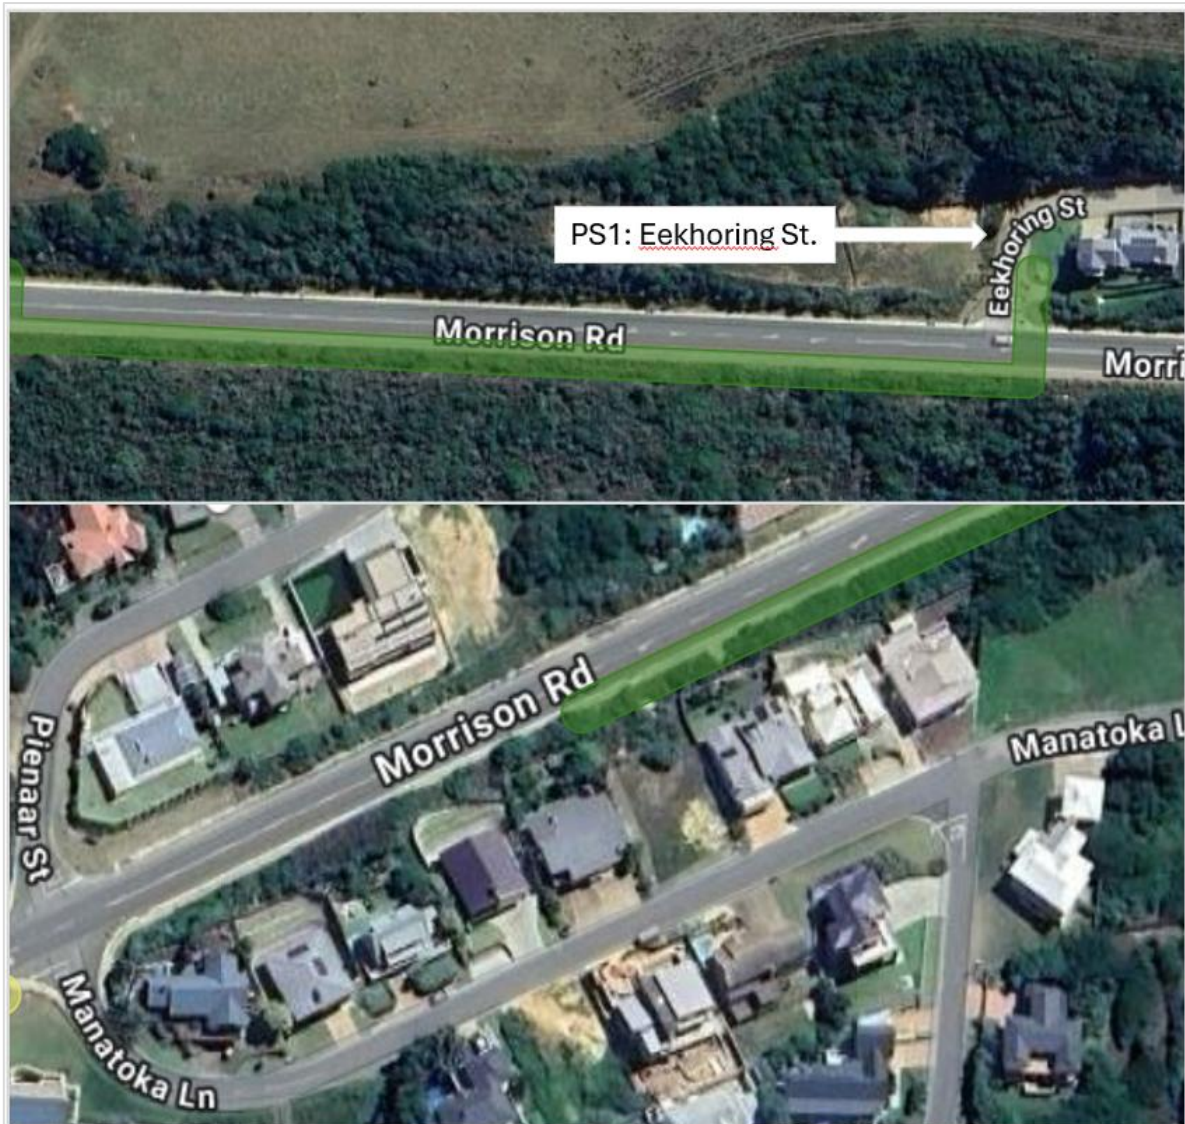
Figure 4: The beginning (top) and end (bottom) of the proposed pipeline following Morrison Road reserve for  $\pm 1.33$  km. 7m disturbance envelope applied.

The pipeline alignment following Morrison Road reserve for ±1.33 km, where it will tie into a new transfer manhole to be connected to the existing gravity sewer system at Manatoka Lane (Figure 4).

The method of installation will be a combination of Horizontal Directional Drilling (HDD) at road crossings, pipe cracking into the existing Ø100mm Asbestos Cement (AC) water pipeline, and trenching (maximum of 1m wide trench with a 3m work area on either side of the trench).

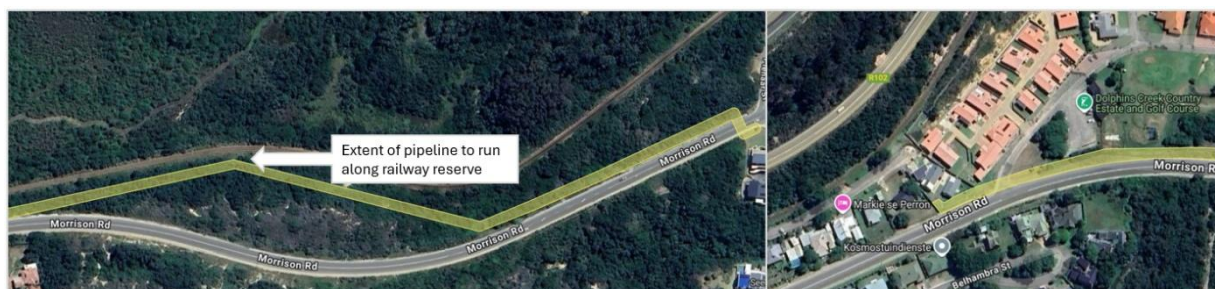
Figure 6. The pipeline alignment from Manatoka Lane (left) to Dolphins Creek Golf Estate (right) for  $\pm 2.41\text{km}$ , 7m disturbance envelope applied.

This pipeline will extend from Manatoka Lane to Dolphins Creek Golf Estate (Figure 6). The length of the pipeline will be  $\pm 2.41\text{km}$ . The pipeline extending into the bush (left image in Figure 6) follows the railway reserve since along this section of Morrison Road, there is insufficient space within the road reserve to accommodate the pipeline due to the presence of other services.

Method of installation will be a combination of HDD at road crossings, Pipe Cracking into the existing Ø100mm AC water pipeline, and trenching (maximum 1m wide trench with a 3m work area on either side of the trench).

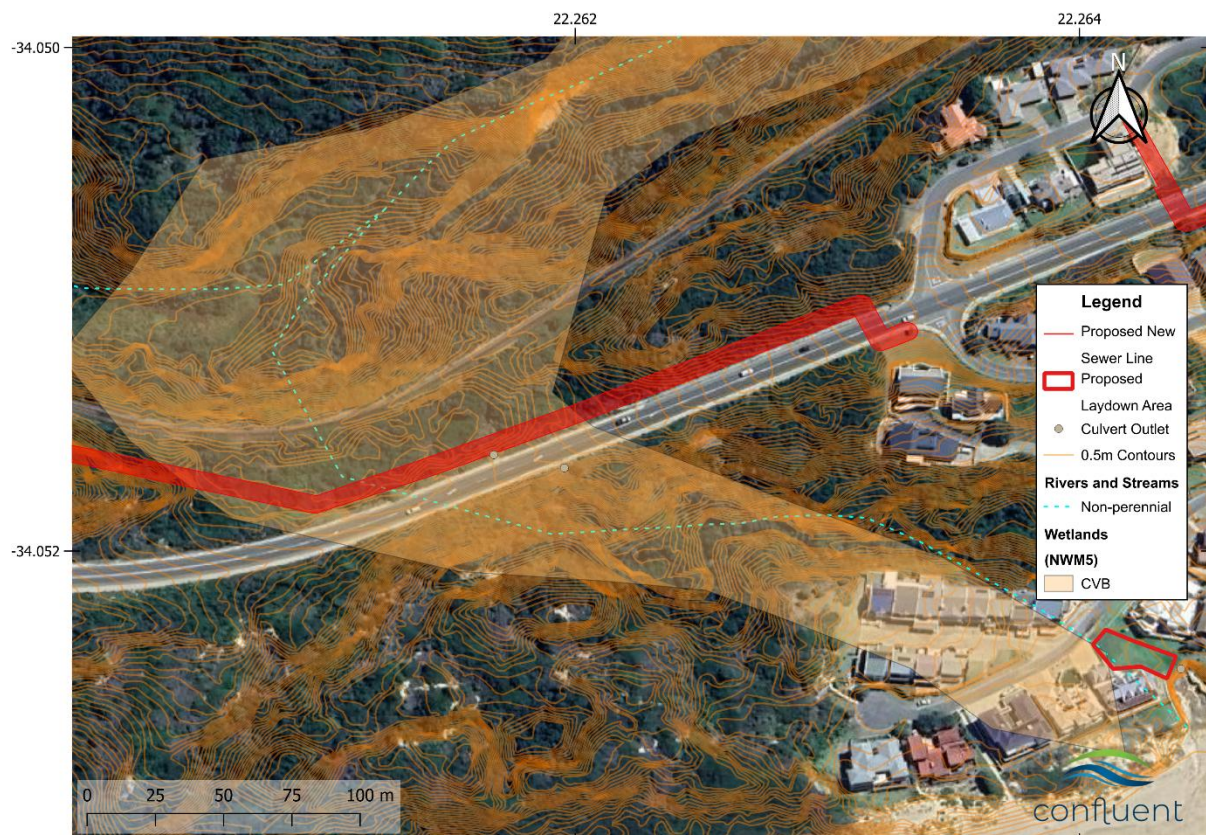
Figure 12: The proposed sewer line at the third crossing of mapped watercourses.

The third crossing (GPS: -34.049008, 22.274516) is approximately 5 km east of the N2 off-ramp and 55.7 m west of H.C. Botha Street. The non-perennial stream is mapped to flow in a south-westerly direction. The non-perennial stream originates on agricultural land adjacent to the north of the sewer line, with a tributary mapped towards the west to join the non-perennial stream 48.8 m north of the sewer line crossing. The non-perennial stream is mapped to terminate adjacent to Thys Olivier Street.

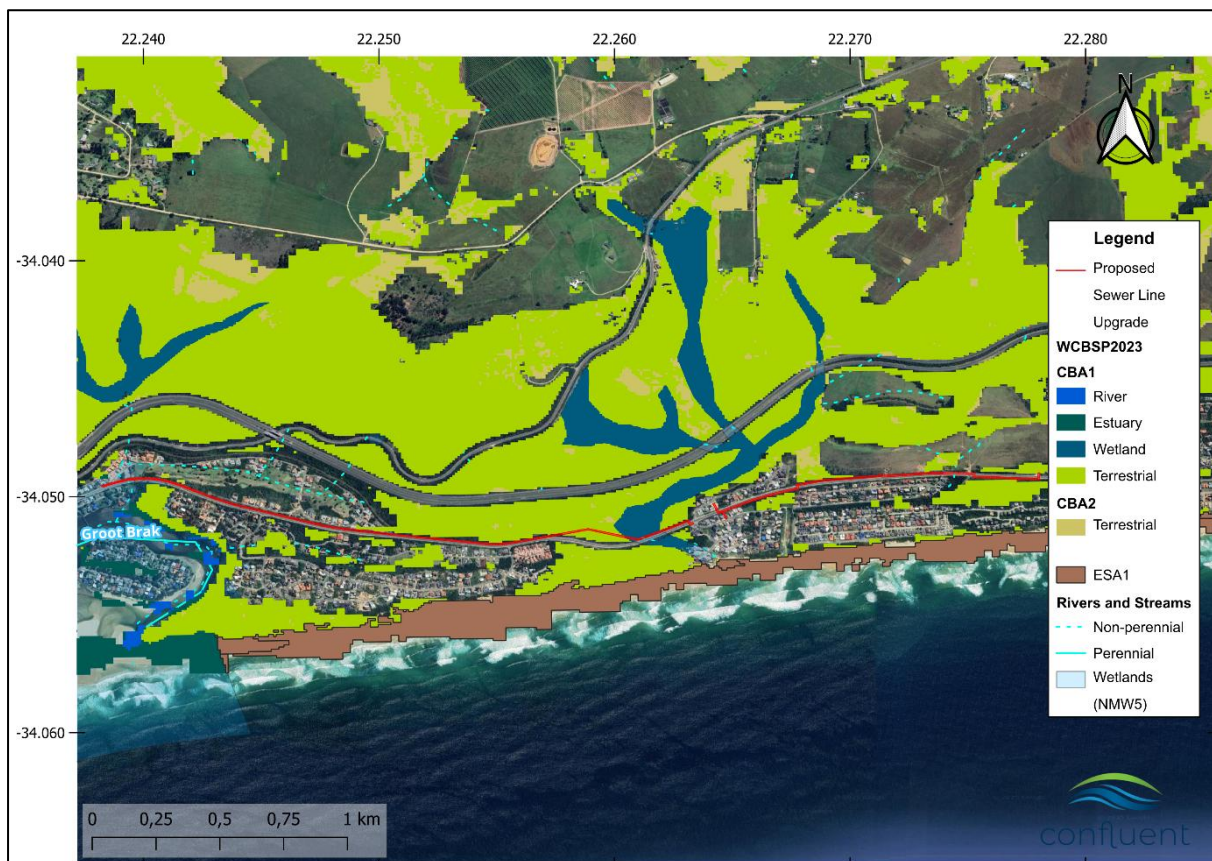
Figure 13. The proposed sewer line to mapped conservation features of the Western Cape Biodiversity Spatial Plan (2023).

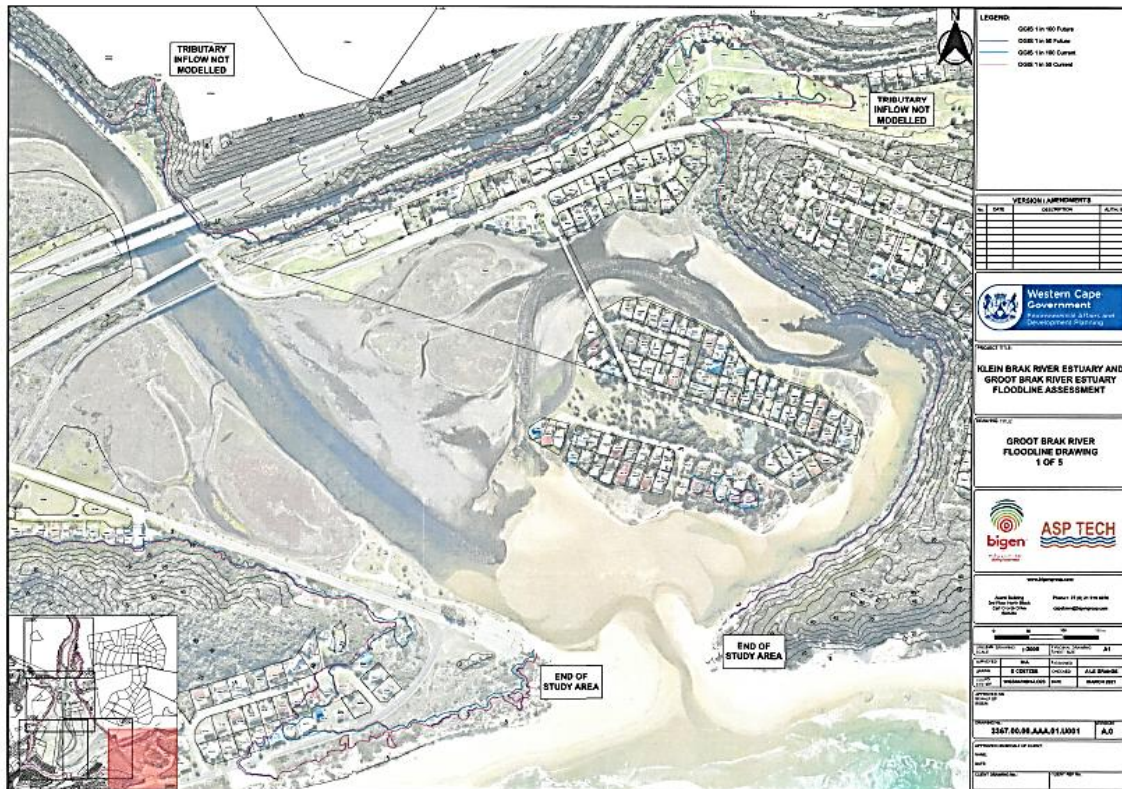
Figure 15: 1:50 (red) and 1:100 (blue) flood lines (DEA&DP, 2021).

flood risk and potential hydrological connectivity to the estuary. The determined 1 in 100 and 1 in 50-year flood lines are in very close proximity to one another, differing by a meter or less (Figure 15; DEA&DP, 2021).

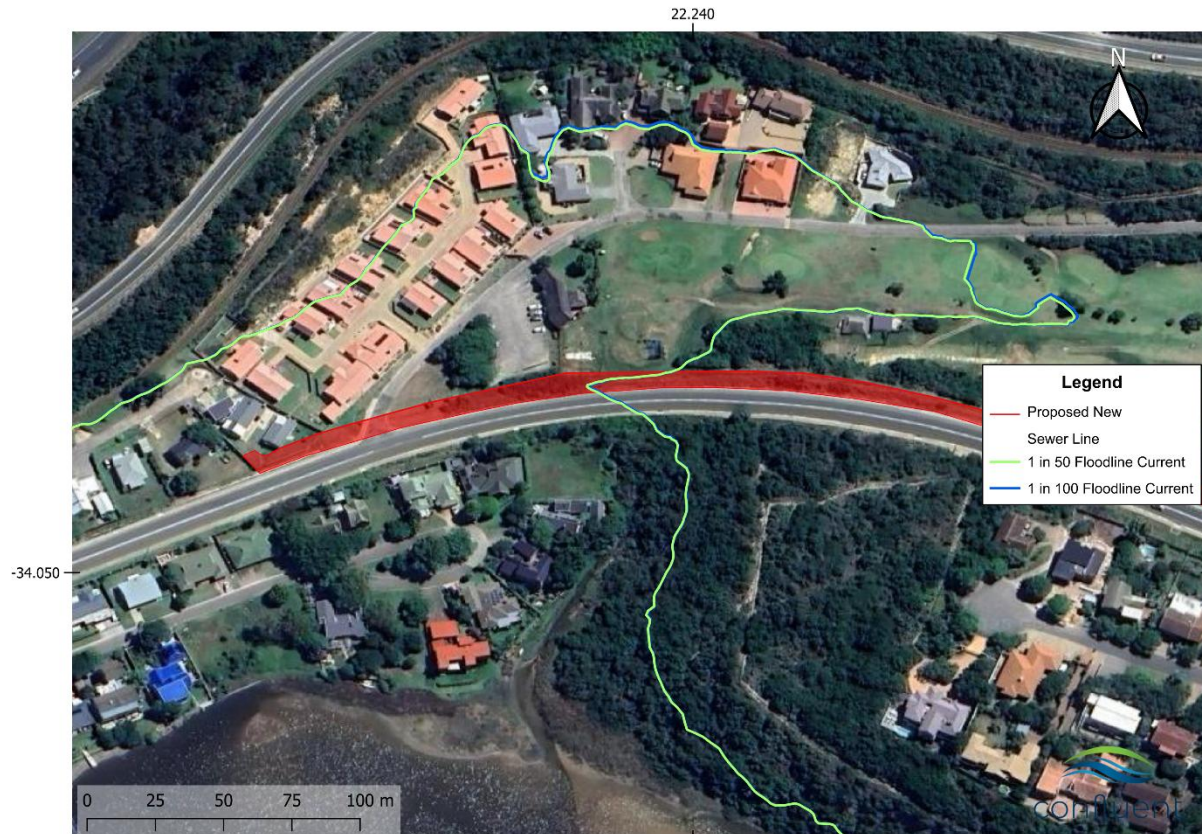
Figure 16: The proposed sewer line in relation to the 1:50 (green) and 1:100 (blue) flood lines (DEA&DP, 2021).

According to the determined flood lines, the proposed new sewer line is to be constructed within the 1 in 100 and 1 in 50-year flood lines of the Great Brak Estuary (Figure 16). It is thus recommended that mitigations should be applied to reduce the likelihood of any spillage of sewage during flooding events.

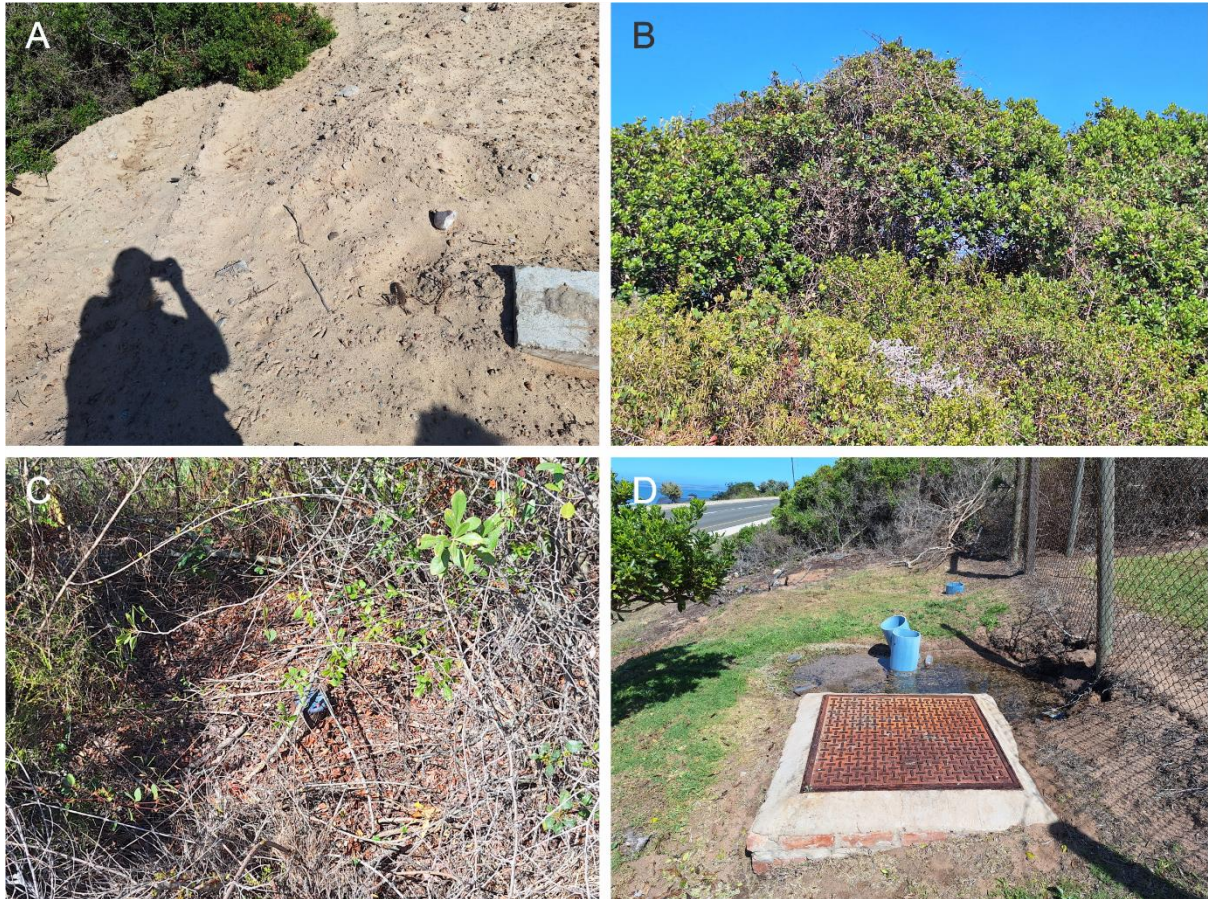
*Figure 19: A – Sandy soil in the location of the proposed sewer line, B – General vegetation in the area, C – Evidence of alien clearing, D – Leaking potable water pipe.*

The site visit was conducted on the 17<sup>th</sup> of October 2025, during which time the entire extent of the proposed sewer line was traversed on foot (Figure 18). At the time of the site visit, the weather was clear. The extent of the sewer line's terrain can be described as undulating, with a flat section at the start of the proposed sewer line near the Great Brak Estuary. The soil across the entire extent of the sewer line is sandy (Figure 19: A), with expected high water infiltration rates.

The vegetation along and within all mapped watercourses on the site is terrestrial and includes, but is not limited to, *Osteospermum moniliferum* (Bietou), *Hermannia flammea*, *Carissa bispinosa* (Num-Num), *Pterocelastrus tricuspidatus* (Candlewood), *Sideroxylon inerme* (Milkwood) and several *Searsia* species (Figure 19: B). Some alien vegetation was also observed, especially in the mapped watercourse at the first crossing, which includes *Acacia cyclops* (Rooikrans), *Ricinus communis* (Castor Bean), *Solanum mauritianum* (Bugweed) and *Melia azedarach* (Chinaberry). Evidence of alien clearing was observed more towards the east along the proposed sewer line (Figure 19: D). It should be noted that at the time of the site visit, a portable water pipe transporting water from the reservoir was leaking, creating a deep puddle and causing erosion along the fence located just south of the pump station (Figure 19: D).

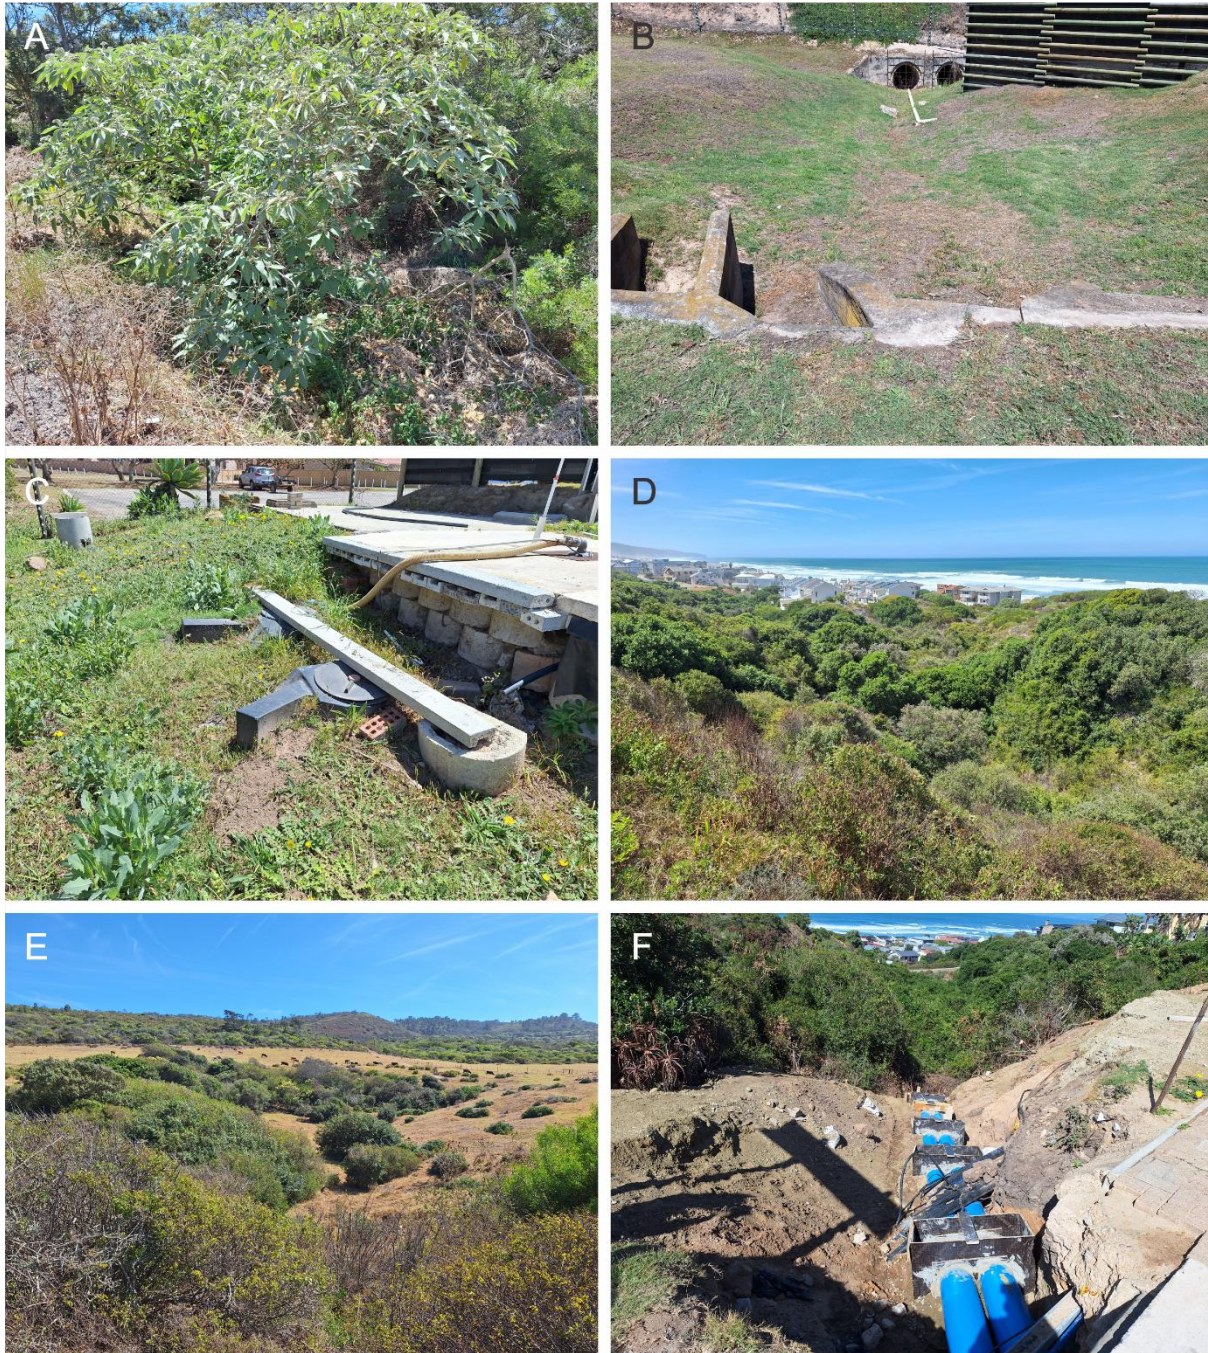
Figure 20: A – Alien invasive *Solanum mauritianum* (Bugweed) within the mapped watercourse at the first crossing, B – Culverts aligned with the watercourse at the first crossing with overflow pipe of conservancy tanks, C – Conservancy tanks adjacent to the west of the mapped watercourse, D – A view of the flow path at the second crossing towards the south, E – A view of the flow path at the third crossing towards the north showing the agricultural field, F – A view of the flow path at the third crossing towards the south showing the exposed existing infrastructure in sandy soil.

The mapped watercourse at Crossing Three is also referred to as a flow path for the same reasons mentioned above. The section north of the proposed sewer line is predominantly pasture with a few *Searsia* species within the valley (Figure 20: E), in contrast to the section south of the proposed sewer line, which is dominated by dense thicket vegetation. At the time of the site visit, the culvert passing underneath the road was being worked on, exposing the existing infrastructure on the southern side of the road (Figure 20: F).

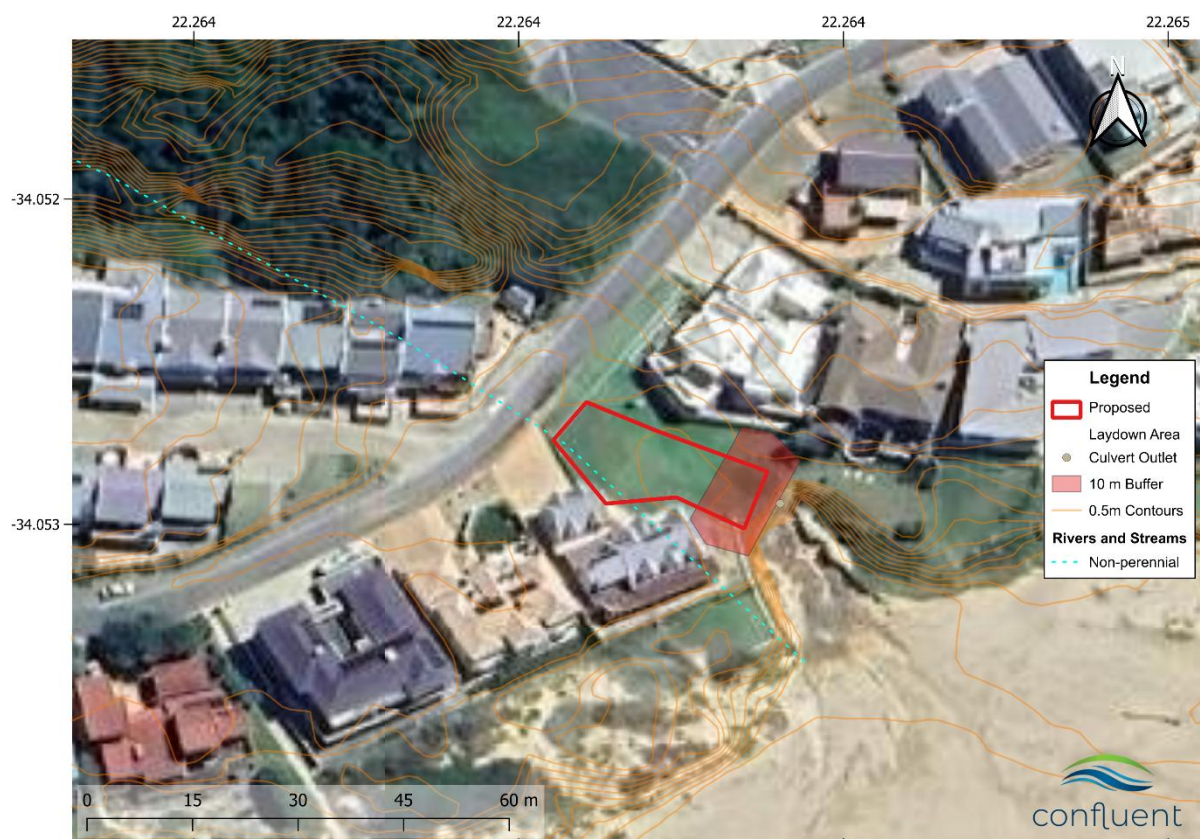
Figure 23: Proposed laydown area in relation to the recommended 10 m buffer

It is recommended that a 10 m buffer area be allowed from the southern edge of the laydown area (Figure 23). This will reduce the likelihood of any material entering the ocean, on the beach, or blocking the culvert below the laydown area. Care should also be taken when converting the conservancy tank to a pump station (PS2) to ensure that untreated sewage does not spill into the flow path, onto the beach or into the ocean. It is thus recommended that spill kits be on site during construction and that a check dam be constructed if a large amount of spillage is expected. Additionally, it is recommended that the sewer line be located in the most disturbed areas adjacent to the road or railway, especially where the sewer line is proposed to run over the hill next to the railway (Figure 6). However, this recommendation relates to terrestrial impacts and is further discussed in the Terrestrial / Botanical specialist report (B. Fouche, Confluent Environmental).
