## Proposed New Installation of Sewerage Infrastructure in Pienaarstrand, Great Brak, Western Cape.

### Specialist Plant Species and Terrestrial Biodiversity Impact Assessment

Version:          Draft Version 4

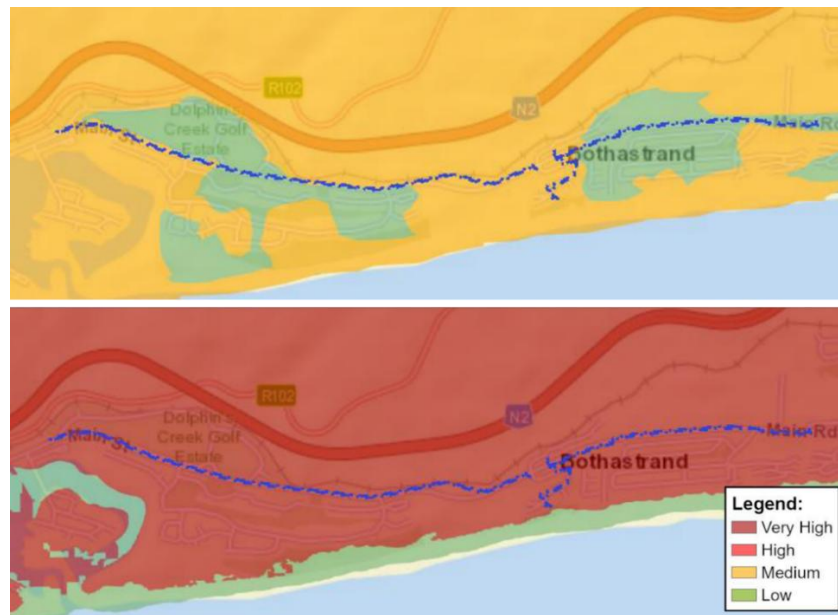
Figure 2: The screening sensitivity maps provided by the Screening Tool report for terrestrial plant species (top) and terrestrial biodiversity (bottom) themes.

According to the Department of Forestry, Fisheries, and the Environment (DFFE) Screening Tool, the SSVR is required because the terrestrial plant species theme has been highlighted as having a **Medium and Low** sensitivity over different sections of the linear infrastructure, and the terrestrial biodiversity has an overall **Very High** sensitivity (Figure 2).

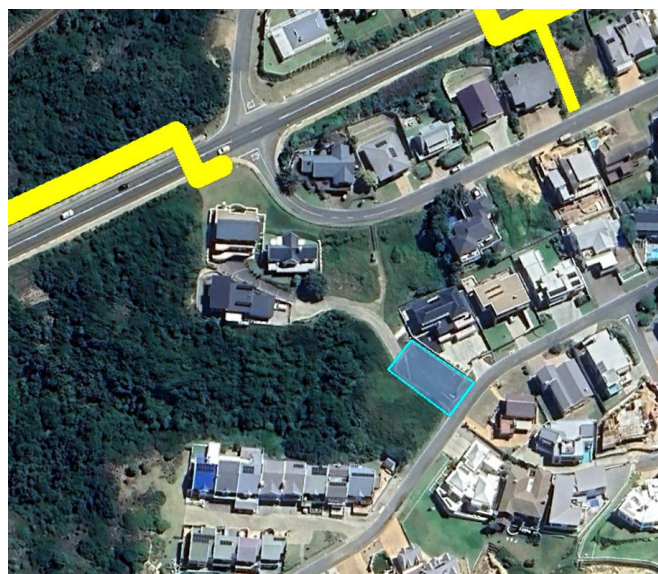
*Figure 3: Temporary storage is indicated in light blue. Pipelines proposed are in yellow.*

A temporary site camp is proposed on an existing parking lot, part of the Municipal Erf 554 (Bitou Street) for the storage of construction materials (Figure 3).

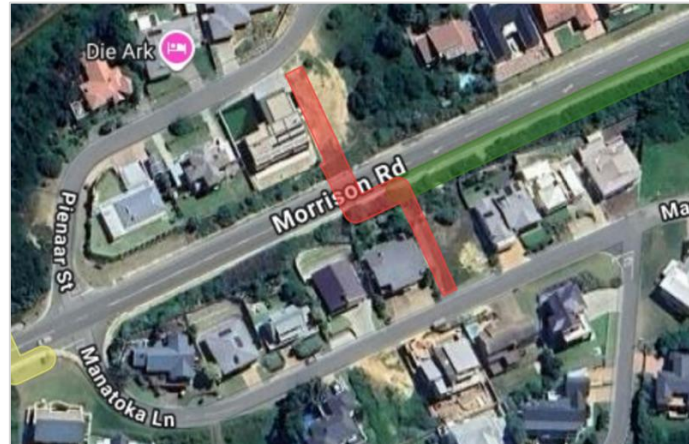
Figure 6. Alignment of the Ø160 mm gravity line from the new manhole in Pienaar Street to the existing manhole in Manatoka Lane ( $\pm 0.1$  km). The 7 m disturbance envelope is shown.

A new gravity sewer line, ca. 0.1 km in length, will be installed from a new manhole in Pienaar Street to an existing manhole in Manatoka Lane, bisecting Erf 507, Morrison Road, and Erf 516 (Figure 6). Installation will be completed using a combination of methods.

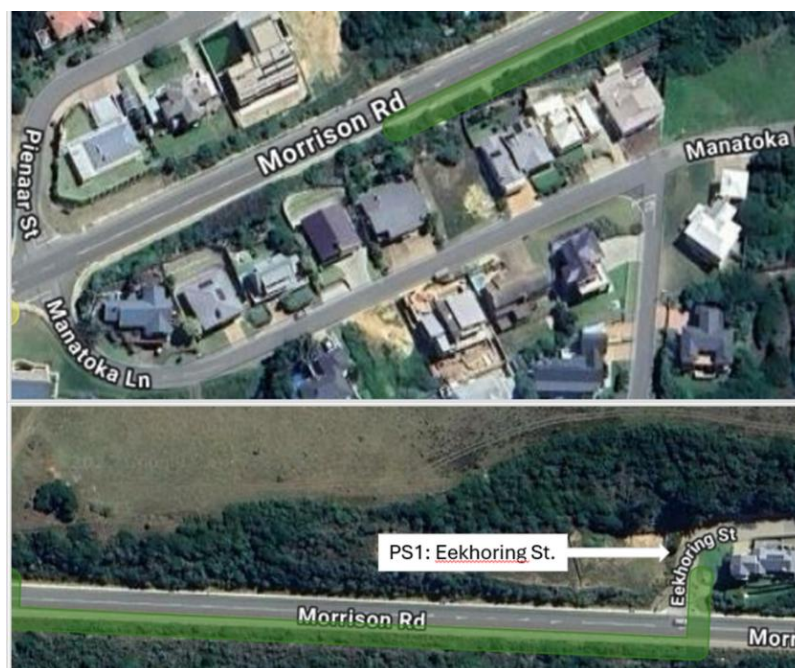
Figure 7: Alignment of the Ø90 mm rising main following the Morrison Road reserve for ca. 1.33 km, from Pump Station 1 (top) to the connection point at Manatoka Lane (bottom). The 7 m disturbance envelope is shown.

The Ø90 mm rising main will commence at Pump Station 1 in Eekhorning Street, following the Morrison Road reserve for ca. 1.33 km before connecting into a new transfer manhole at Manatoka Lane, where it will join the existing gravity sewer system (Figure 7).

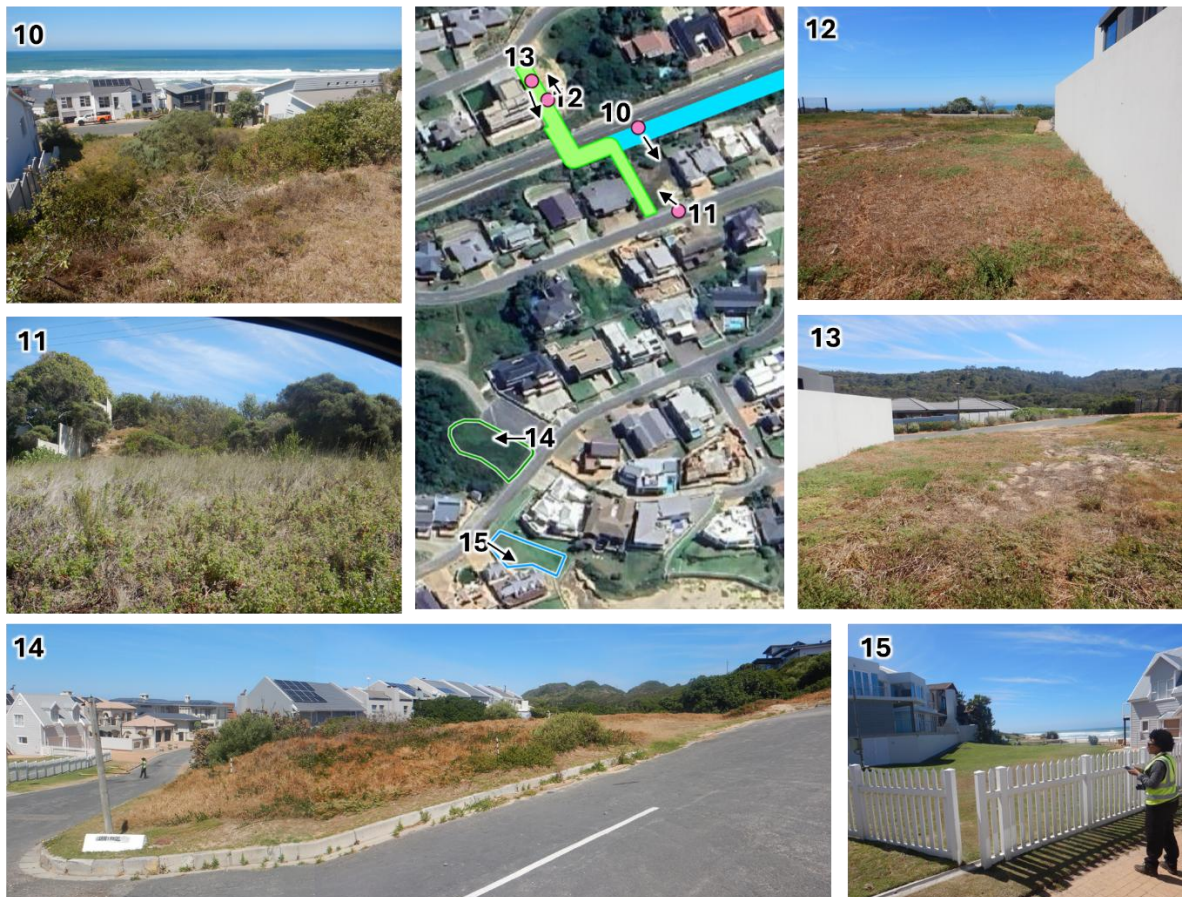
Figure 12: Photos of the proposed New Ø160 mm Gravity sewer line alignment along Morrison Road.

Observations along the proposed Ø160 mm gravity sewer alignment were made to assess habitat condition, vegetation integrity, and potential ecological sensitivity within the 7m disturbance envelope. Figure 12 presents six representative photographs along the alignment.

**Photos 10 & 11:** These show the southern property that is crossed, where patches of recovering thicket are present. The area is largely residential, and no sensitive or threatened species (SCC) were observed. While vegetation here is limited, care should be taken to avoid unnecessary disturbance to the remaining thicket fragments outside of the footprint and PAOI.

**Photo 15:** Shows a lawn area also technically part of the municipal Erf, which is currently located behind a currently fenced lawn. This area is highly transformed.

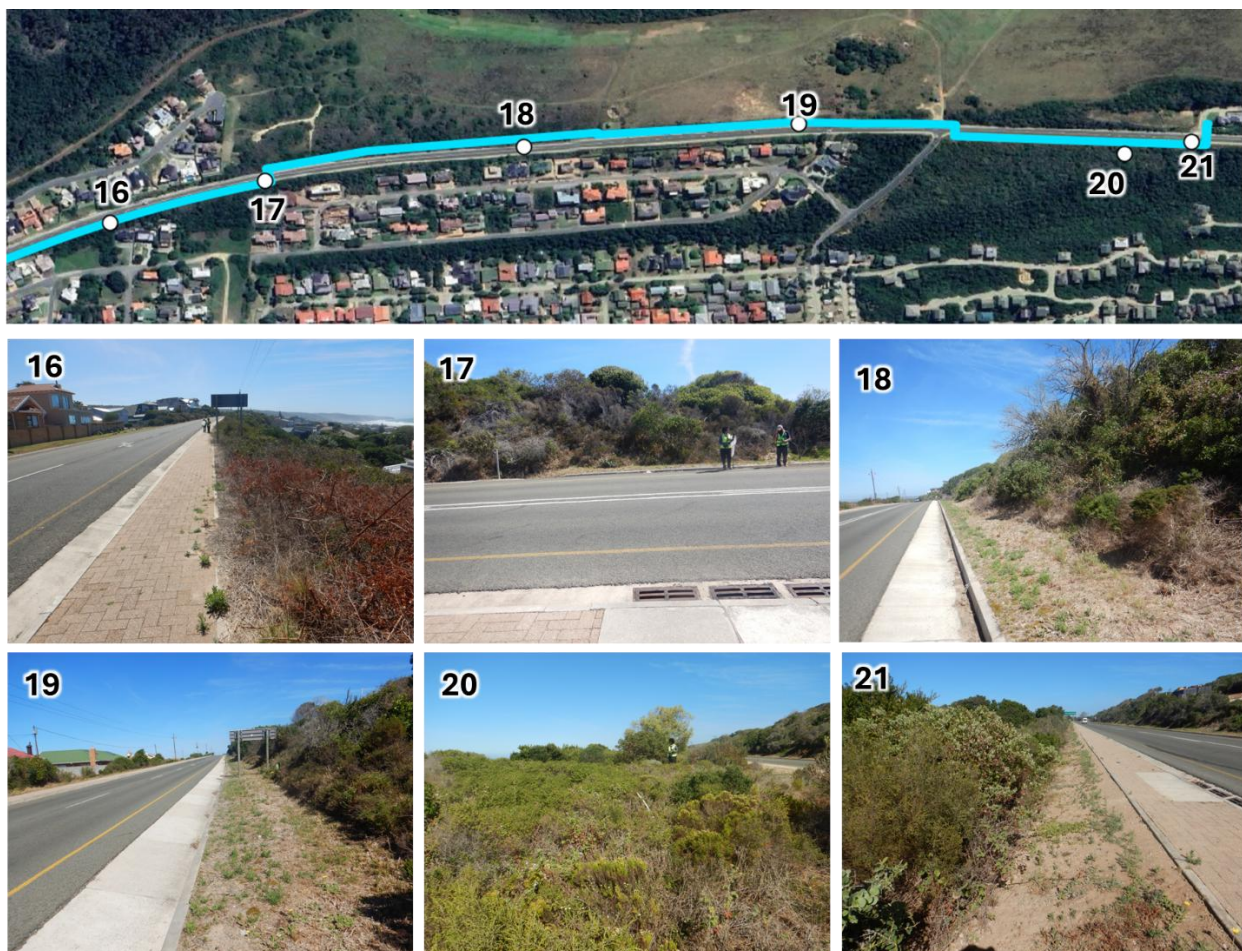
Figure 13: Photos of the proposed New Ø90 mm Rising Main pipeline sewer line alignment along Morrison Road.

Observations along the proposed Ø90 mm rising main alignment highlight a combination of roadside vegetation including remnant thicket, and strandveld. Figure 13 presents six representative photographs illustrating variation in habitat condition and ecological sensitivity.

In summary, the Ø90 mm rising main alignment passes through a mix of moderately sensitive roadside vegetation, thicket remnants, and strandveld. While much of the area is transformed by the road reserve, sensitive thicket and steep slopes adjacent to the footprint require careful management. Appropriate construction methods, including HDD and minimising clearing, will be important to reduce impacts on biodiversity.

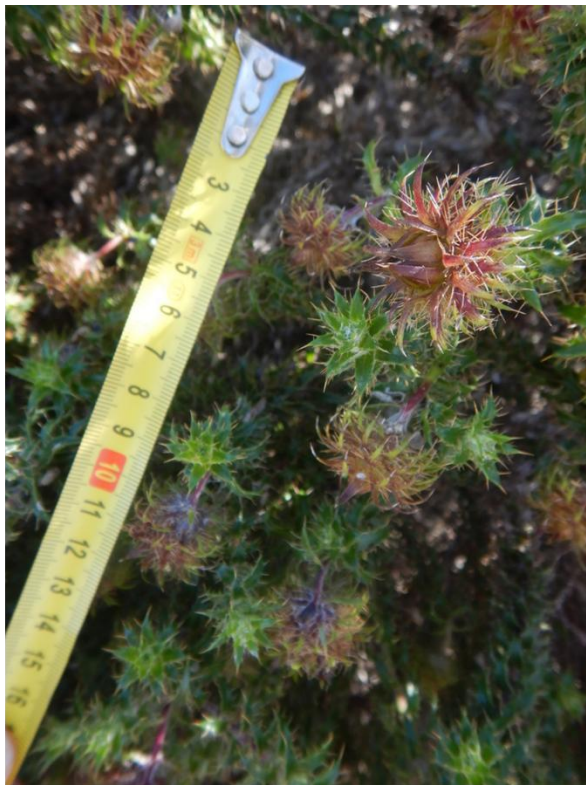
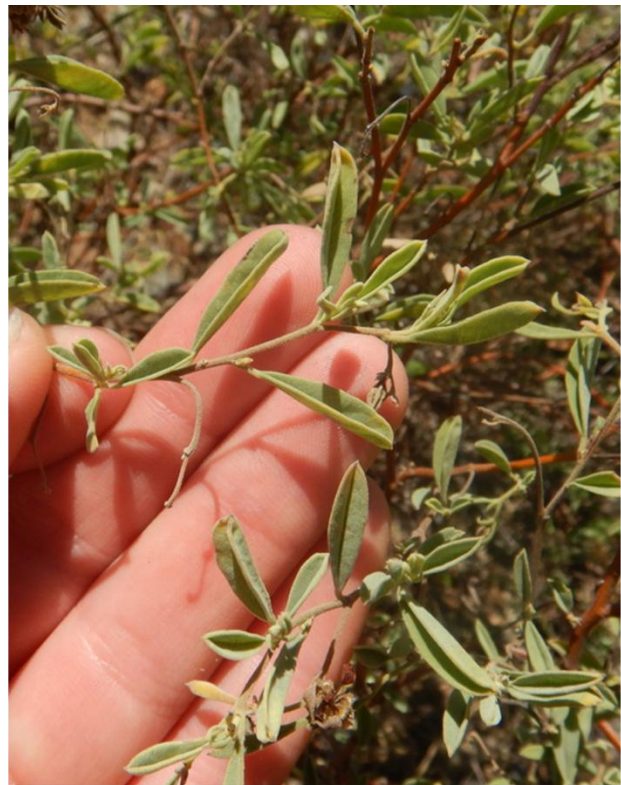
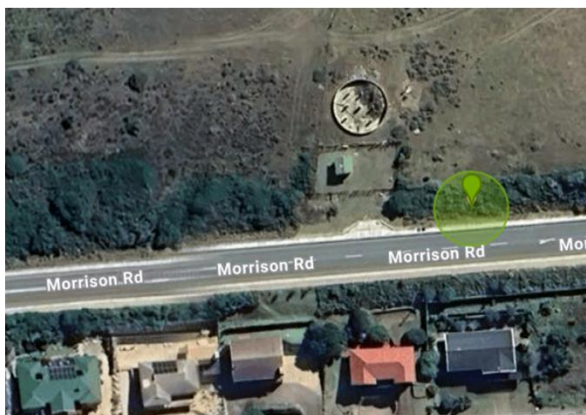
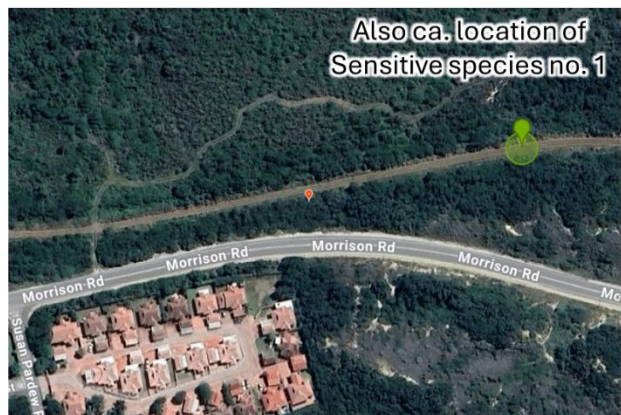
*Cullumia carlinoides* (NT)  
Limestone Snakethistle

*Hermannia lavandulifolia* (VU)  
Lavender Dollsrose

Figure 16: SCC observed during the site assessment with imagery below the species indicating the locations along the proposed route.

Of particular relevance, two species of conservation concern (SCC) were observed: *Hermannia lavandulifolia* (Vulnerable) and *Cullumia carlinoides* (Near Threatened), as shown in Figure 16. Another least concern (LC) species was observed, but it is sensitive to poaching and is therefore called sensitive species “no. 1” (location in Fig. 16). In addition, two protected tree species were abundant within the PAOI, Milkwood trees (*Sideroxylon inerme inerme*) and Cheesewood Trees (*Pittosporum viridiflorum*). The full distribution of protected trees, as well as the survey tracks followed during the site assessment, are provided in Appendix 10.3, alongside a mapped overview of their locations.

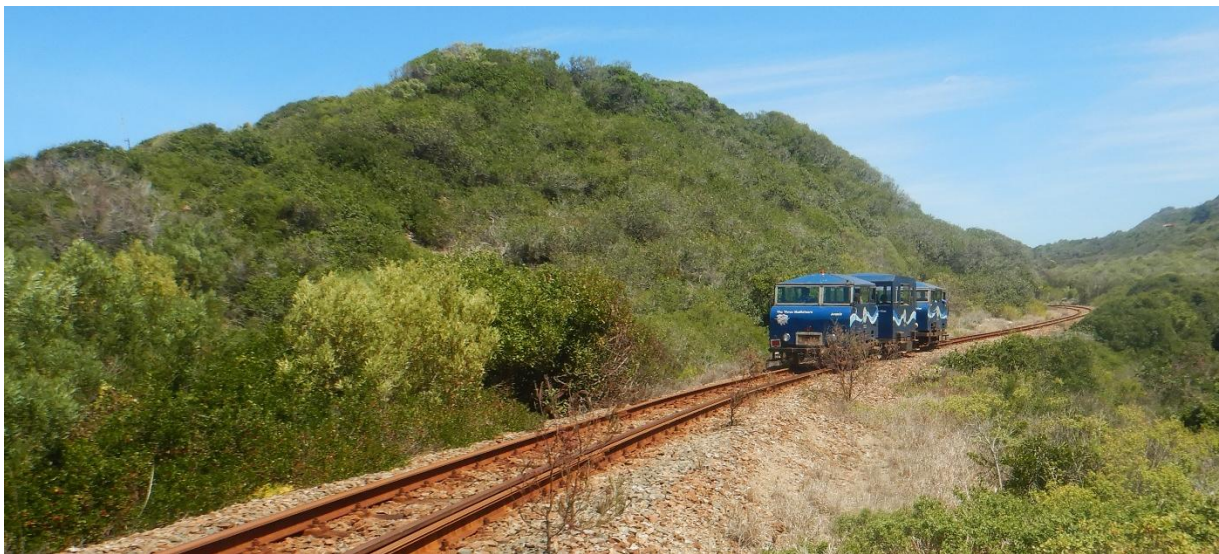
*Figure 19: A photo of the steep dune adjacent to the railway covered in milkwood trees. Conveniently, the tram is visible for scale in this image.*

**Description:** The pipeline alignment currently deviates from the road reserve to traverse a steep dune adjacent to the railway, which is densely vegetated with milkwood trees and associated coastal thicket species (Figure 19). This area represents a high-sensitivity zone (Section A) due to intact vegetation structure, limited natural regeneration, and the presence of mature trees.

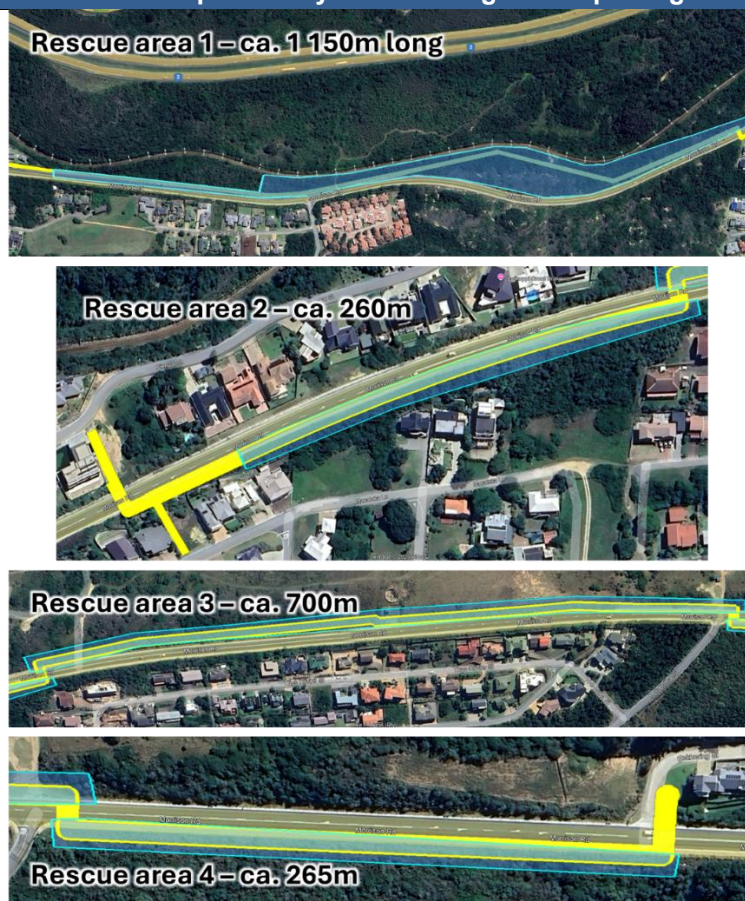
| Outcomes and Actions | Responsibility | Monitoring and Reporting Actions |
|---|---|---|
| Conduct a Plant Search and Rescue Operation within 4 identified areas that the pipeline will cross (see the blue polygons in the image below) | ECO, botanist | <ol style="list-style-type: none"> <li>1. Rescue <b>grasses, succulent, and geophyte plant species</b>, or any species that could have a high likelihood of survival post construction.</li> <li>2. Monitor staff helping to ensure plants are removed for maximum survivability.</li> <li>3. Record the species and location of all rescued plants.</li> <li>4. Preferably store the plants nearby or alternatively at an agreed upon location / nursery where they can be watered regularly</li> <li>5. Undertake weeding of the rescued plants every second month</li> <li>6. ECO to record all rescued plants that go missing or that die during their time in the nursery</li> </ol> |

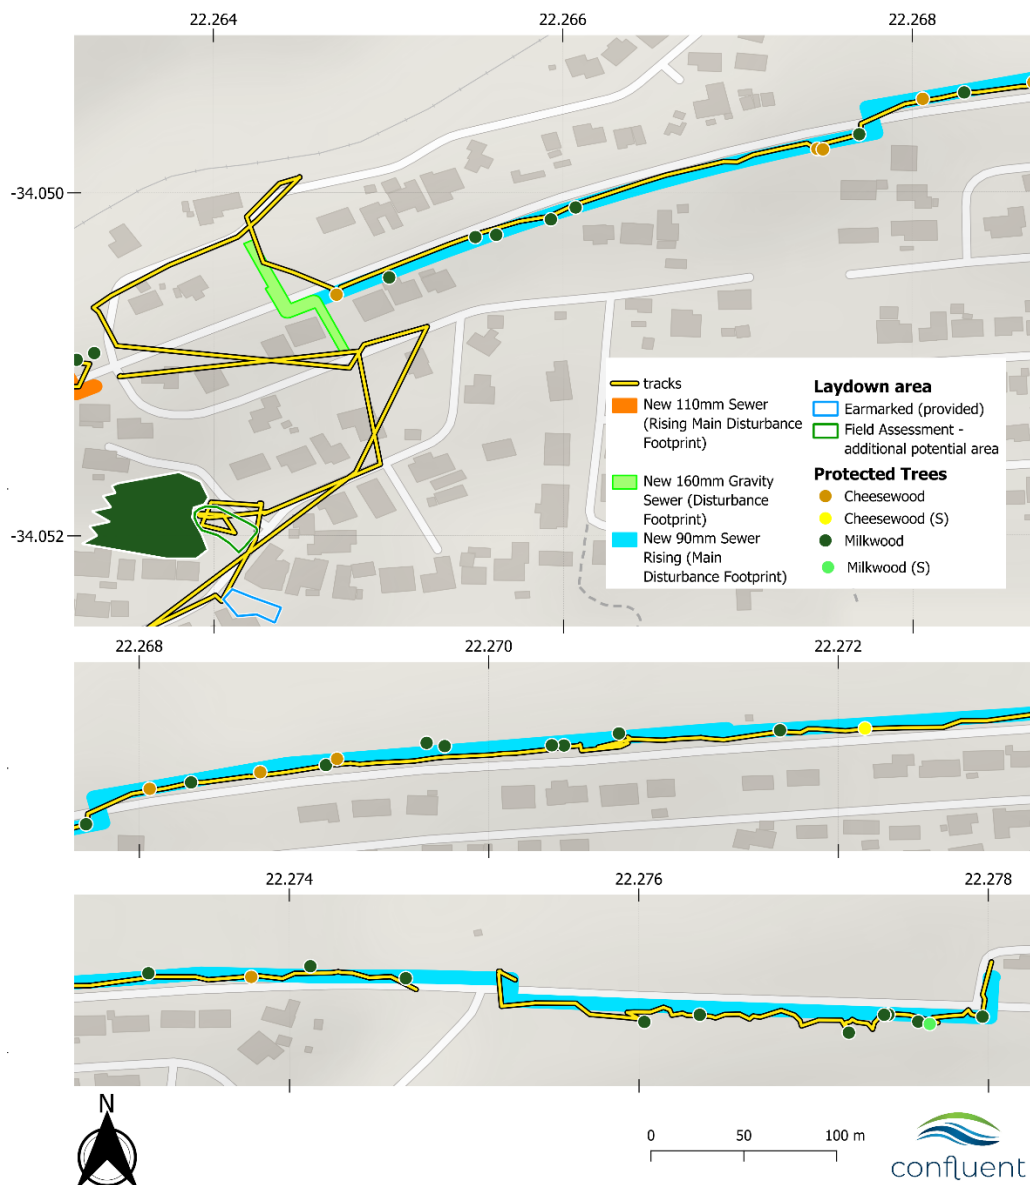
Figure 22: An illustration of the track and protected trees observed during the site assessment for the eastern half of the sewer line proposed. (S) indicates a seedling.

The site assessment track walked is illustrated in Fig. 21 and 22. In addition to the track, the location of protected trees recorded during the site assessment is also illustrated.
