# Proposed Sheep Feedlot on Portion 1/177 Vrolykheid, Prince Albert, Western Cape.

## Aquatic Biodiversity Impact Assessment Report

**Date:** June 2025

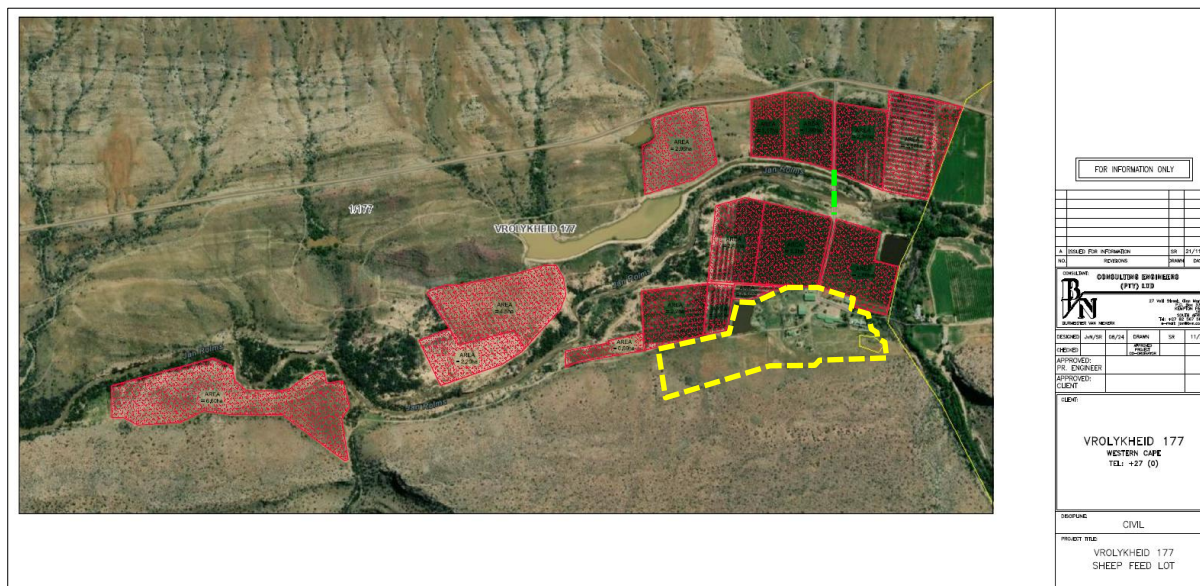
Figure 2. Layout of the existing fields where periodic irrigation with feedlot-generated wastewater is proposed (in red). Yellow dotted area consists of buildings and animal pens associated with the feedlot; river crossing upgrade is indicated by the green dotted line.

The landowner proposes to change the land use to a sheep feedlot. Two areas of old fields will be used for concentration of animals in the feedlot pens, and fields that are currently used for crop and pasture production will be irrigated with wastewater from the feedlot to provide food for the sheep as well as produce for sale (Figure 2). Wastewater is proposed to be transferred from the animal pens via an earth furrow to an existing off-channel dam, from where it will be periodically irrigated on fields (Figure 2).

The main access road to the farm must be upgraded at the crossing over the Jan Rolms River (See Figure 2 for location). At present, it consists of a gravel road over gabions which allow seepage of the river under base flow conditions, but no continuous flow paths (Figure 4). The road is overtopped when there is flooding limiting access to the farm, which is why the upgrade is proposed.

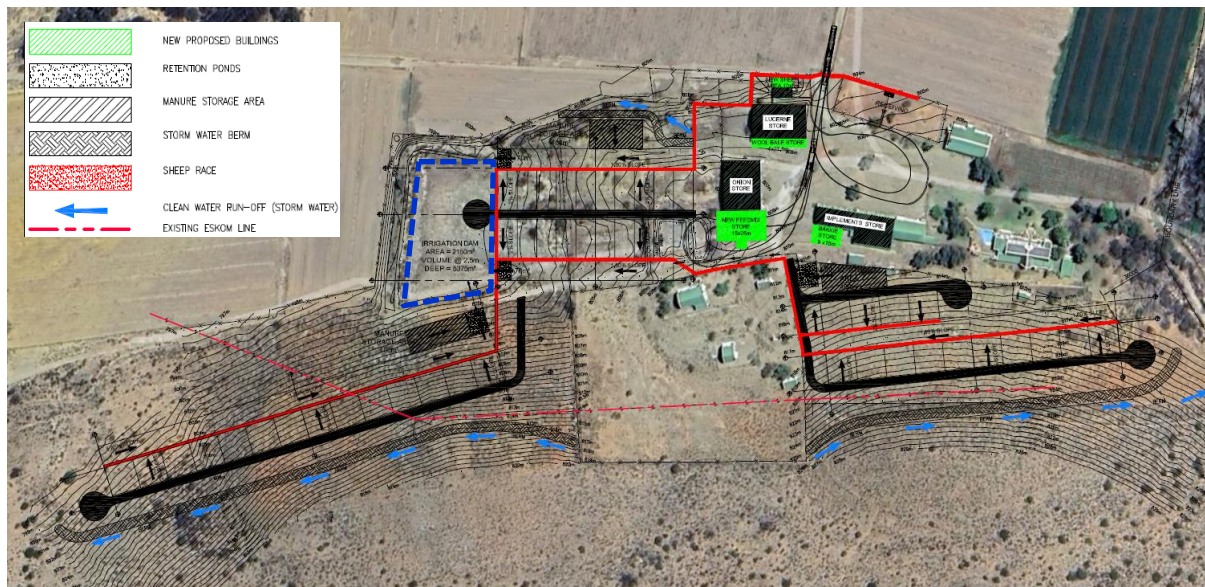
Figure 3. Proposed layout of the feedlot area showing animal pens in old fields to the south. Off-channel dam for storing wastewater for irrigation is indicated by the blue dotted line.

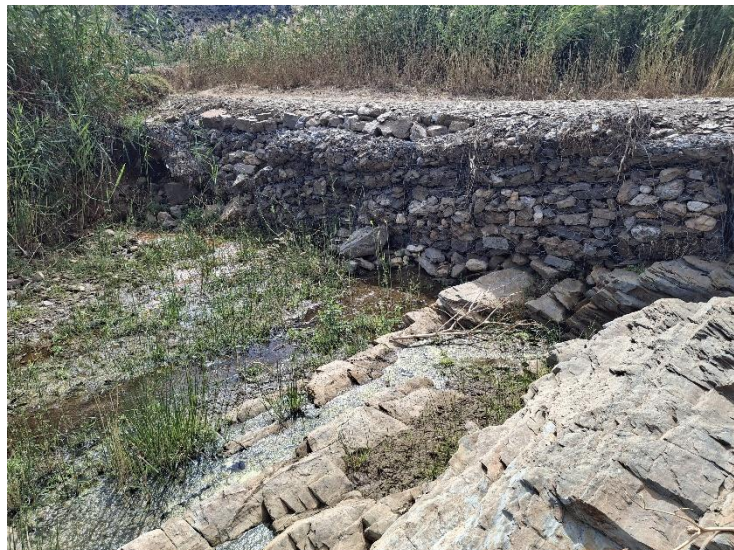
Figure 4. Photo of the existing road crossing the Jan Rolms River on gabions.

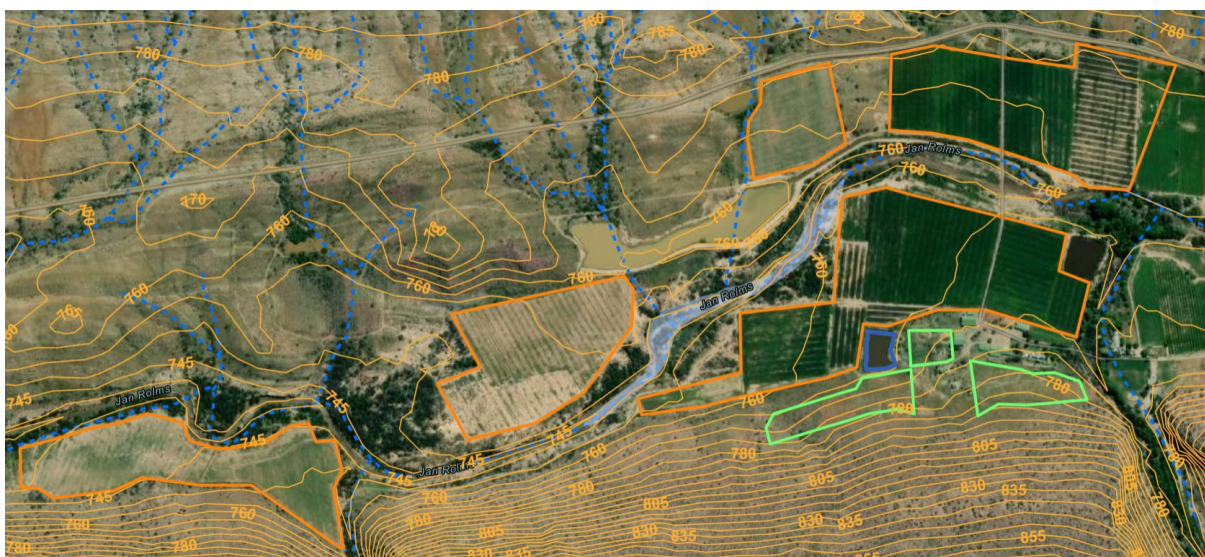
Figure 10. 5m site contours and mapped watercourses overlaid with feedlot areas and existing fields (from Cape Farm Mapper).

The existing fields south of the Jan Rolms River are on mostly flat areas of land, mostly likely in the floodplain of the river (Figure 10). The area of proposed sheep pens is located on moderately sloping ground which drains in a northerly direction, mostly towards areas of existing fields and buildings.

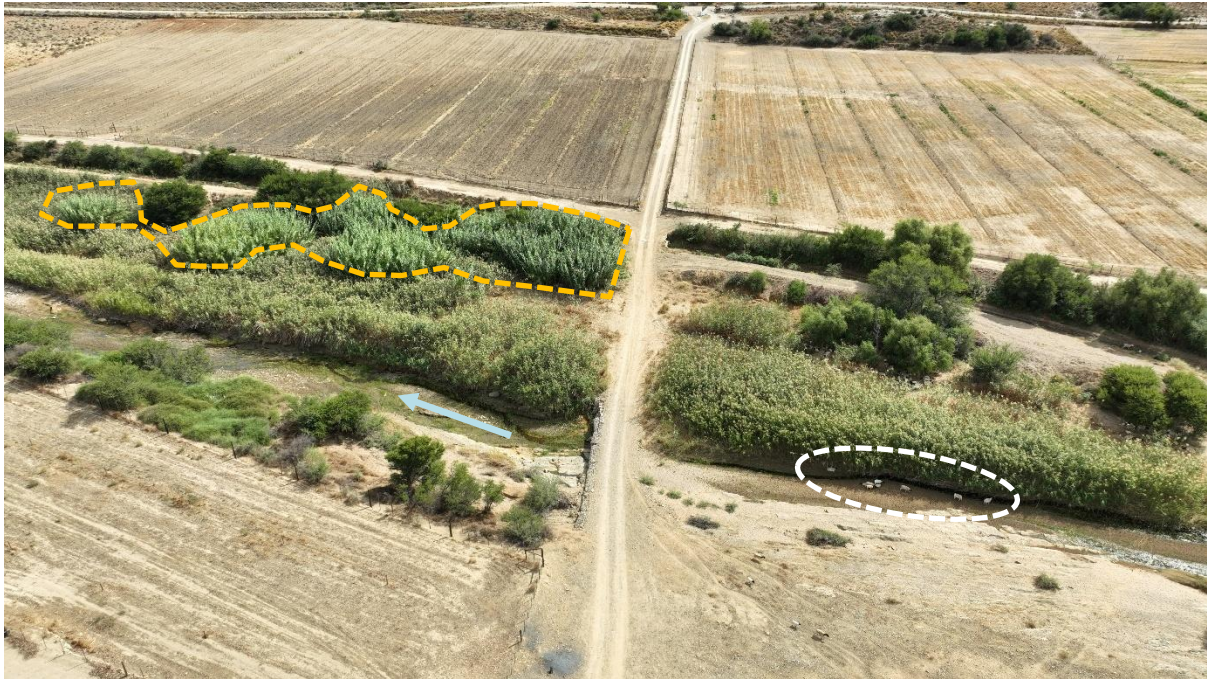
Figure 14. The existing river crossing to be upgraded showing: White = unrestricted sheep access; Orange = Stands of invasive Spanish reed (*Arundo donax*); Blue arrow = flow direction.

Free-ranging sheep were observed in the riverbed, along with numerous spoor including faeces and footprints. Evidence of widespread grazing on instream sedges and rushes was evident, with most plants heavily grazed in the area assessed. Common plant species in the riverbed include *Cyperus longis*,

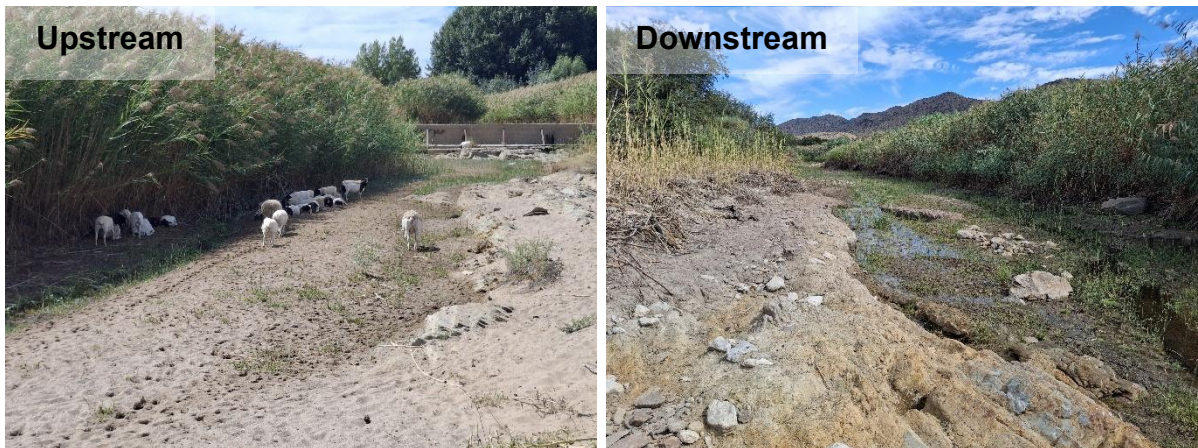
Figure 15. Photos showing the riverbed upstream (sandy) and downstream (rocky) of the road crossing.

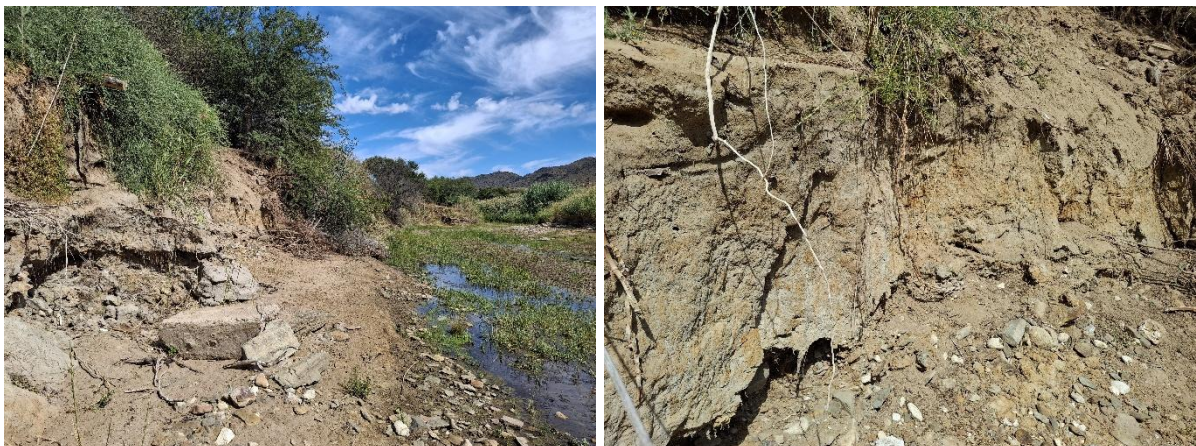
Figure 16. Bank erosion downstream of the road crossing indicating high levels of soil mottling consistent with wetland conditions.

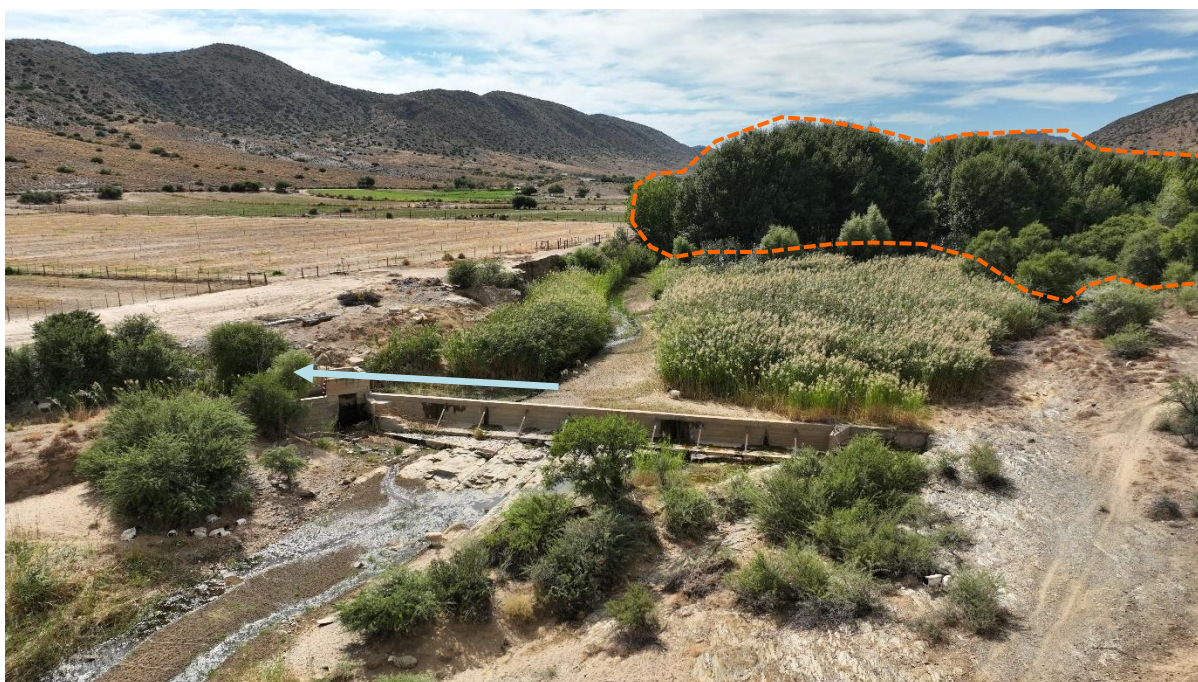
Figure 17. Weir approximately 90m upstream of the road crossing which diverts water via a furrow (blue arrow) to the Stilbaai Dam. Orange = dense invasion of *Populus* sp.

Upstream of the road crossing is another instream barrier in the form of a vertical concrete weir which was historically constructed to divert water via a furrow to the Stilbaai dam (Figure 12). As in the case of the road crossing, a large volume of sediment has accumulated upstream of the weir, while the downstream section is sediment starved and rocky. An invasion of alien invasive Poplar trees (*Populus* sp.) is present about 70m upstream of the weir and is spread between Portion 1/177 and the neighbouring property (Figure 17). This stand of trees has been present for a few decades with what appears to have been minimal attempts at control or management.

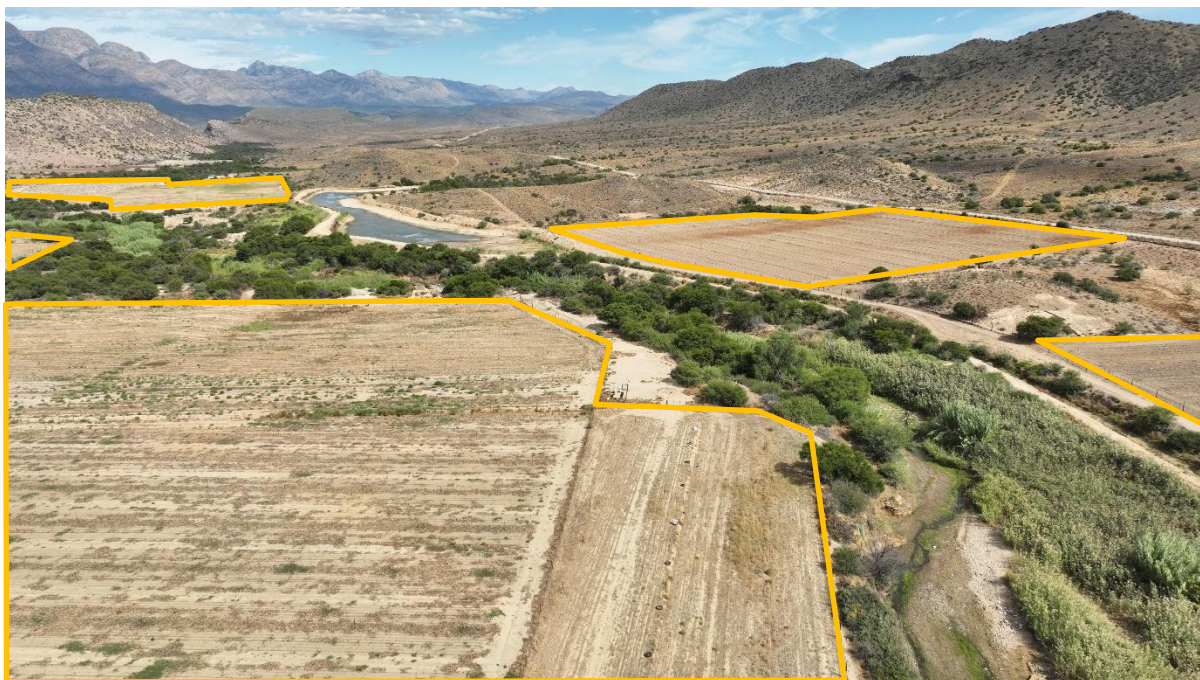
Figure 18. The Jan Rolms River downstream of the road crossing flowing between existing fields (in yellow) where proposed irrigation with wastewater from the sheep feedlot would take place.

Existing fields where future irrigation with wastewater is proposed are located very close to the Jan Rolms River (Figure 18). Although gradients are mostly flat which would potentially reduce the amount of surface runoff from fields towards the watercourse.

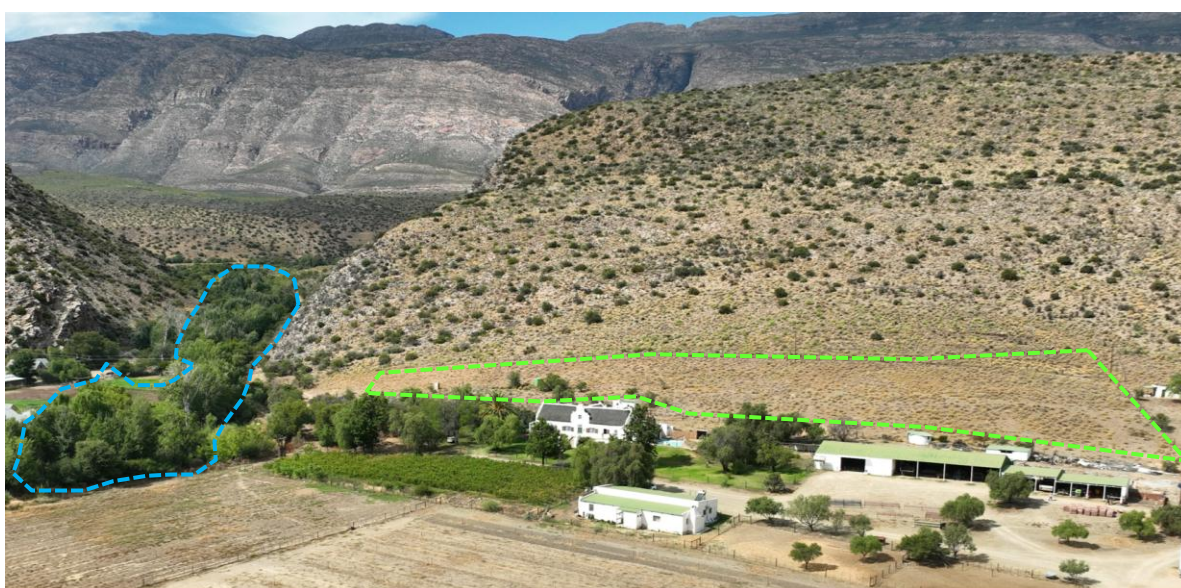
Figure 19. Proposed sheep pen area (green) closest to the unnamed tributary (blue) of the Jan Rolms River.

The eastern edge of the proposed sheep pens is located near the riparian vegetation associated with the unnamed tributary of the Jan Rolms River (Figure 19).

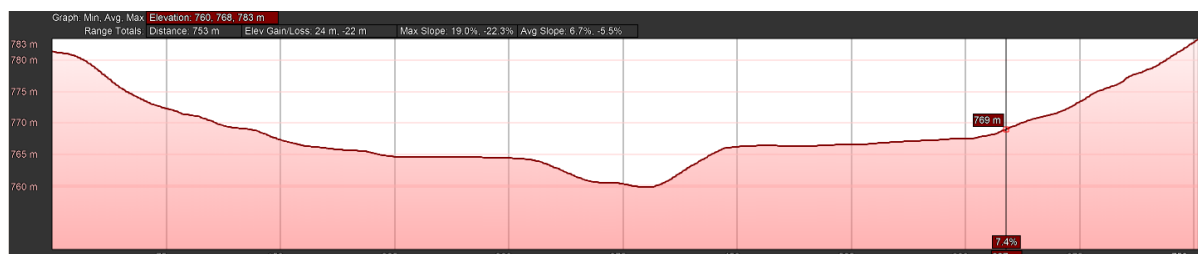
Figure 21. Cross section elevation profile of the river and valley sides approximately 500m either side. Note the generally flat floodplain areas where farming occurs on both sides of the river channel.

The watercourse has features and characteristics of both a channelled valley-bottom wetland and a river with riparian zone, typical of the Klein Karoo region. The Level 4 hydrogeomorphic unit is confirmed as a **River**, which is defined as linear, with discernible bed and banks, which periodically carries a concentrated flow of water (Ollis et al., 2013). The extent of the river includes the riparian vegetation.

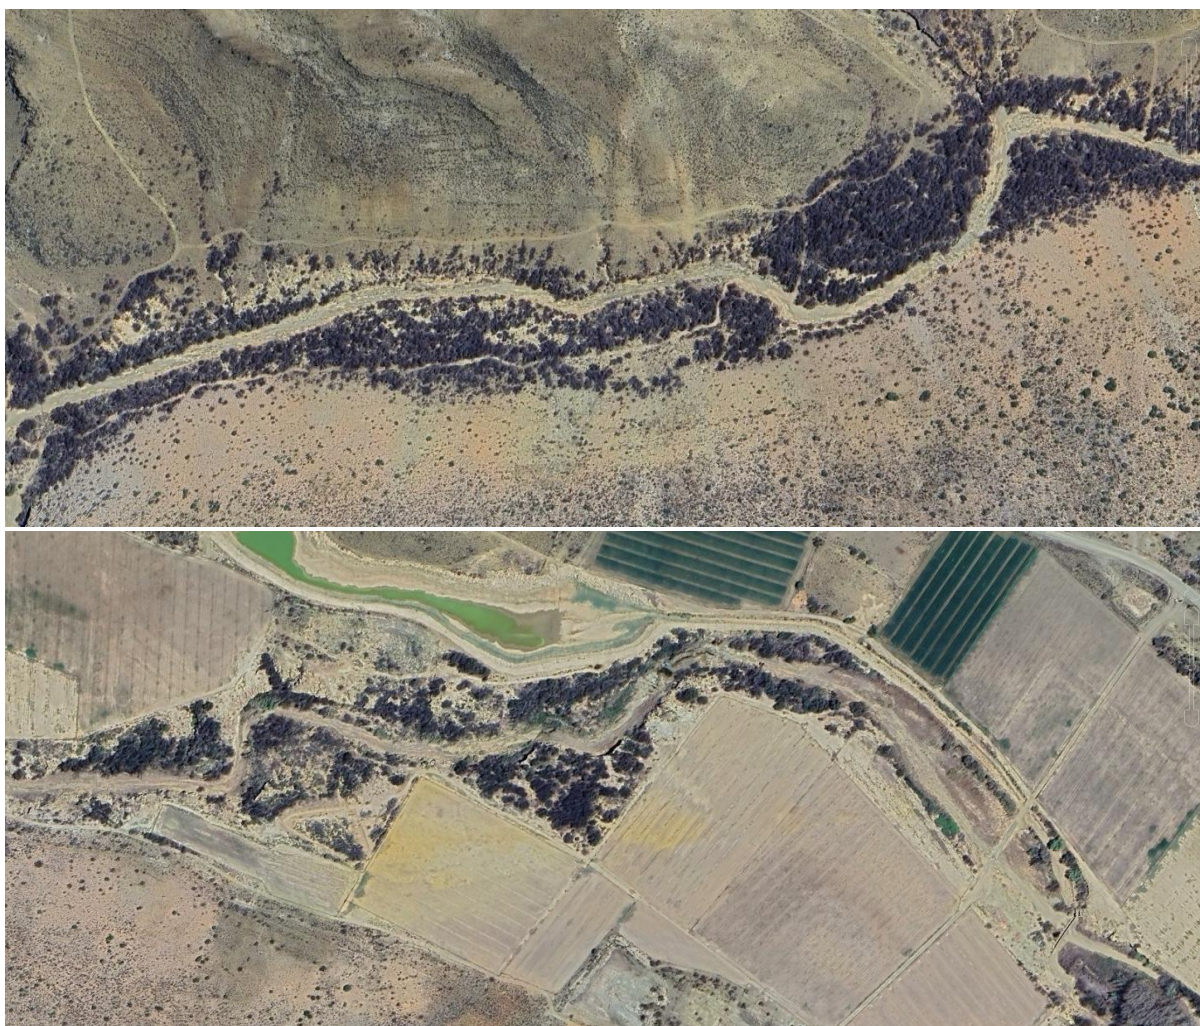
*Figure 22. Comparison of a relatively undisturbed section of the Jan Rolms River riparian zone downstream (above) of the farmed area on Portion 1/177 (below) for comparison.*

Delineation of the watercourse followed standard methods (DWAF, 2005) and mostly followed the riparian zone using both present and historical imagery as a guide. Elevation profiles at numerous points across the river were also used to get a sense of the riparian zone extent, as well as reference sections of the river downstream where the riparian zone is relatively intact (Figure 22). One difficulty when delineating the riparian zone is that the existing fields have been in place for many decades and have certainly intruded into the riparian zone in some areas. But it is not possible to determine exactly where that point would have been given the gaps in historical images. Therefore, an estimate based on the width of the riparian zone in areas with higher confidence was utilised.

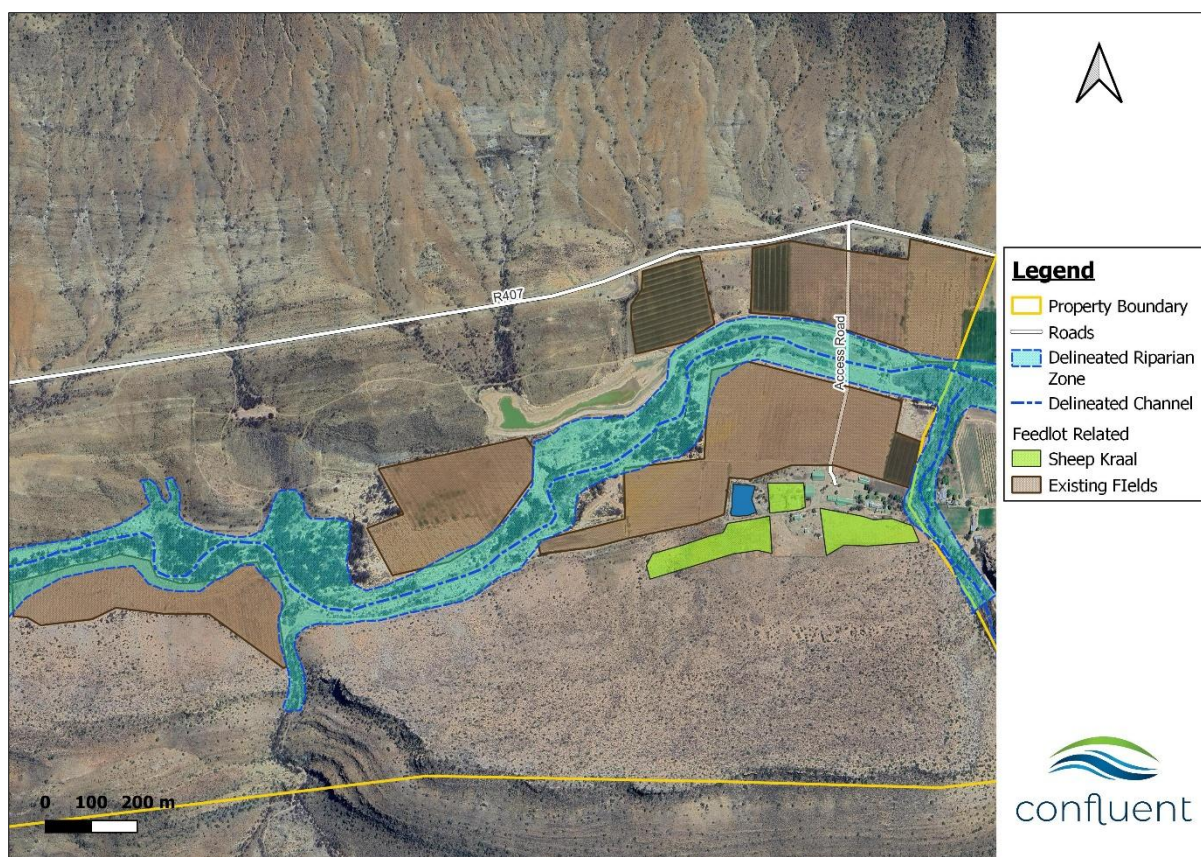
Figure 23. Delineated river channel and riparian zone of the Jan Rolms River proximal to existing fields and proposed feedlot areas.

The riparian zone and river channel delineation are provided in Figure 23. This shows that for the most part the existing fields are located outside of the estimated historical extent of the riparian zone. There are a few fields which have extended into what was probably riparian vegetation historically. The is most notable on the westernmost field on the southern side of the river.

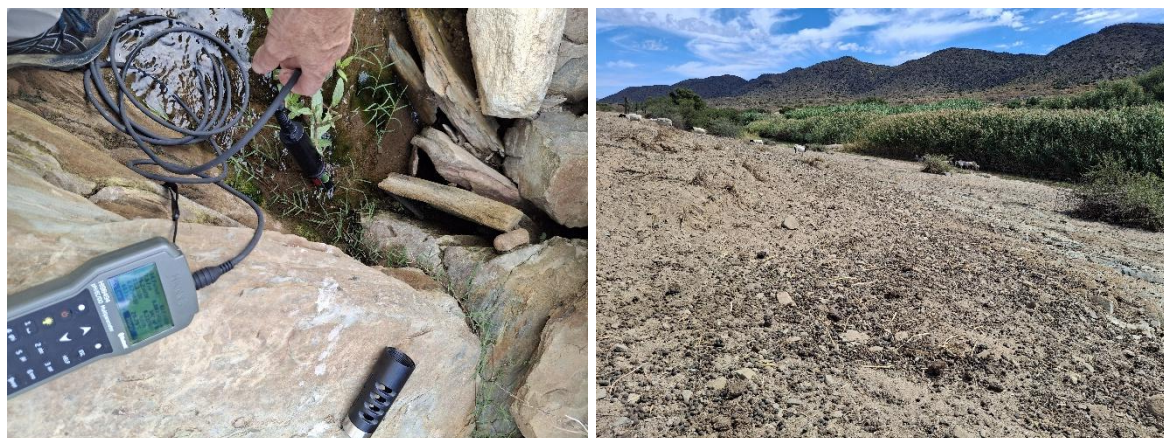
Figure 24. Water quality testing (left) and sheep droppings in feeding area adjacent to the river upstream of the crossing (right).

Basic water chemistry values were obtained from the Jan Rolms River at two locations, immediately upstream and downstream of the existing access road across the river. This provides a very basic understanding of current water quality and a baseline to which any further monitoring can be compared. Results in Table 3 show a distinct difference in most measured parameters upstream and downstream of the road crossing. The pH and dissolved oxygens values differed but were both within the range acceptable for aquatic life. Electrical conductivity was fairly elevated as unimpacted waters are typically in the range of 100 – 250 uS/cm (personal observations). This could be related to agricultural return flows and concentration of ions due to high evaporation rates. Sheep were standing in an around the area upstream from the road crossing, and there is evidence that they frequently utilise this area as the southern bank in the area is devoid of vegetation and a feeding trough is present next to the river (Figure 24).

Water Quality Parameter	Upstream Crossing	Downstream Crossing
pH	8.20	7.60
Electrical Conductivity (uS/cm)	746	687
Dissolved Oxygen (mg/L)	8.22	6.56
Temperature (°C)	22.72	20.20

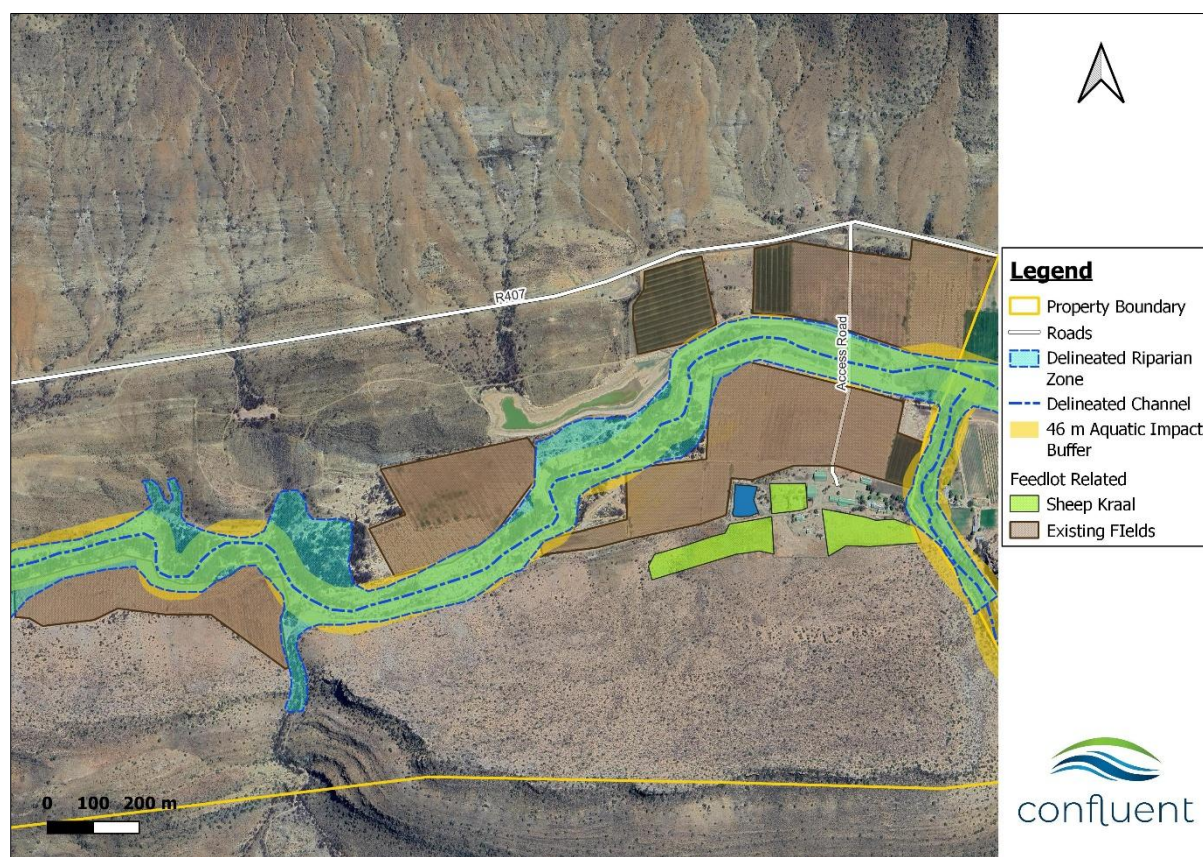
Figure 25. Agricultural area indicating full extent of the recommended aquatic impact buffer of 46m.

The delineated watercourses and associated aquatic impact buffers are provided in Figure 25. From a management perspective, future activities associated with the feedlot (irrigation of fields with wastewater and sheep kraals) should be excluded from either the riparian zone or the 46m buffer, whichever is the greatest.

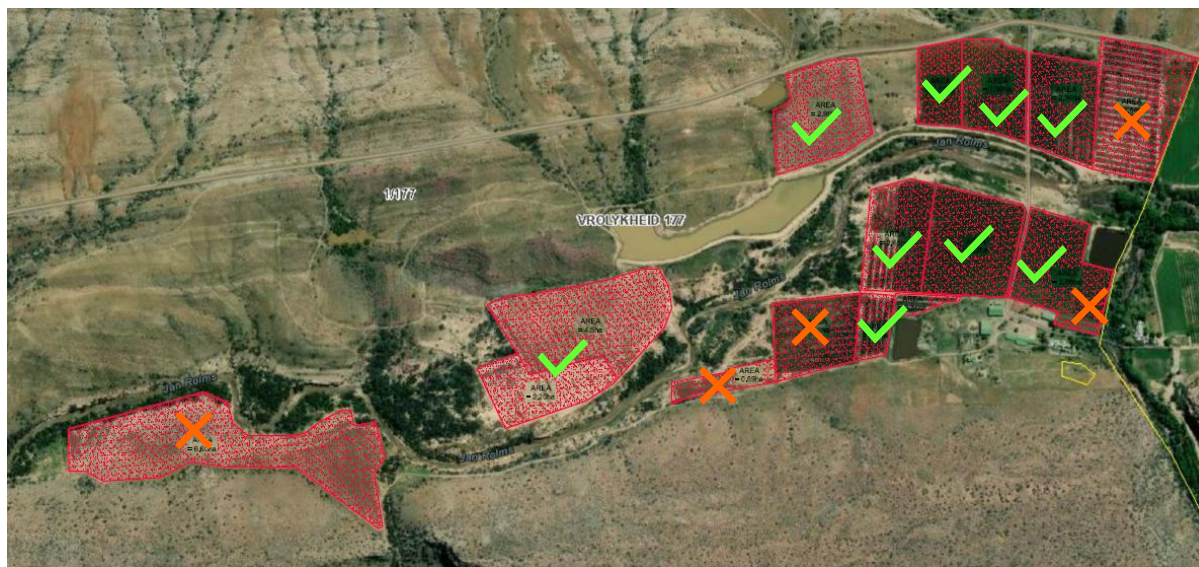
Figure 27. Proposed fields for irrigation and spreading of feedlot waste indicating those where the 46m buffer is upheld (ticked), and four fields where the boundary is considered too close to the watercourse for these practices (crossed).

existing fields are situated closer to the channel than the recommended buffer of 46 m, and in some cases extend into the historical riparian area. Of the fields proposed for irrigation and with wastewater and spreading of manure, four of them are laid out too close to the watercourse at present (Figure 27). Two possible options for mitigation would be either to:

- A) Adjust the extent of the four fields in areas where they extend into the recommended buffer, or
- B) Do not irrigate/spread waste on the five fields indicated with wastewater or solids. Irrigation should be maintained with current sources from clean surface water. This may be complex to achieve in practicality but may be considered a viable option.

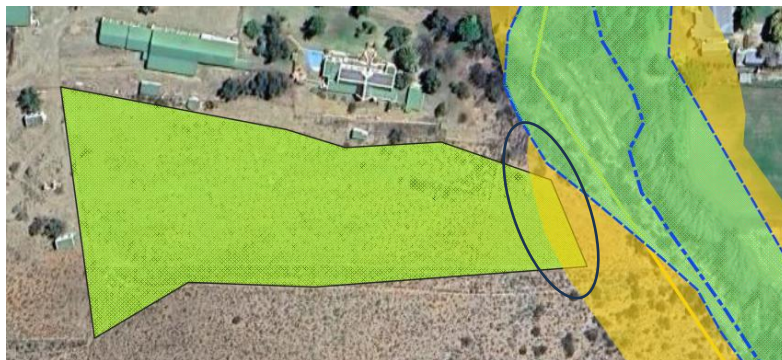
Figure 28. The overlap (encircled) between the eastern extent of the proposed sheep kraal and the 46 m buffer. Refer to Figure 29 for more detail.

One of the two areas indicated for concentration of high numbers of sheep is located adjacent to the tributary of the Jan Rolms River. The eastern edge of this area extends approximately 13 m into the 46 m buffer (Figure 28). It is therefore recommended that the extent of the field

be adjusted away from the buffer to protect this watercourse. If this area was essential to recover from elsewhere, then the western edge of the field could be extended towards the west into an old field with no impact to aquatic ecosystems.

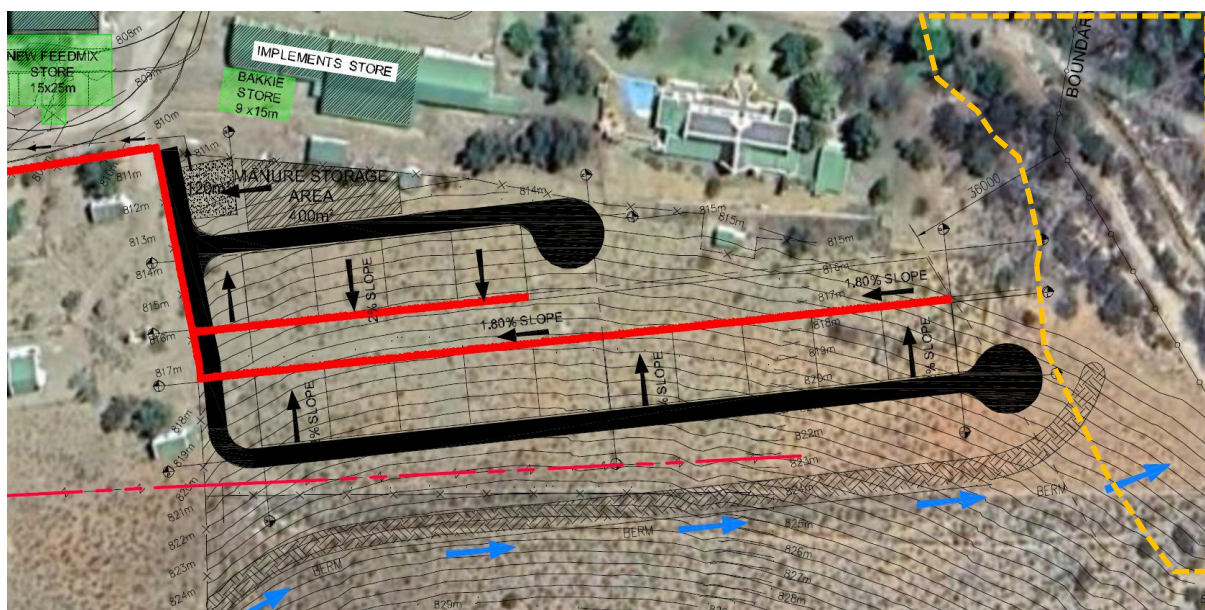
Figure 29. Proposed detail of the eastern sheep kraal layout annotated to show the approximate line of the 46 m buffer.

An enlargement of the eastern sheep kraal planned layout is provided in Figure 29. This shows that a soil berm will be established along the southern extent of the sheep kraal to intercept surface runoff from the upslope area and divert it towards the Jan Rolms tributary. It also shows that the approximate location of the 46 m buffer is almost entirely outside of the footprint of the sheep kraal. It should therefore be relatively straightforward to ensure the footprint of this section be kept out of the buffer.

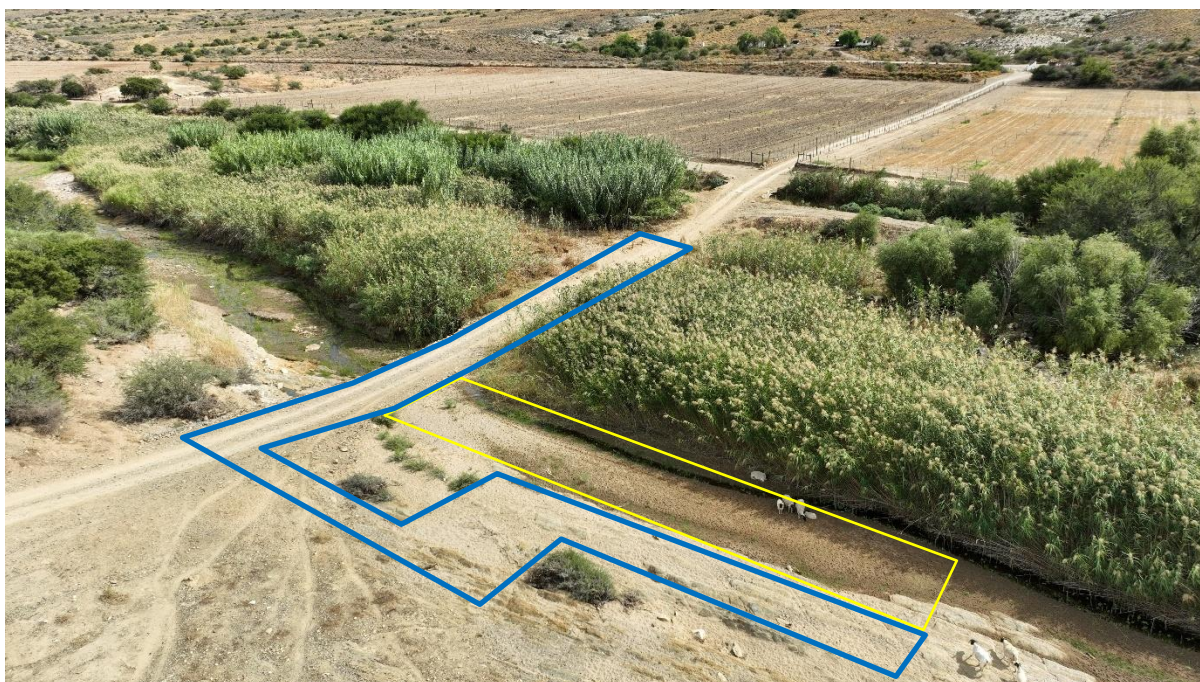
*Figure 30. Area of sand that may be excavated to provide material for the new road crossing (yellow). Measures approximately 30 m long x 5 m wide x 0.5 m depth on average. Heavy vehicle access points (blue).*
