“House Maritz”

Erf 390 & Rem 141 Keurboomstrand

Coastal Engineer’s Report

WML Coast Pty (Ltd)

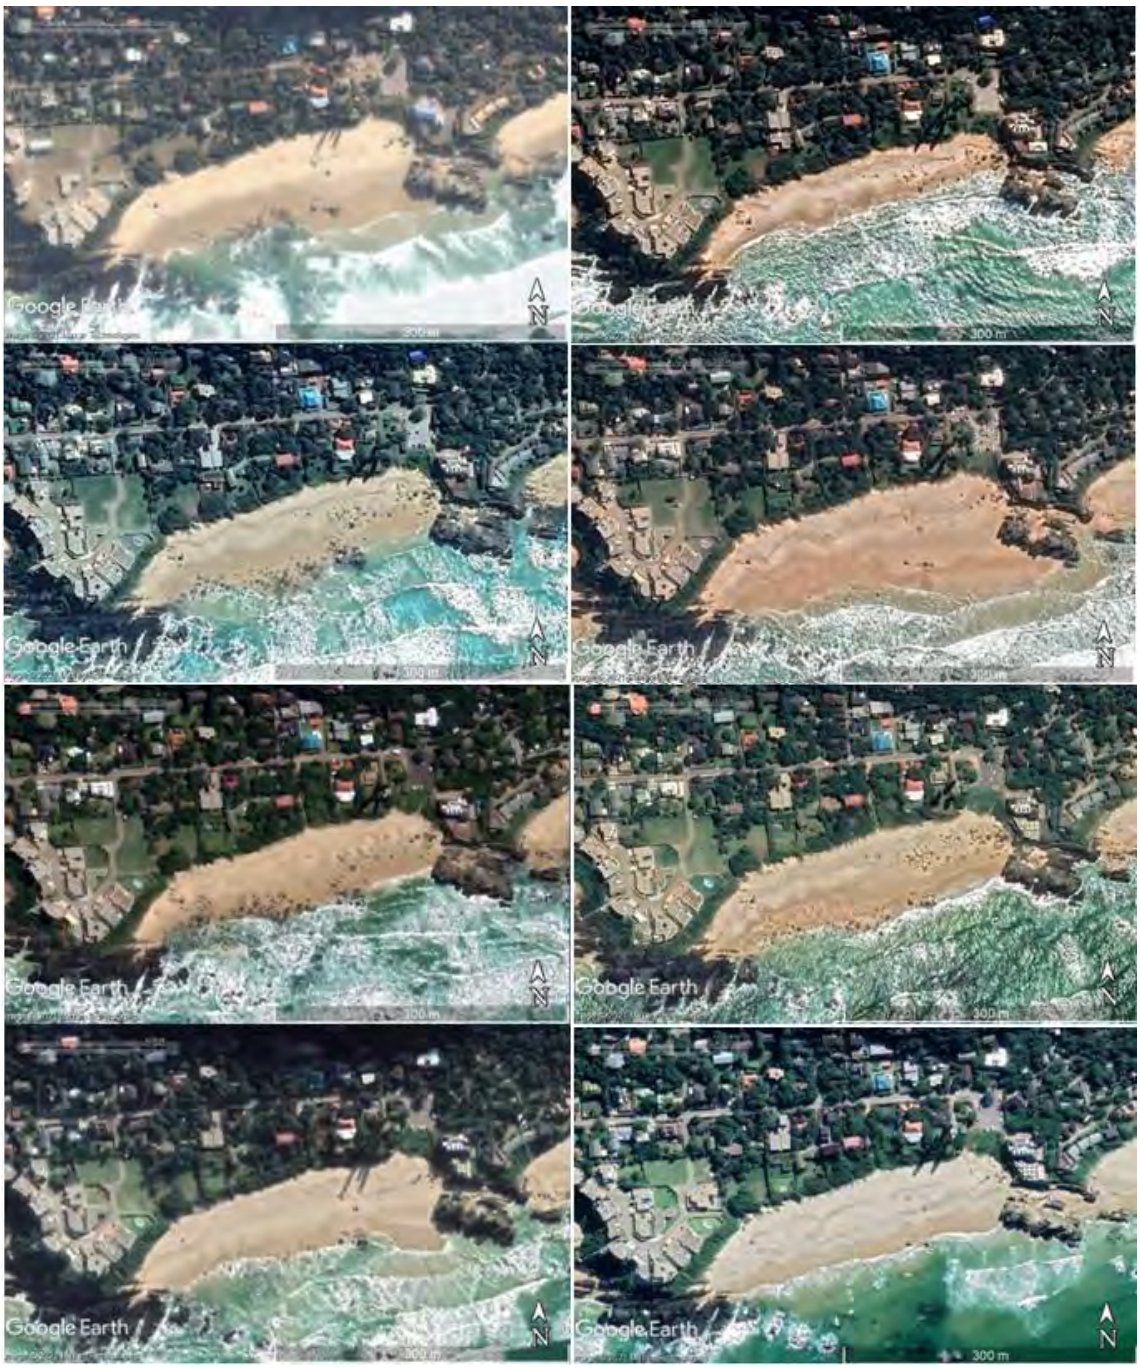
The Keurboomstrand Beach sand erodes and accretes intermittently over time and appears to be currently "dynamically stable". Selected historical aerial photographs over the past 17 years are shown in Figure 10. West of Erf 390 thin dune vegetation appears to have grown further seaward over the past decade whereas the vegetation line in front of the public parking to the east shows some erosion (see Figure 11). These minor trends are probably primarily due to pedestrian traffic rather than coastal processes. The effects of climate change (including sea level rise and increased storm intensity) can nonetheless be expected to pose increasing risk to the beachfront properties in this area.

Figure 10: Selected satellite images of Keurboomstrand Beach between 2004 and 2021 (Google Earth)

Figure 11: Satellite images taken 2010 (top) and 2021 (bottom) of Keurboomstrand in front of Erf 390

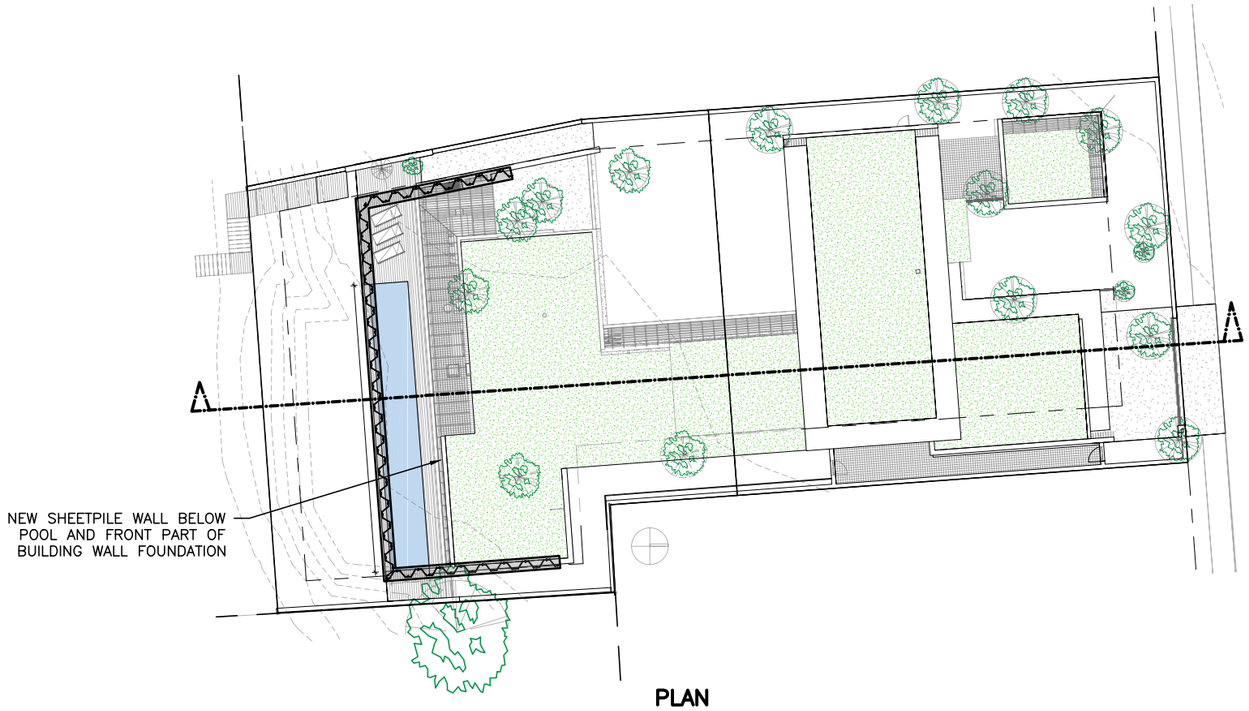
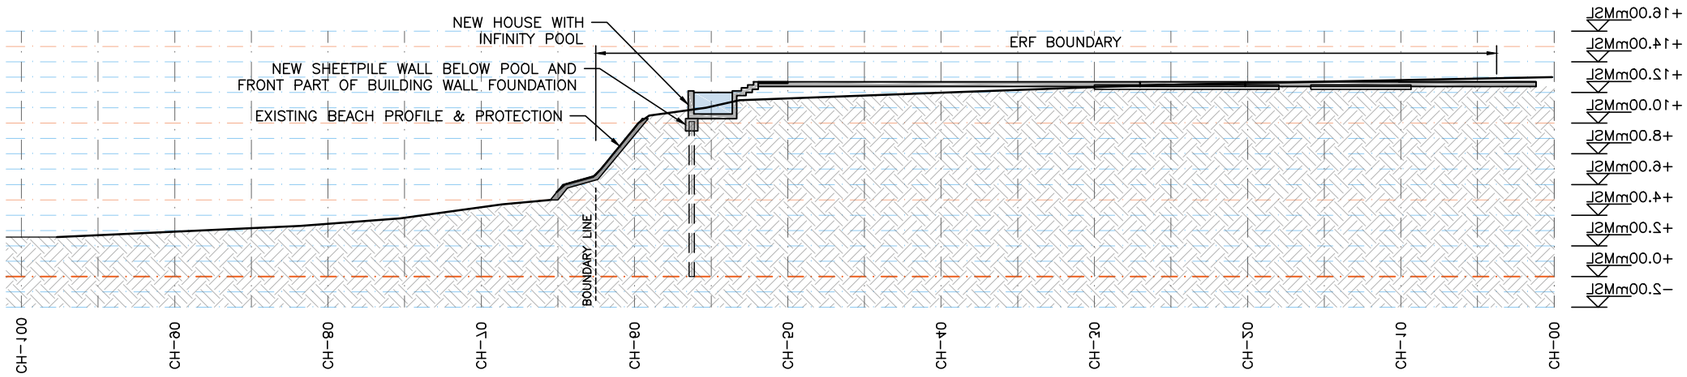
DRAWING : PLAN & TYPICAL SECTION OPTION 02: SHEETPILE WALL

Options 02 and 03 are integrated into the structural design of the building. With these options the existing retaining wall would remain in place and maintenance of the existing gabions just outside the beachfront Erf boundary would be recommended to reduce the risk of undermining. In the event of retaining wall failure the building itself would remain stable but the front terrace / beach access stairway would need to be repaired.

OPTION 02: SHEETPILE WALL (Drawing 210518/21)
