“House Maritz”

Erf 390 & Rem 141 Keurboomstrand

Coastal Engineer’s Report

WML Coast Pty (Ltd)

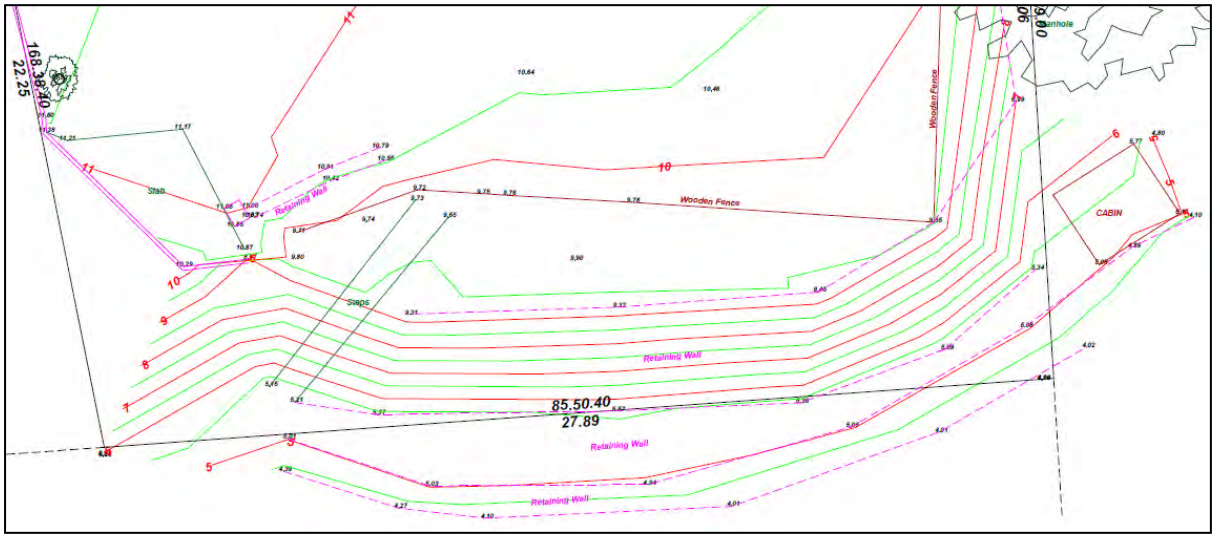
beachfront side of Erf 390. A gabion wall, mostly outside of the Erf boundary, protects the toe of the retaining wall. Both the gabions and the interlocking concrete blocks have been in place since 2004 (the earliest date of Google Earth historical imagery) and potentially much longer than that. The gabion wall was apparently managed as part of the property by the previous owner. Photographs in Figures 5 and 6 show details of the retaining wall. Approximate levels are as follows:

Figure 4: Extract of Detail Plan (Beacon Survey, June 2021) showing topographical levels (above MSL) on the seaward (southern) boundary of Erf 390

Figure 5: Photograph showing the site from the south (Stefan de Kock, Perception Planning)

Figure 6: Photographs showing the interlocking concrete block retaining wall, stairway and upper concrete retaining wall / viewing deck (Melissa Mackay, CapeEAPrac)

The gabion wall below the toe of the interlocking concrete block wall (see Figure 5) offers some protection from undermining but this is not considered sufficient for extreme wave run-up events, which are expected to occur more and more frequently in the future due to the effects of climate change.

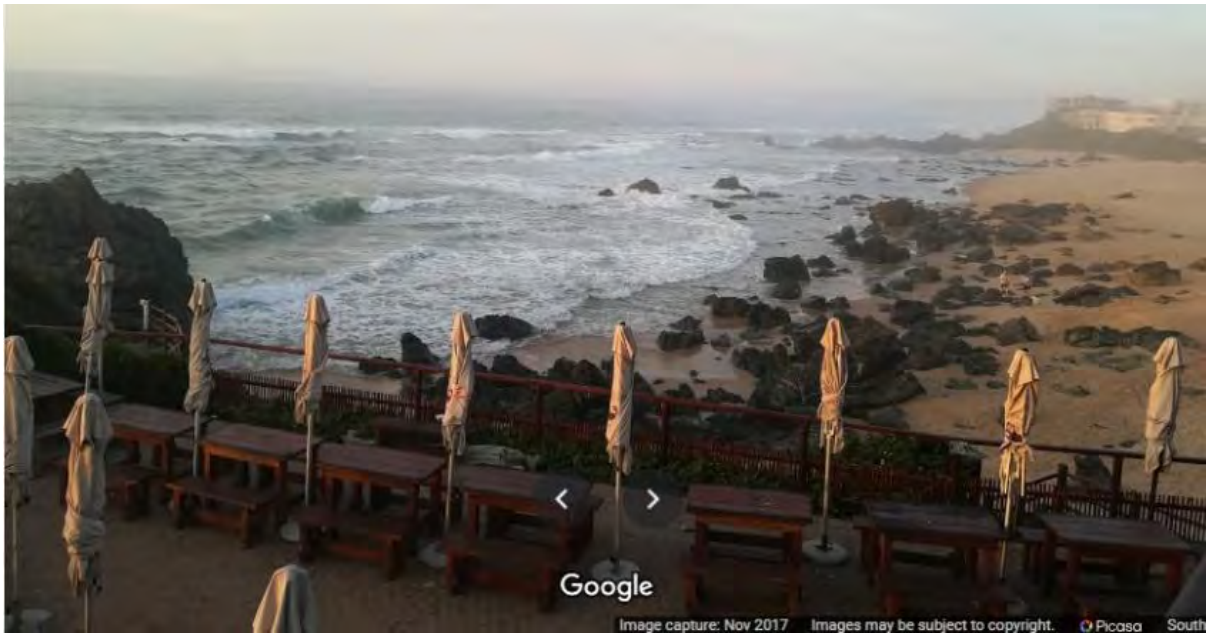
Figure 8: Photograph of the beachfront in front of Erf 390 (Google Maps, Nov 2017). Large boulders/protruding rock provide some protection from wave attack and help to retain sand on the beach.

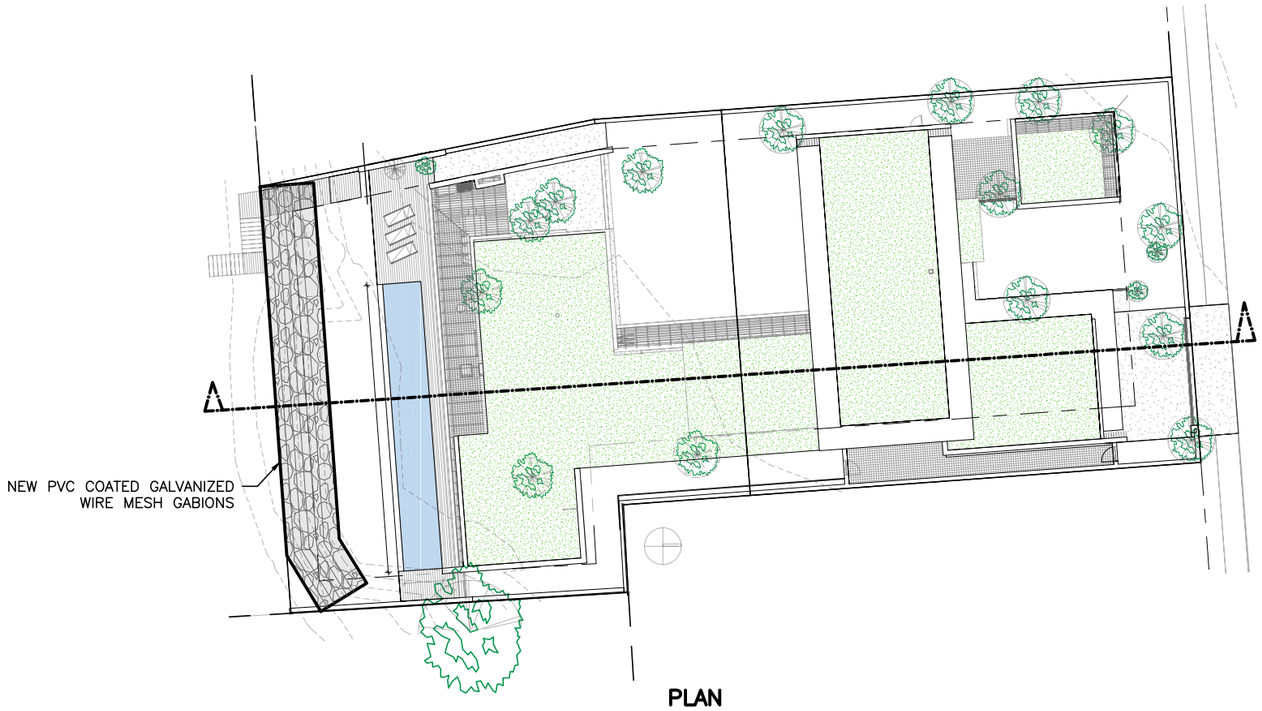
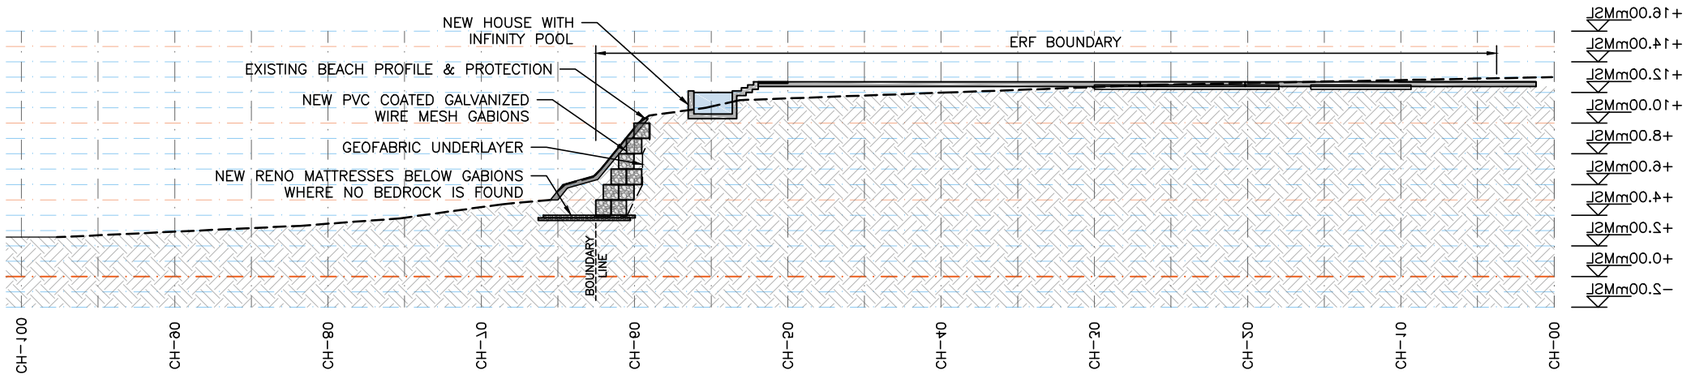
DRAWING : PLAN & TYPICAL SECTION OPTION 01: GABION WALL

While no physical inspections were made and no structural details have been reviewed, we consider the retaining wall on the beachfront edge of Keurboomstrand Erf 390 to be at risk from coastal attack. Interlocking concrete block retaining walls are typically highly susceptible to complete failure (via a "domino effect") when undermined and are not suitable as seawalls when the structures behind are reliant on them. The photograph below shows failure of such a seawall in Herolds Bay in 2006.

OPTION 01: GABION WALL (Drawing 210518/11)

Gabions (Option 01) are a relatively low cost seawall construction option which can be built to a steep slope. Construction is a labour intensive but relatively simple operation with well established methods and specifications. When covered with top soil vegetation can re-establish with roots between the stones. The integrity of a gabion structure is however completely reliant on the wire mesh cages. A double layer of gabions is therefore considered the minimum possible protection within the wave run-up zone, and inspections and maintenance are required throughout the life of the structure.

After consultation with the client and the architect, replacement of the existing interlocking concrete block retaining wall with a gabion wall (option 1 above) was selected as the preferred risk mitigation solution (see Drawing 210518/11). This solution protects the full embankment and swimming pool as well as the building and also reduces the potential risks to the public property associated with failure of the existing wall. The gabion wall with timber decking and stairs is deemed fitting with the new dwelling design. The exposed gabion wall structure can be fit within the boundary of Erf 390 (set back from the toe of the existing wall). However, a buried toe mattress which extends over the seaward boundary line (to the existing half buried gabions) will be required for scour protection. This may trigger an additional listed activity in terms of Environmental Regulations and will be included in the environmental assessment.
