**Aquatic assessment in terms of Section 24G of NEMA application  
for Bosse Dam, Lower Schoonberg Farm, Western Cape**

**Prepared by: Dr. Jackie Dabrowski of Confluent Environmental (Pty) Ltd**

**For: Cape EAPrac**

**November 2019, updated April, 2021**

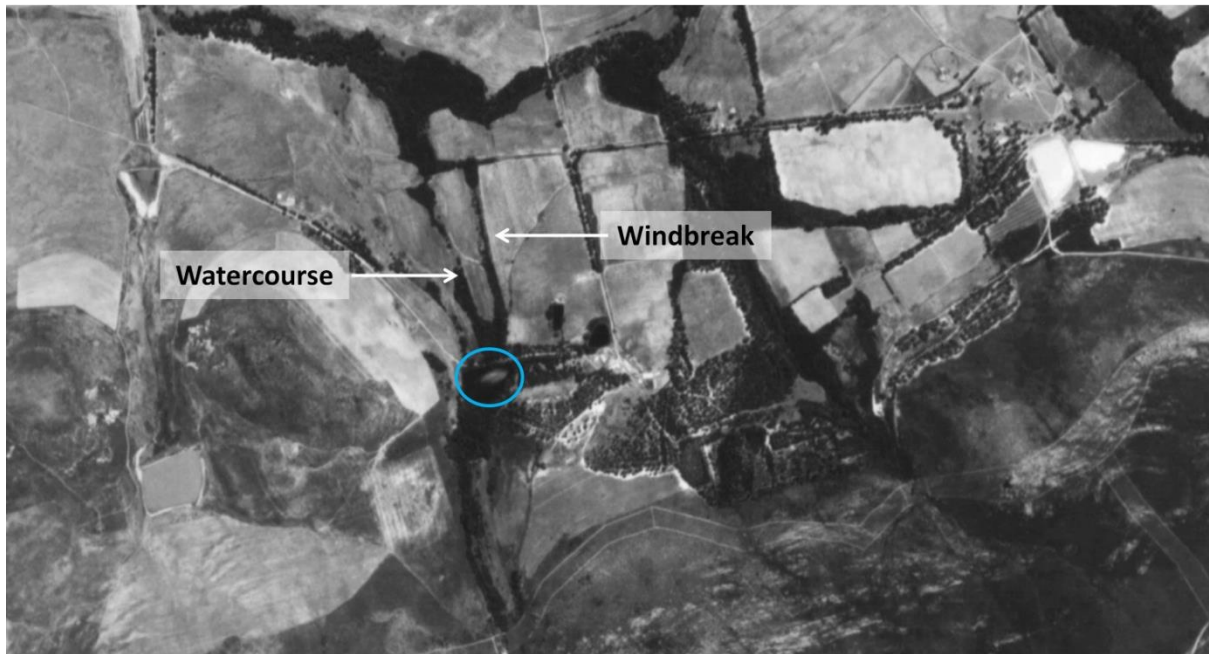
Historical aerial imagery was obtained from the Chief Directorate: National Geo-spatial Information. Bosse Dam was constructed on Lower Schoonberg Farm many decades ago, and is visible on historical aerial photographs from 1968 (Figure 6). Downstream of the embankment was a straight line of trees which was probably *Eucalyptus* trees planted as a windbreak. The less linear line of vegetation almost parallel to the west of the windbreak was probably the original watercourse which has been obscured by recent clearing.

Figure 6. Historic aerial photo dated **1968** showing evidence of Bosse Dam (blue) and agricultural activities.

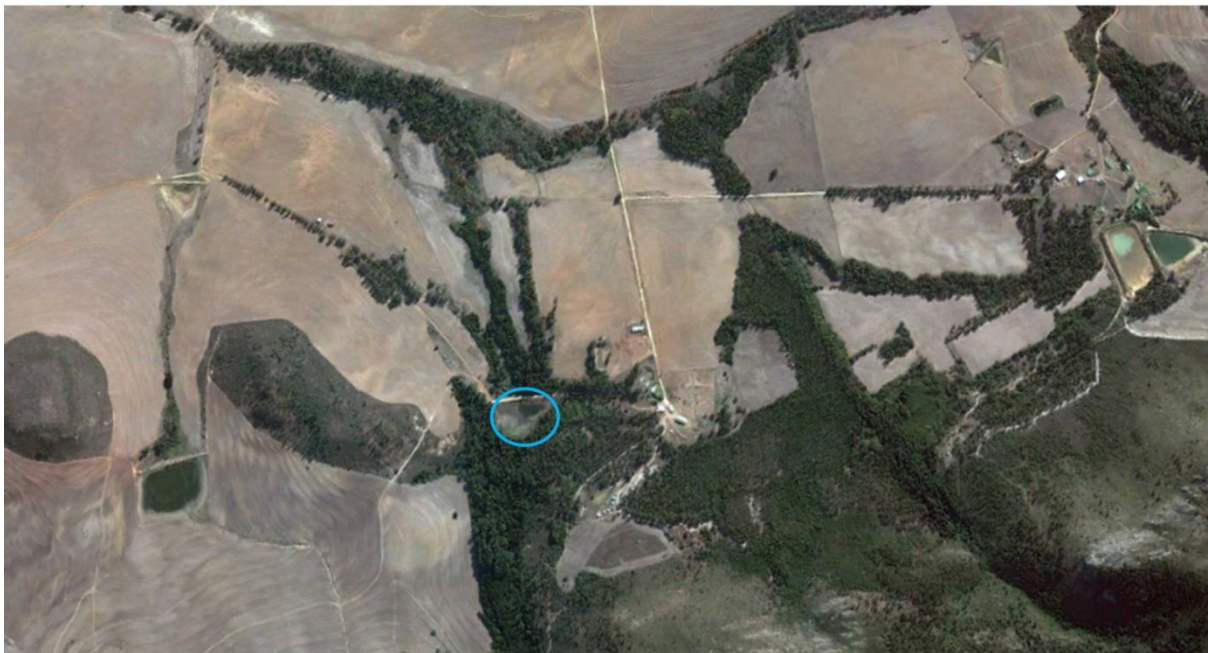
Between the end of October 2018 and January 2019 the vegetation bordering the dam, as well as the full extent of riparian vegetation below the dam along the watercourse flowing into the Brak River, has been cleared (Figure 7 and Figure 8). According to the land-owners, this vegetation mostly consisted of alien plants such as *Eucalyptus*, which was burnt in a wild-fire towards the end of 2018. Some of the excavated sediment from the dam and the burnt plant material has been used as infill along the watercourse, and the original watercourse downstream of the embankment cannot be easily distinguished.

Figure 7. Satellite image showing Bosse Dam (blue) dated **October 2018** prior to clearing activities.

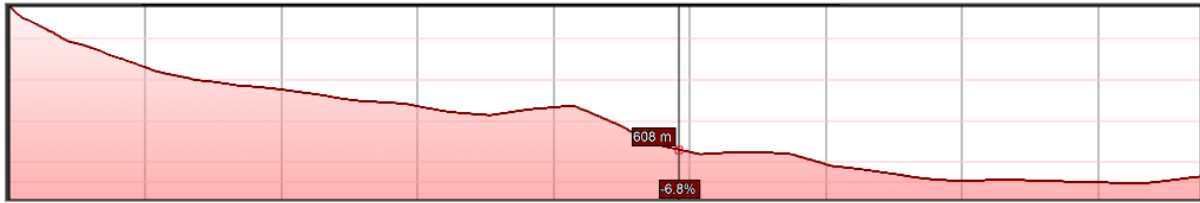
The longitudinal profile for the Suikerboslaagte Stream from the hills upstream of the dam to the approximate confluence with the Brak Stream is shown in Figure 9. Below the dam wall the terrain slopes gently until it becomes approximately flat. The area in the vicinity of the confluence is also very gently sloping with very broad valley sides adjacent to each watercourse. As a result the watercourse is largely unconfined in a broad valley bottom. This is why the channel when present is indistinct, as apart from disturbance related to clearing activities, the gradient is too gentle to result in the distinct formation of a channel in places.

Figure 9. Longitudinal profile for Suikerboslaagte Stream with vertical line indicating the approximate location of the dam embankment.
