PO Box 10865, George, 6530 Email: jan@janbrink.co.za Our reference: JB2049-02 Your reference: Bosse Dam 2020-10-03

RE-ASSESSMENT OF BOSSE DAM SURVEY, SCHOONBERG FARM

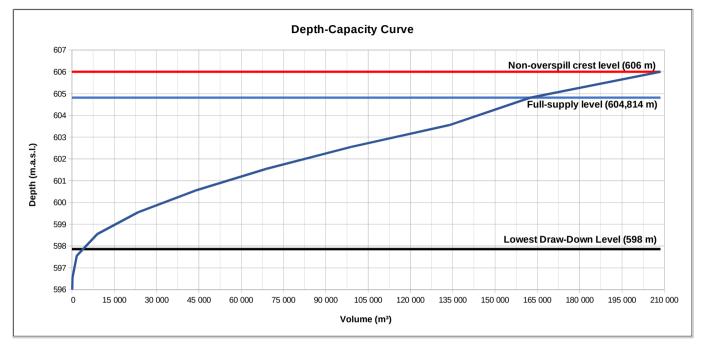
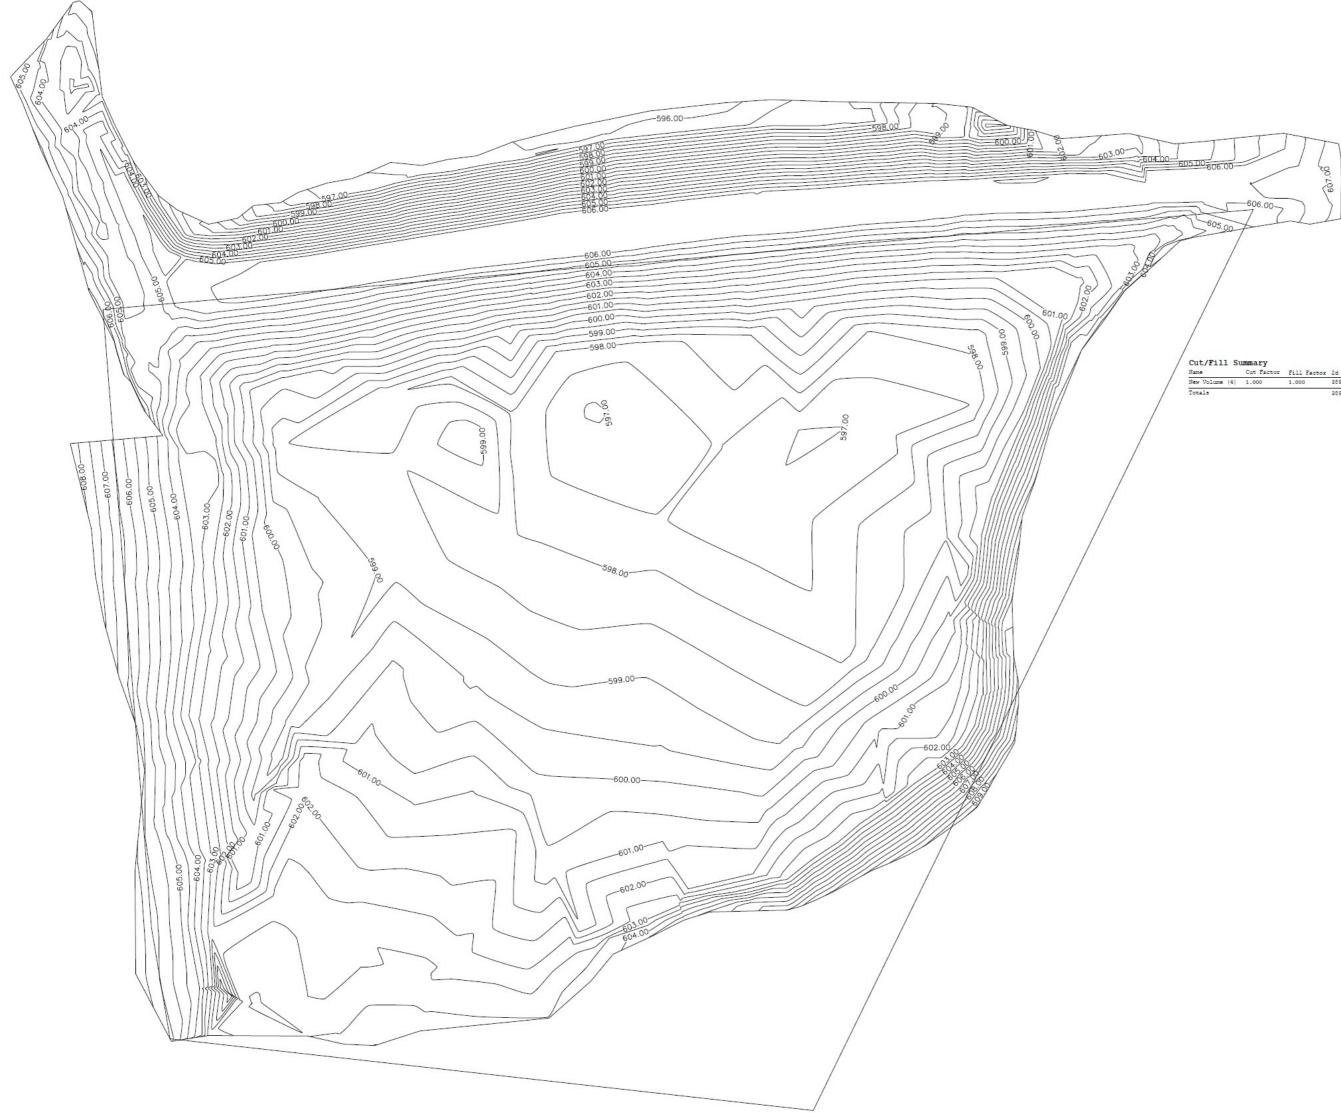
CAPACITY CURVE (UPGRADED DAM)

ut/Fill Summary									
ame	Cut Factor	Fill Factor	2d Area	Cut	Fill	Net			
ew Volume (4)	1.000	1.000	38918.21sg.m	164708.76 Cu. M.	2181.00 Cu. M.	162527.76 Cu. M. <cut></cut>			
otals			38918.21sq.m	164708.76 Cu. M.	2181.00 Cu. M.	162527.76 Cu. M.«Cut»
