GARDEN ROUTE BOTANICAL GARDEN - DAM MAINTENANCE MANAGEMENT PLAN

**Rehabilitation of flood damage to the George Botanical Garden
dam wall: Aquatic specialist inputs & Environmental Control**

Prepared for SMEC (Project C1945) and the George

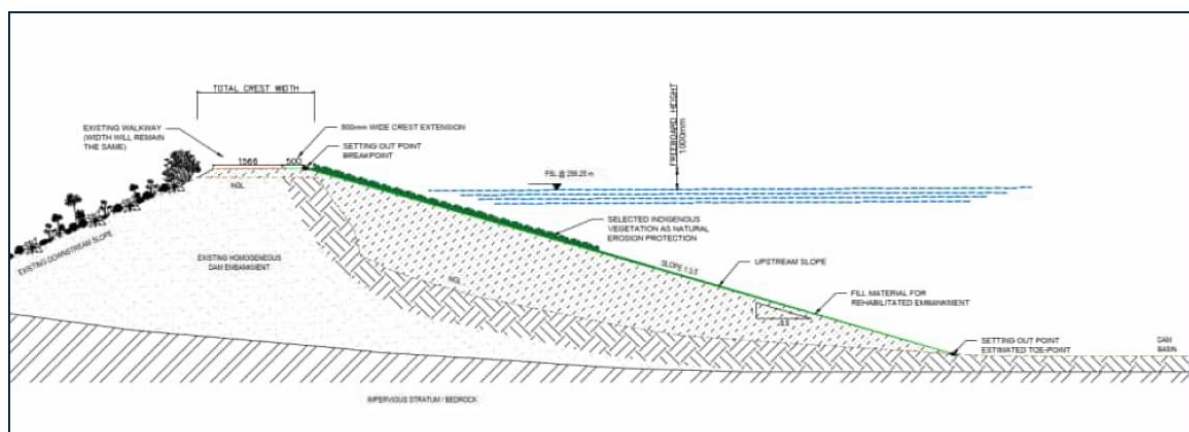
The SMEC report provides detailed design and methods for rehabilitation and maintenance of the dam (SMEC, 2023). A cross section of the proposed rehabilitation of the upstream embankments is provided in Figure 3 which depicts a relatively flat slope of 1:3.5. The aim of is to improve stability, reduce erosion, increase safety during maintenance work, and reduce the risk of foundation conditions that are difficult to detect. The proposed rehabilitation measures would result in the Full Supply Capacity of the dam reducing from 27 818 m³ to 20 412 m³.

Figure 3. Cross section of the new proposed upstream embankment (SMEC, 2023).

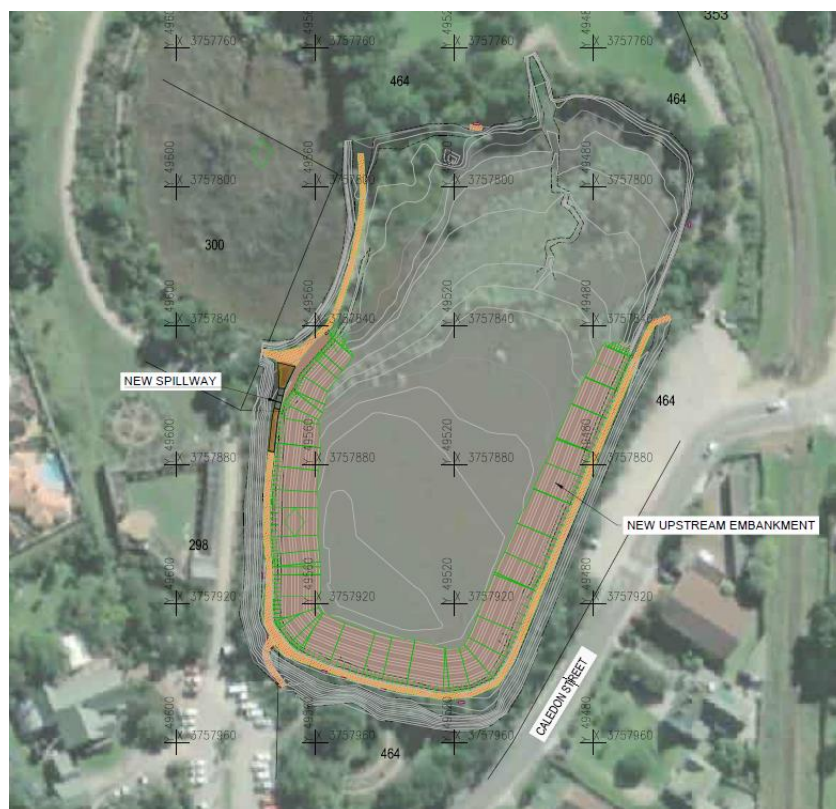
- Construction of new spillway at the location of existing overflow pipes which discharge into an existing open channel connecting to the stormwater system in Caledon Street (Figure 4).

Figure 4. Surveyed layout of the dam relative to surrounding area indicating location of the existing spillway to be upgraded (SMEC, 2023).

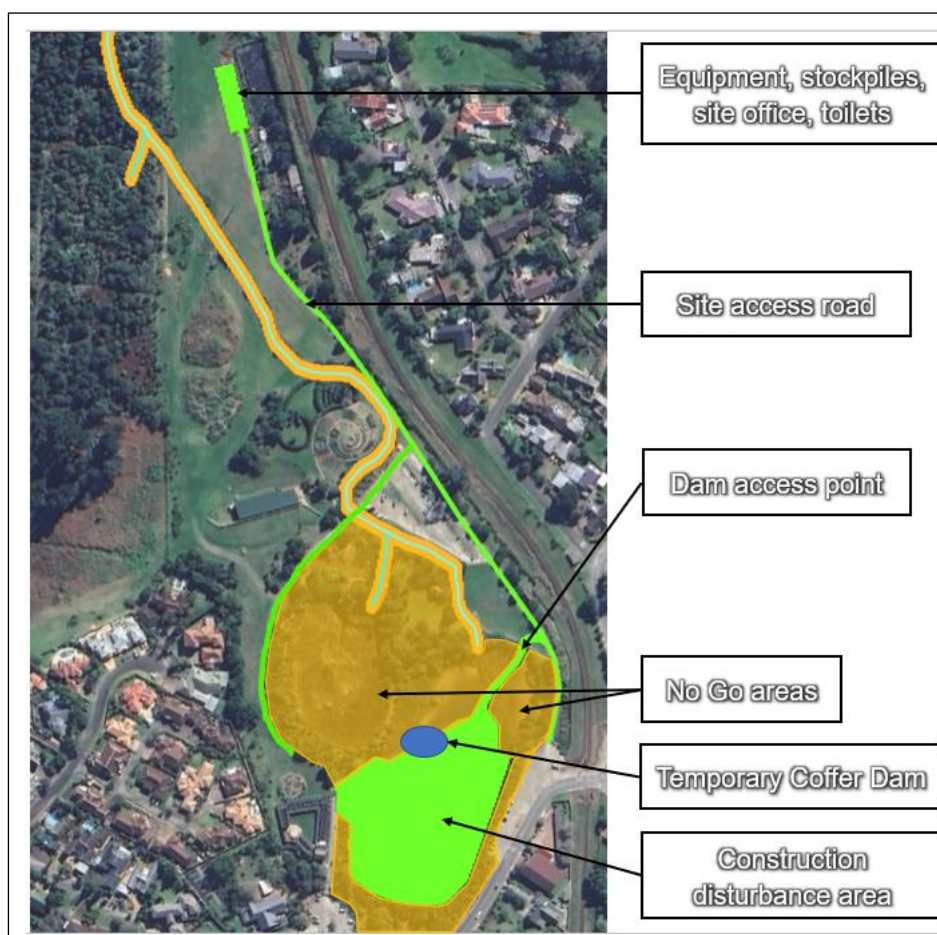
Figure 12. Annotated photo of the site showing access point, temporary coffer dam, site office locations, and no-go zones during the construction phase. Orange colour indicates 'No-go' areas while green indicates areas of disturbance expected during construction.

- Construct the coffer dam in line with the inflow from the furrow, between the construction area and No-Go area indicated in Figure 12. The dam should have a 'low' side with a gentle slope where terrapins can climb out, bask in the sun and move over land inside the No-Go area if they wish. Water lilies and other aquatic plants can be placed in the coffer dam to provide shelter and food.
