Maintenance Management Plan for the Bigai River Floodplain, Knysna, Western Cape.

Prepared for: Knysna Municipality

May 2023 (updated September 2023)

of **Confluent Environmental (Pty) Ltd**

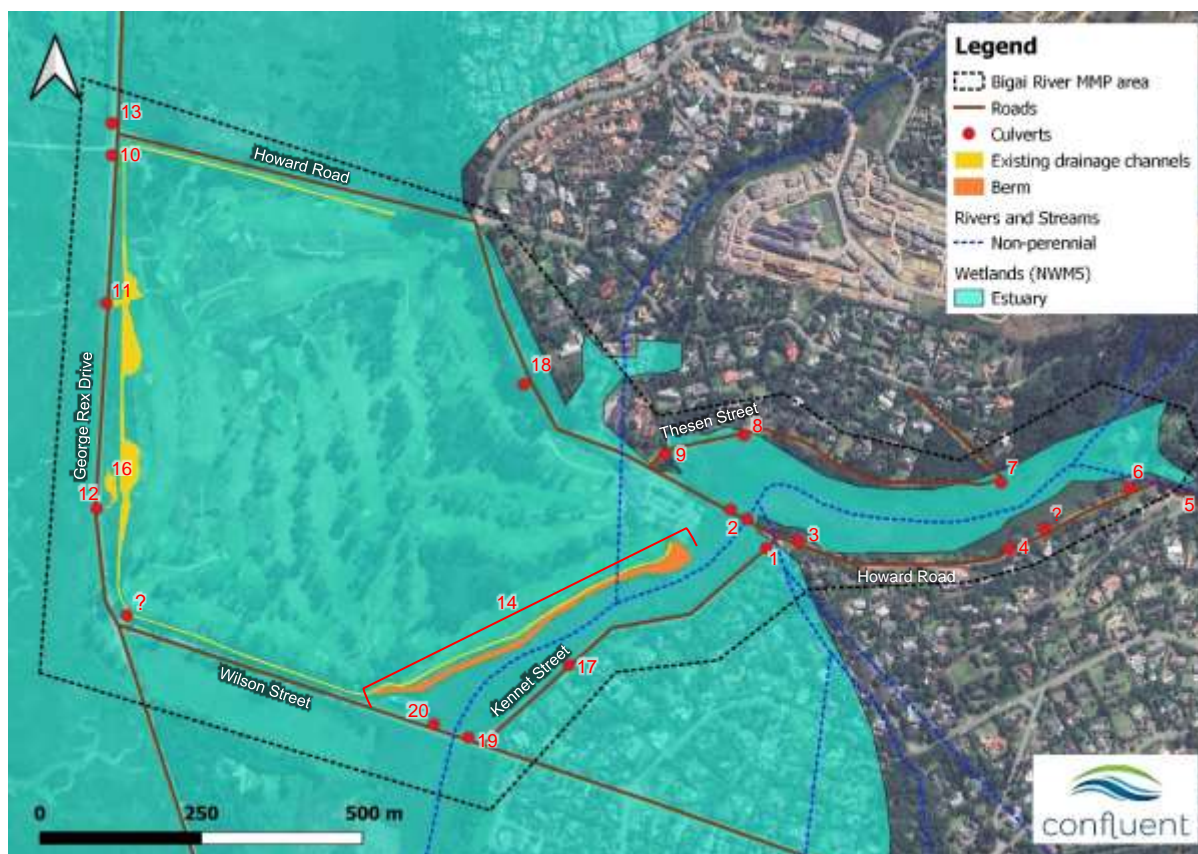
Figure 2. Area covered by this MMP indicating infrastructure and areas where maintenance is required.

Photos of infrastructure and points where maintenance is required are presented in Table 9. The coordinates of each site are indicated and correspond with points indicated in Figure 2. Most culverts could be located, but some are well hidden by dense vegetation which will require clearing to access and maintain. Many culverts were completely blocked with reeds and silt and had standing water in them.

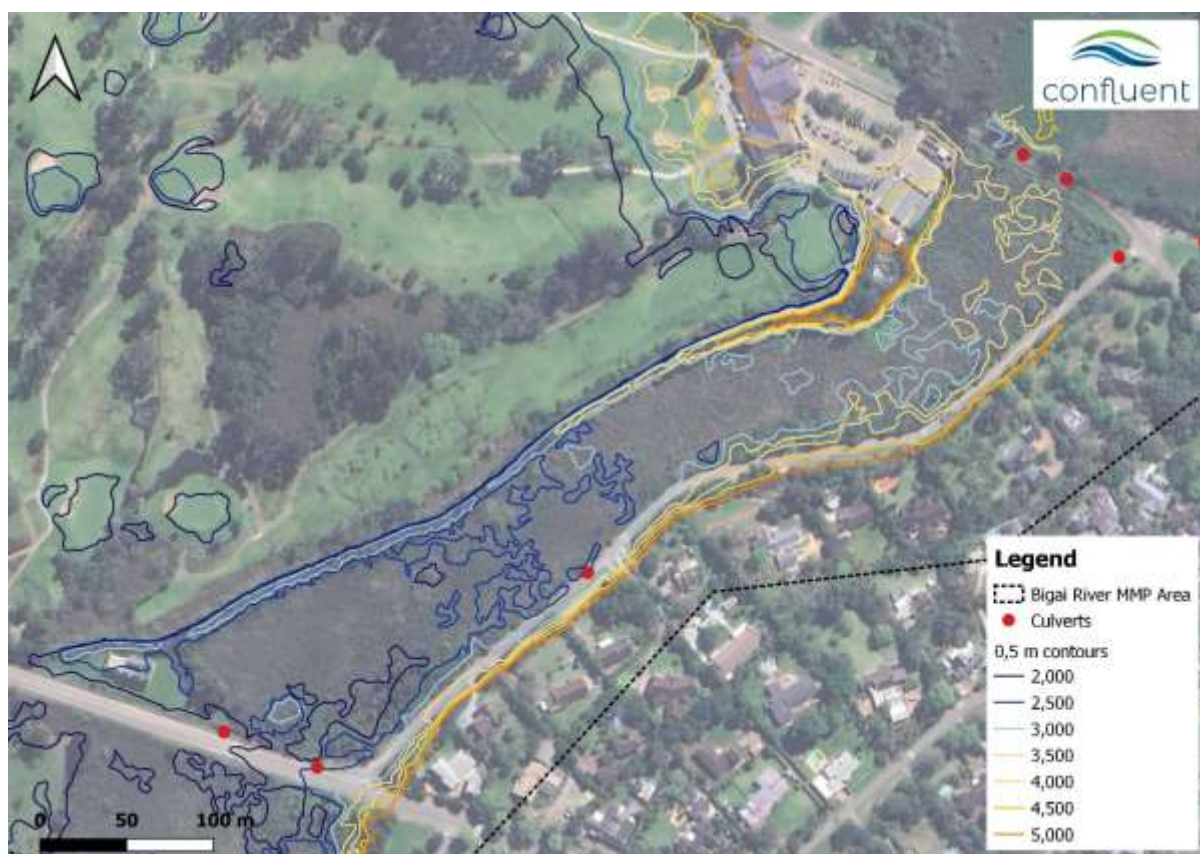
Islands of sediment around Howard Street range between 3.5 and 4.0 m.a.m.s.l (light yellow in Figure 9). The height gradually decreases downstream to Wilson Street where elevation ranges between 2.0 and 2.5 m.a.m.s.l (medium to darker blue in Figure 9).

- The Knysna Golf Course is at a lower level than the Bigai River. The Golf Course ranges between 0.5 and 2.0 m.a.m.s.l, which means the Bigai River in the area around Howard Street is approximately 1.5 m to 2.0 m higher than the golf course. Assuming that the golf course and wetland were on more-or-less the same contours in 1936 this means a large quantity of sediment has accumulated in the wetland.

- While height differences are minimal between Howard and Wilson Street, there is still a gradual decrease in levels in a downstream direction indicating that flow downstream would be maintained, albeit at a slow rate.
- There did not appear to be obvious plugs of sediment upstream or downstream of the few culverts which appear in relation to contours in Figure 9 (2013), indicating that sediment may be quite evenly distributed through the wetland. This makes sense because there are no channelled sections of the wetland, with water dispersing fairly uniformly across the site. However, this could only be confirmed with a repeat survey similar to that presented here.

Figure 9. Contours of the Bigai River between Howard Street and Wilson Street in relation to culverts. Based on 2013 Lidar survey of coastal areas (DEA&DP).

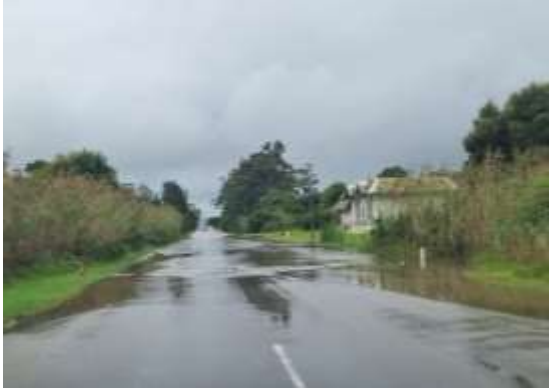
34° 3'42.07"S, 23° 4'31.46"E
Thesen Street

34° 3'13.13"S, 23° 4'17.58"E
Wilson Street. Water flows over the surface of the wetland preferentially towards the electrical sub-station which is not aligned with culverts.

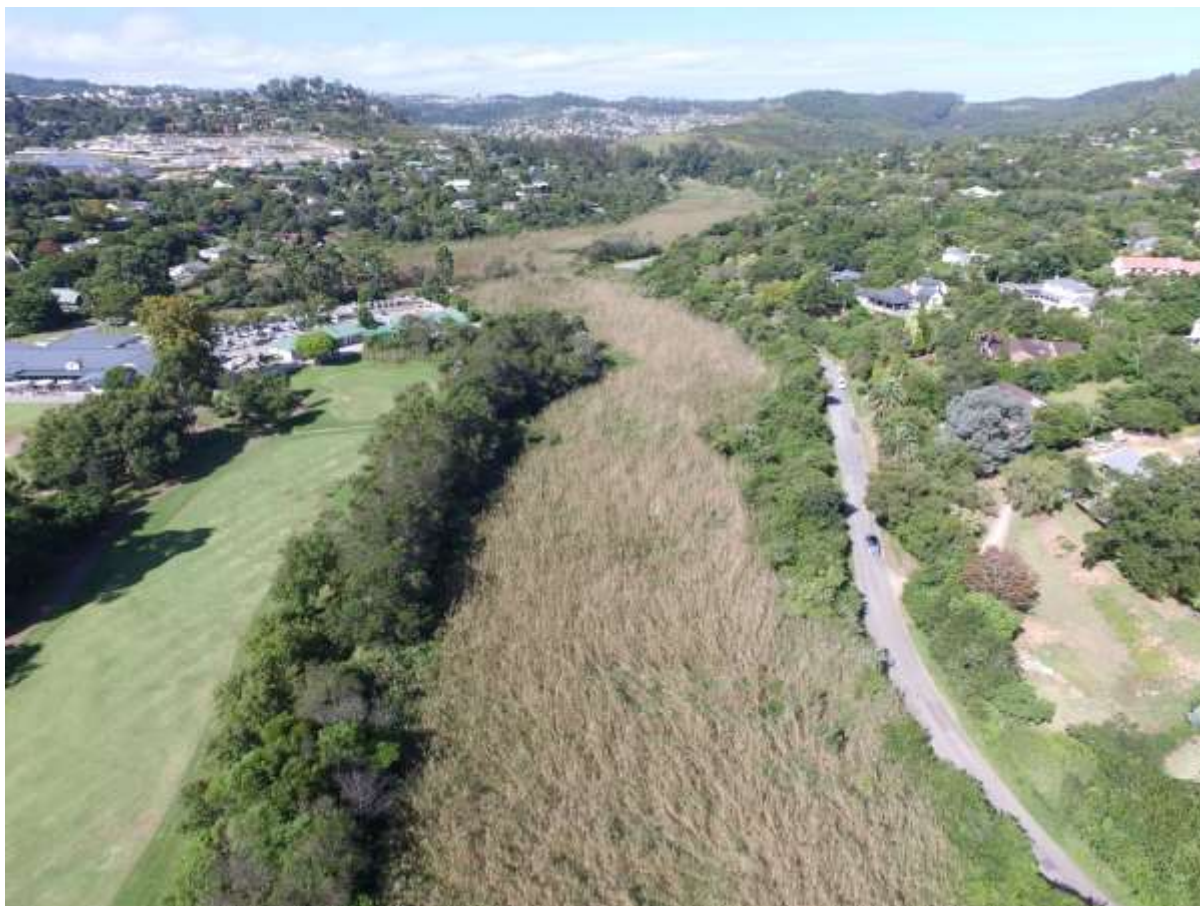
The extent of the Bigai Wetland assessed in this report is indicated in Figure 2. This section of the wetland is classified as an Unchannelled Valley Bottom Wetland according to Ollis *et al.* (2013). No channels have formed within the wetland despite high volumes of stormwater inflow (Figure 13).

Figure 13. Drone image of the Bigai Wetland looking north-east with the 9th hole of the golf course to the left, and Kennet Street to the right.
