OUTENIQUA SENSITIVE COASTAL AREA EXTENSION REGULATIONS: Environmental Impact Report for minor activities

Construction of new primary dwelling of Erf 222 Buffalo Bay; paving of existing gravel driveway to erf from Main Road; elevated walkway within Main Road reserve to entrance & paved parking bays within Main Road reserve.

Erf 222 Buffalo Bay, Knysna

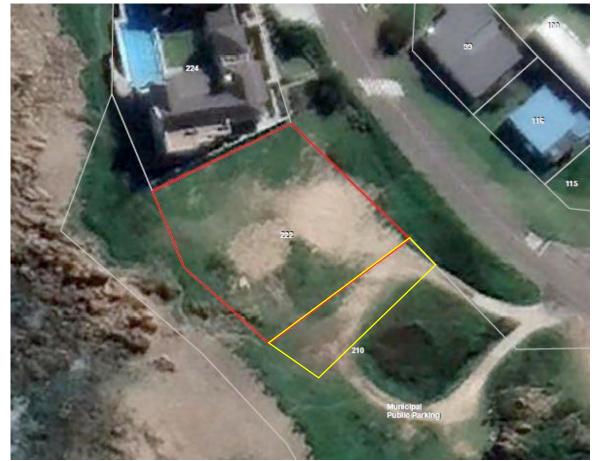
Aerial image indicating Erf 222 **(red polygon)** & neighbouring property cadastral boundaries (courtesy Google Earth Pro, 2021). Yellow polygon indicates approx. portion of Erf 210 under Encroachment Agreement.

It is the intention of the Applicant to make use of the transformed portion of the municipal Erf 210 directly adjacent to and east of Erf 222 as a temporary construction site camp & stockpile are. When the construction is completed the landowner of Erf 222 intends to rehabilitate this area with locally occurring indigenous plants, as prescribed by the Encroachment Agreement with the Municipality for continued access across this portion of land (see Appendix C for Plan of area considered under the Encroachment Agreement between landowner of Erf 222 and the Municipality). The intention to re-instate the low bollard fence along this disturbed portion of land and access road (in terms of the Encroachment Agreement) will reduce unauthorised vehicle access (and associated trampling of vegetation and compaction) to the seashore. There is a small 'island of vegetation', as well as a designated public vehicle access and parking to the braai area on Erf 210 further to south-east, which will not be affected by the proposed activities on Erf 222 or in terms of the Encroachment Agreement.

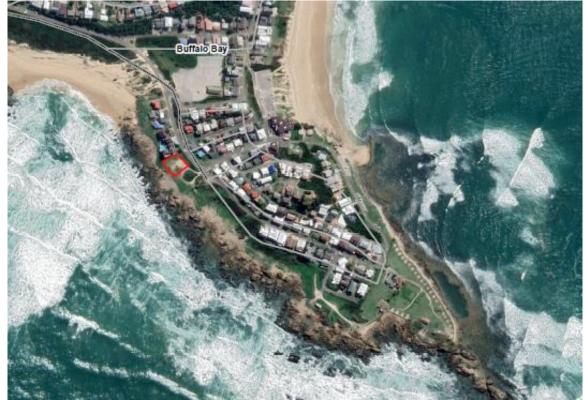
Buffalo Bay headland and coastline (Google Earth Pro 2021). Erf 222 indicated as red polygon.

Erf 222, Buffalo Bay is located on a convex portion of rocky coastline, on the western side of a headland which protrudes south-east into the sea. Approx. 70m to the north-west a concave beach extends west. The seashore is predominantly rocky, with rock pebbles, directly in front and to the south and east of Erf 222, Buffalo Bay (refer to Figures below). A section of sandy beach starts approx. 70m away to the north-west.
